Material Received for Examination

Imploded steel tube sample, identified by the Ordnance Group as no. 28, was received for metallographic examination. This sample was in three pieces with deep cracks running in a radial direction. Some cracks went from the center to the outside while others went within a fraction of an inch of the outside. The general shape was somewhat suggestive of a clover leaf, Fig. 1.

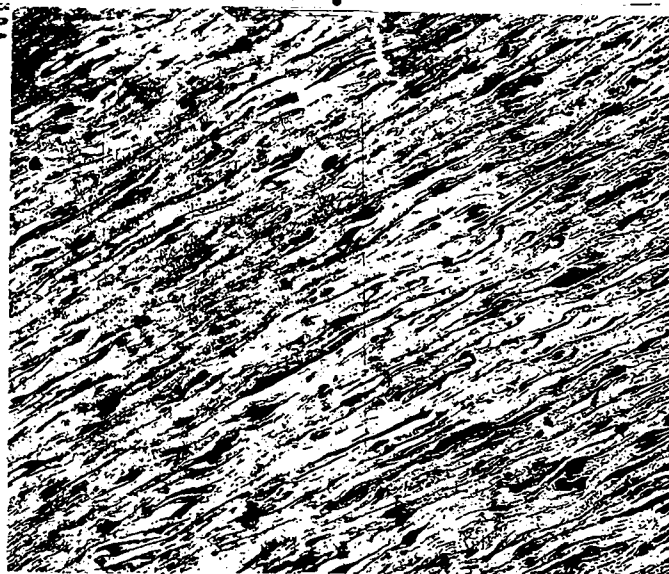
Microscopic examination of the dark and the light areas showed as in the earlier sample that the dark areas were characterized by what appeared to be profuse Neumann bands, while the light etching areas were comparatively free of banding. The Neumann bands observed on this sample were more chaotic and less distinguishable as individuals than on the previous imploded sample 21. There is possibly a slight doubt that they are Neumann bands, but intermediate etching zones seem to show Neumann bands, and hence it is inferred that the dark etching areas are areas of exceedingly profuse bands which can not be distinguished as individuals. Figs. 2-5 show the structure of various sections cut from the slab. The elongated grains shown in Fig. 2 are characteristic of transverse areas near the center of the section. Fig. 3 shows almost an equi-axed grain structure near the outside of the section. Examination of this sample showed that the grains became progressively elongated toward the center or banded region. The longitudinal sections, characterized by Figs. 4 and 5 for the banded, interior areas, show a fairly equi-axed grain structure.

Fig. 2 Area of Profuse Neumann Bands
Transverse Section X 100
Etching reagent: 1% nital
Photo no. 2009

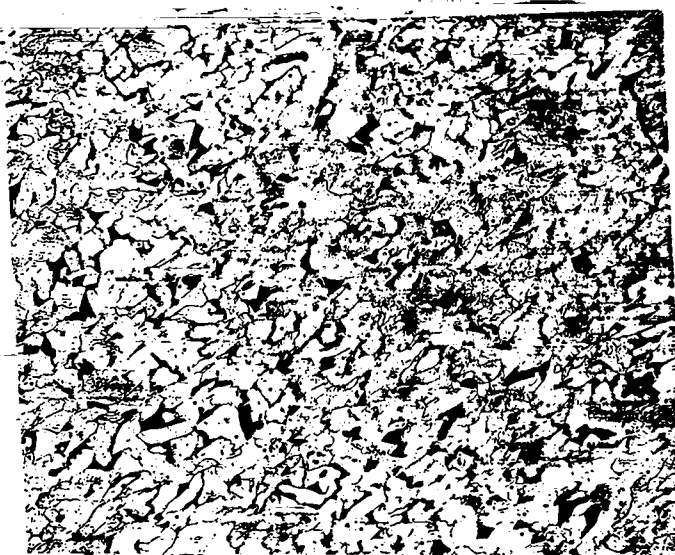
Fig. 3 Area of Normal Structure
(few or no Neumann Bands)
Transverse Section X 100
Etching reagent: 1% nital
Photo no. 2010

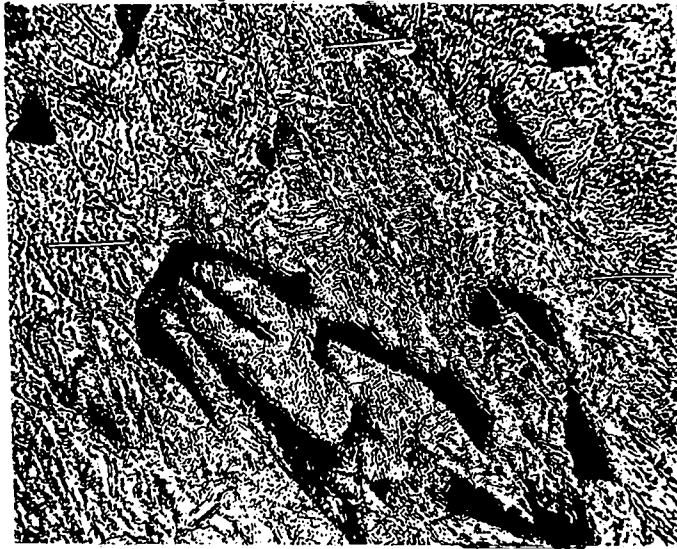
Fig. 4 Area of Profuse Neumann Bands
Longitudinal Section X 500
Etching Reagent: 1% nital
Photo no. 2011-1

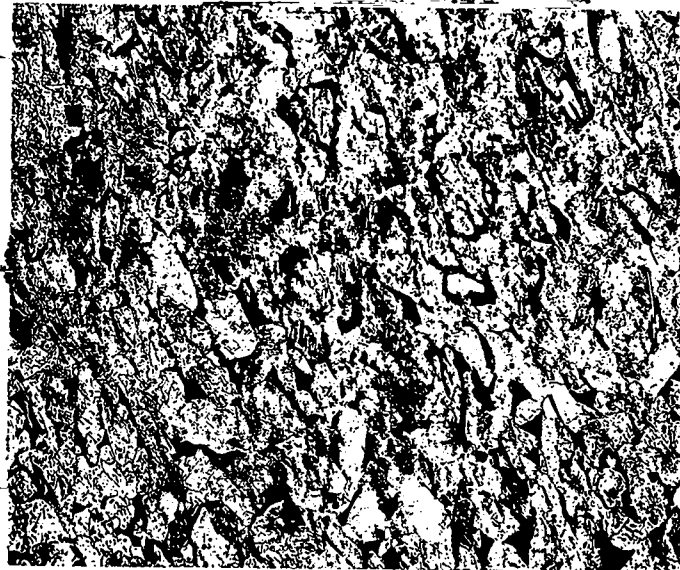
Fig. 5 Area of Profuse Neumann Bands
Longitudinal Section X 100
Etching Reagent: 1% nital
Photo no. 2011-2
