LESSONS LEARNED FROM EARLY CRITICALITY ACCIDENTS

Richard E. Malenfant
Los Alamos National Laboratory

Nuclear Criticality Technology Safety Project Workshop
Gaithersburg, Maryland
May 14-15, 1996

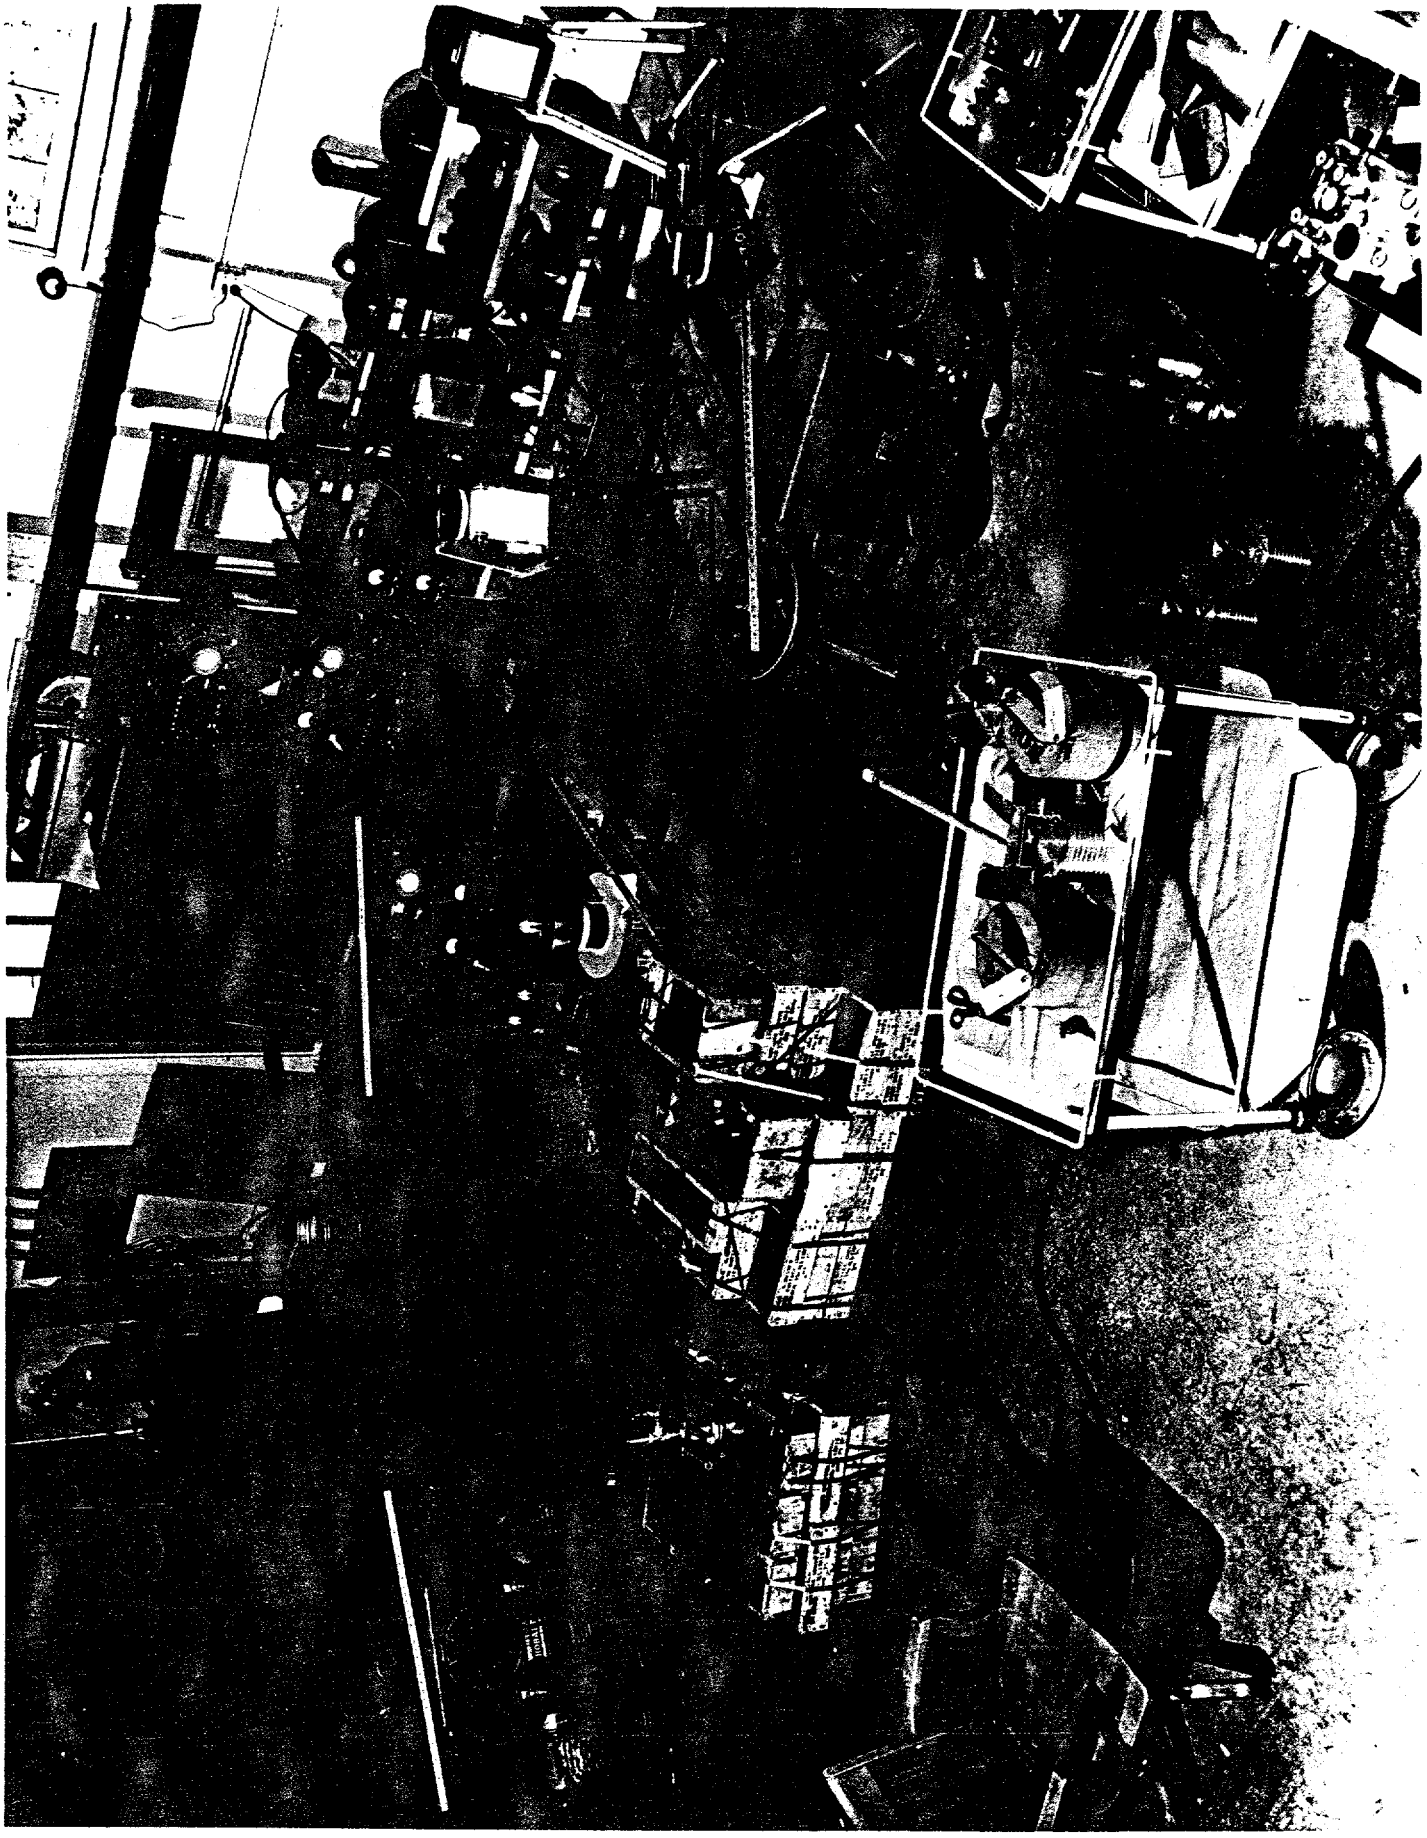
The area in which the experiment was conducted was cluttered and non essential equipment and personnel hampered the operation (Fig. 1).

Although it is argued (see attachment) that the experiment was not done carelessly, the condition of the experimental area and presence of non participants indicate a cavalier disregard for all but the most rudimentary safety features.
