NUCLEAR-CRITICAL ACCIDENT AT THE LOS ALAMOS
SCIENTIFIC LABORATORY ON DECEMBER 30, 1958

LAMS-2293
HEALTH AND SAFETY
(TID-4500, 14th ed.)

H. C. Paxton
R. D. Baker
W. J. Maraman
Roy Reider

This report is an informal account of the findings of a Los Alamos Scientific Laboratory committee appointed to investigate the circumstances surrounding the nuclear-critical accident that occurred at the Laboratory in December of 1958. It has been prepared to distribute the information as promptly as possible and presents the facts known at the time of writing.

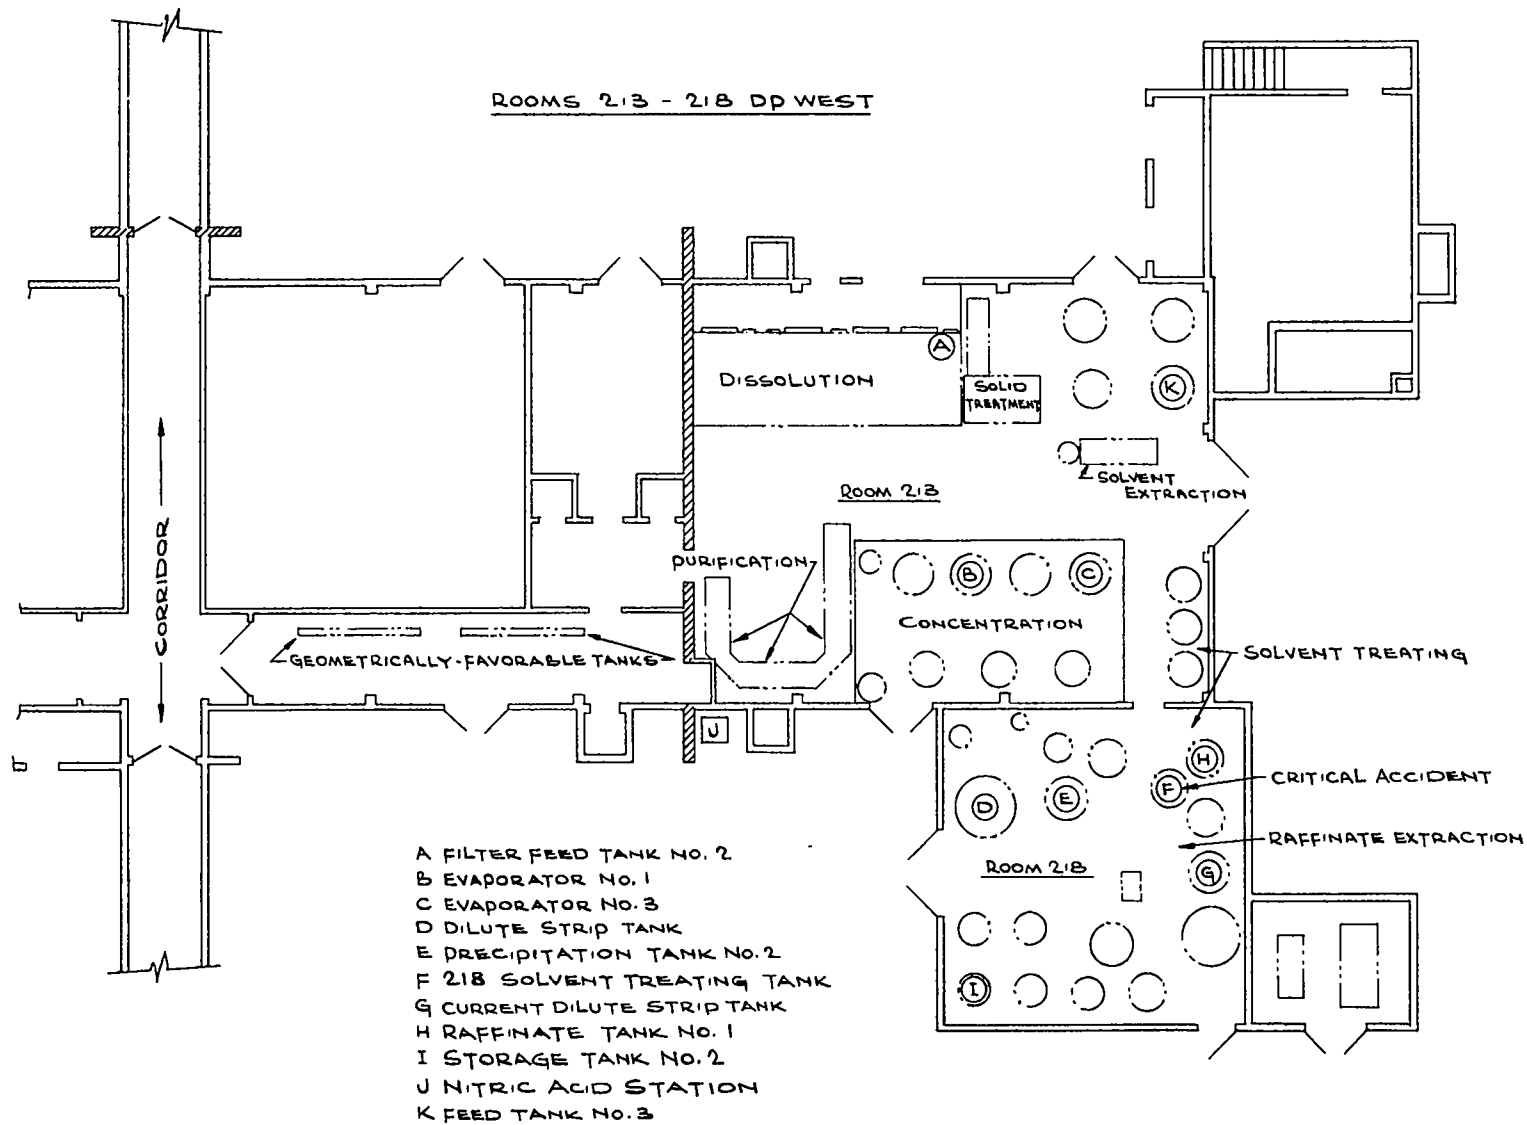
Fig. 3 Layout of equipment in area where accident occurred.

Material transfers leading up to the accident were as follows (refer to Fig. 3 for container locations).

1. Dilute Strip Tank: Fifty gallons of water had been previously added and agitated to attempt to dissolve an estimated 20 lb of solids in the bottom of this tank. This slurry was transferred into the Current Dilute Strip Tank, and the remaining solids were flushed into that tank with a 15-gallon stream of water.

2. Evaporator No. 1: Out of a 110-gallon batch of concentrated dilute strip and peroxide filtrate, 100 gallons was transferred to Filter Feed Tank No. 2 for filtration. (This is the capacity of the tank.) The remaining 10

gallons of slurry was transferred to the Current Dilute Strip Tank.

3. Current Dilute Strip Tank: In addition to the above solutions this tank contained an estimated 320 gallons of dilute strip, 100 gallons of acidified caustic from solvent treating, 15 gallons of solvent residual from phase separation of dilute strip, and 2 gallons of a special recovery solution containing 4 g of Pu.

4. 218 Solvent Treating Tank: A 145-gallon batch of treated solvent containing 2.9 g of Pu was transferred from this tank into Raffinate Tank No. 1.

5. Storage Tank No. 2: This tank contained an 80-gallon batch of an emulsion resulting from the second treatment of a batch of solvent. This material was transferred into the 218 Solvent Treating Tank.

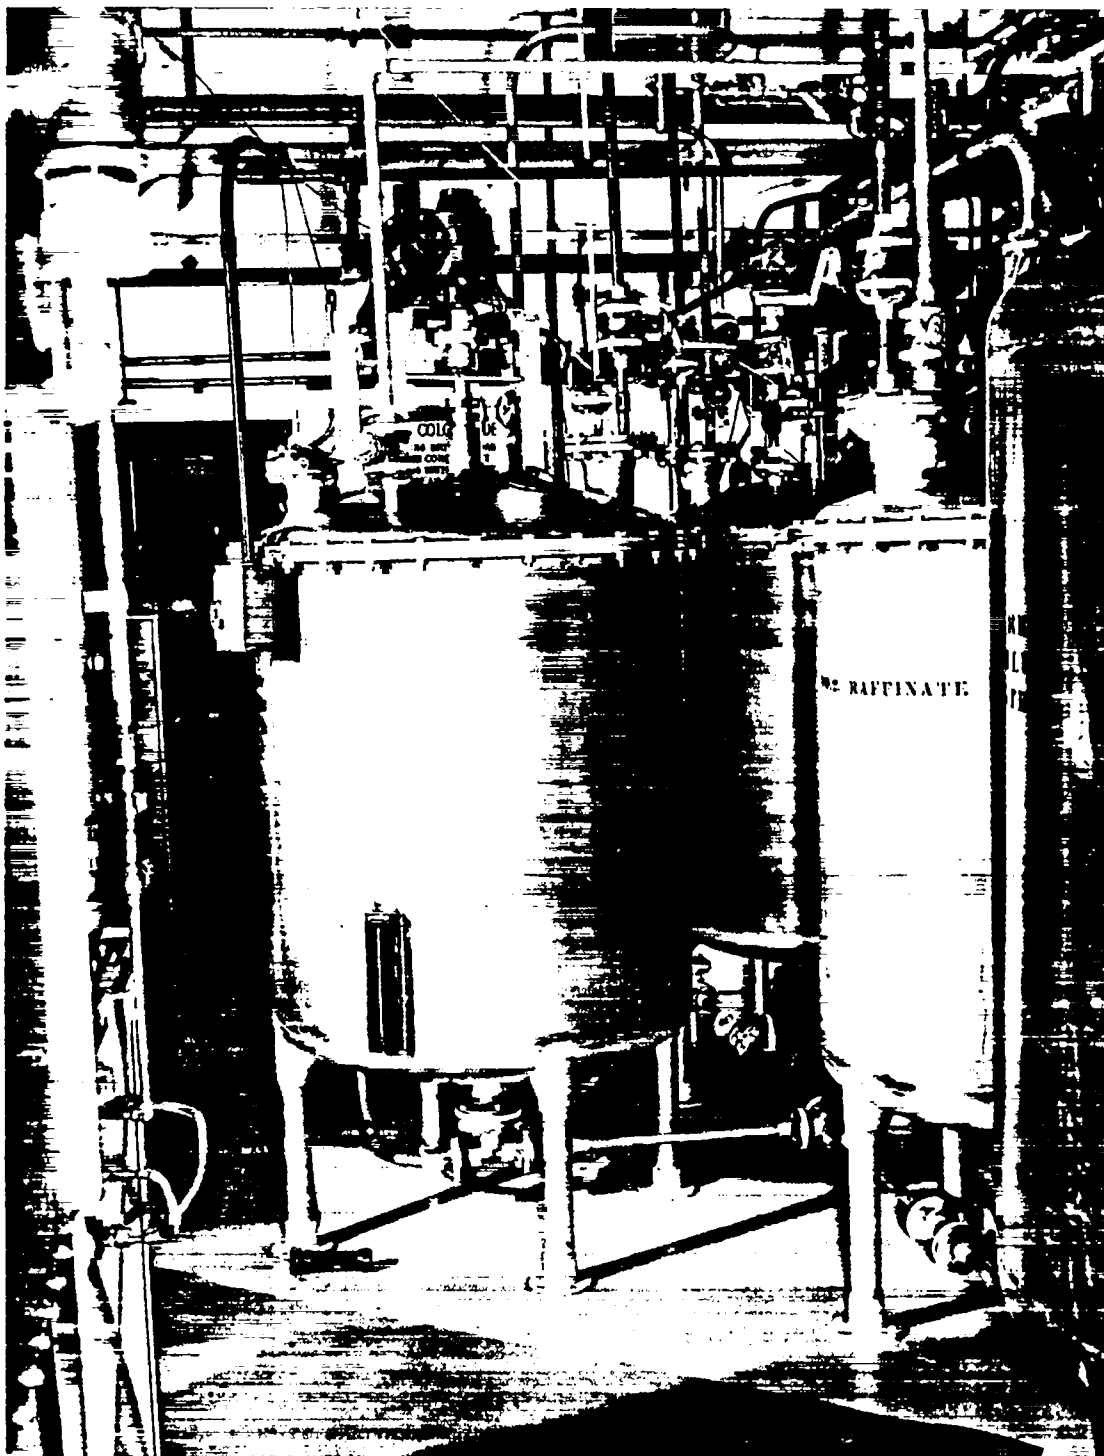
Fig. 10 218 Solvent Treating Tank.

solvent layer on top of the solution. Subsequent transfer of this plutonium-rich solvent and the nitric acid slurry of residual solids in the bottom of the tank into the 218 Solvent Treating Tank (Figs. 10, 11, and 12) acidified the emulsion, freeing additional solvent for further extraction of any remaining hydrolysis products into the combined organic phase. As in the case of the Current Dilute Strip Tank, mixing and extraction resulted from the air-sparging of this material through the bottom inlet of this tank. Upon cessation of the air-sparging the solvent phase separated into an 8-in. layer on top of the aqueous which was subcritical at this time. This thickness was determined by evaluation of the solutions in the tank after the accident. Phase separation took about 2-1/2 minutes.

A chemical operator started the motor driving the mechanical agitator in the solvent-treating tank. There was a "blue flash" and a muffled report. The operator, who was looking into a sight glass at the top of the tank (Figs. 10 and 12), was knocked off the two-step ladder on which he stood. Though the shock displaced the tank about 3/8 inch at its supports, the tank was not ruptured and no plutonium escaped. The operator apparently turned the stirrer motor off, then on again (this time noticing a rumbling sound), ran out a nearby exterior door, and called that he was "burning up." A second operator, some 40 feet away in an adjoining room, saw a reflection of the light on the walls ("like a photo-flash"), heard the report, went to help, and was joined by a third operator. Returning to lead the first man to a shower (on request, apparently as the result of suspecting an acid burn), they passed the tank, and the second operator turned off the stirrer motor.

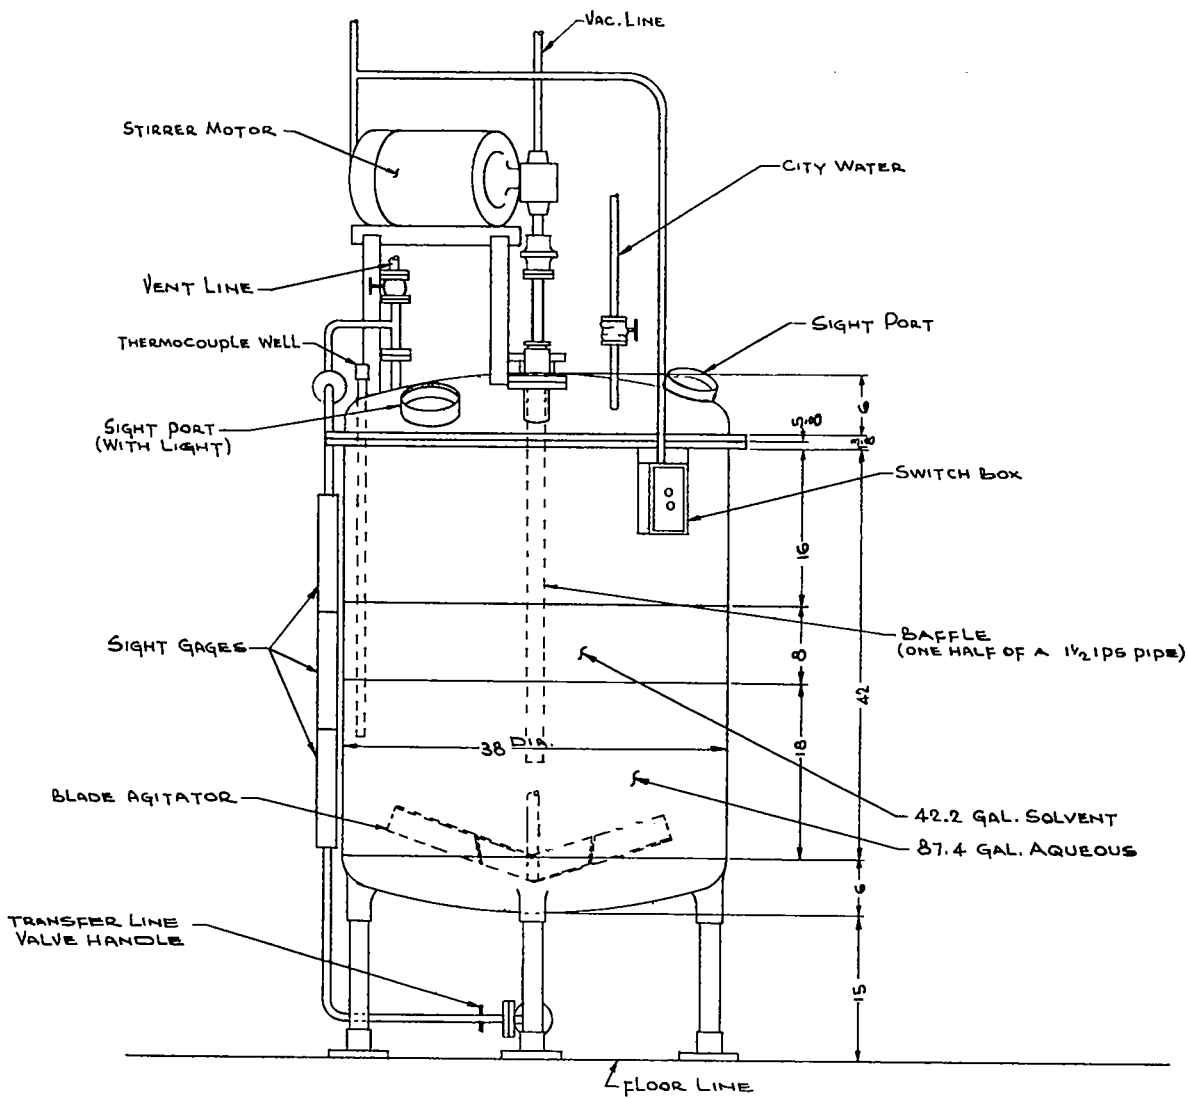
The situation in the 225-gallon, 38-in.-diameter, solvent-treating tank immediately before the accident is believed to be as illustrated in Fig. 12: 87.4 gallons of aqueous solution contained 40 g of Pu, and on top, a 42.2-gallon layer of solvent contained 3.27 kg of Pu. Solids (containing 60 g of Pu) were suspended in both the aqueous and organic phases and at the interface. Few solids settled to the bottom of the tank. Estimates based on Fig. 13, taking into account the tank diameter and effects of neutron "poisons," indicate that the 8-in.-thick solvent layer was barely subcritical at the plutonium concentration of 20 g/liter (the estimated critical thickness is 8-1/4 inches, and the actual configuration was roughly 5 dollars subcritical).

Fig. 12 Diagram of solvent-treating tank, showing levels of aqueous and organic phases before stirrer was activated.

The initial action of the stirrer in the solvent-treating tank forced aqueous solution up along the wall, displacing the outer portion of the solvent layer and thickening the central portion. An average increase in solvent-layer thickness of about 0.4 inch, corresponding to an average radius decrease of 1/2 inch, could account for the obviously supercritical configuration. The burst was certainly terminated by the violent disturbance that it generated, and continuation of the stirring diluted the plutonium beyond the point at which a critical reaction could recur.

Additional evidence that the plutonium was concentrated in the solvent layer when the burst occurred is given by the long-lived gamma activity of the stainless steel baffle (type-347) that was located about 6 inches within the wall of the solvent-treating tank (Fig. 12). Scanning indicated a peak in activity about 1 inch below the mid-plane of the solvent layer.

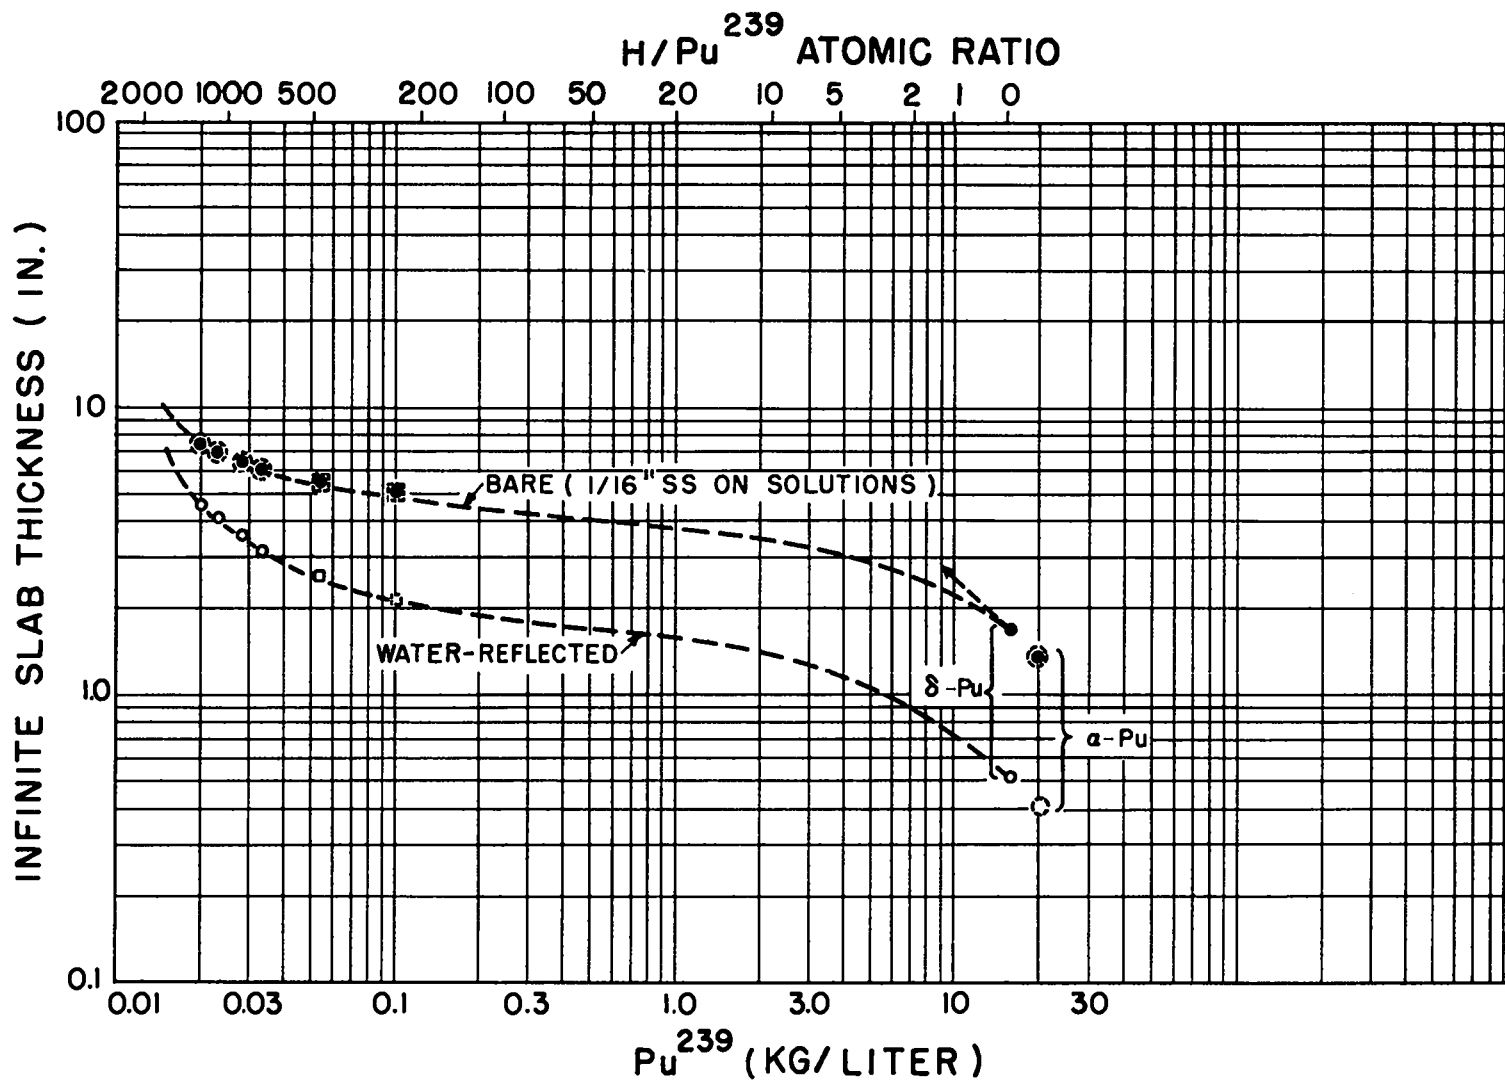
Fig. 13 Estimated critical thicknesses of infinite slabs of homogeneous water-moderated Pu^{239} in the absence of NO_3 and Pu^{240} . Based on data from F. E. Kruesi, J. O. Erkman, and D. D. Lanning, Hanford Report HW-24514, May 1952 (classified).

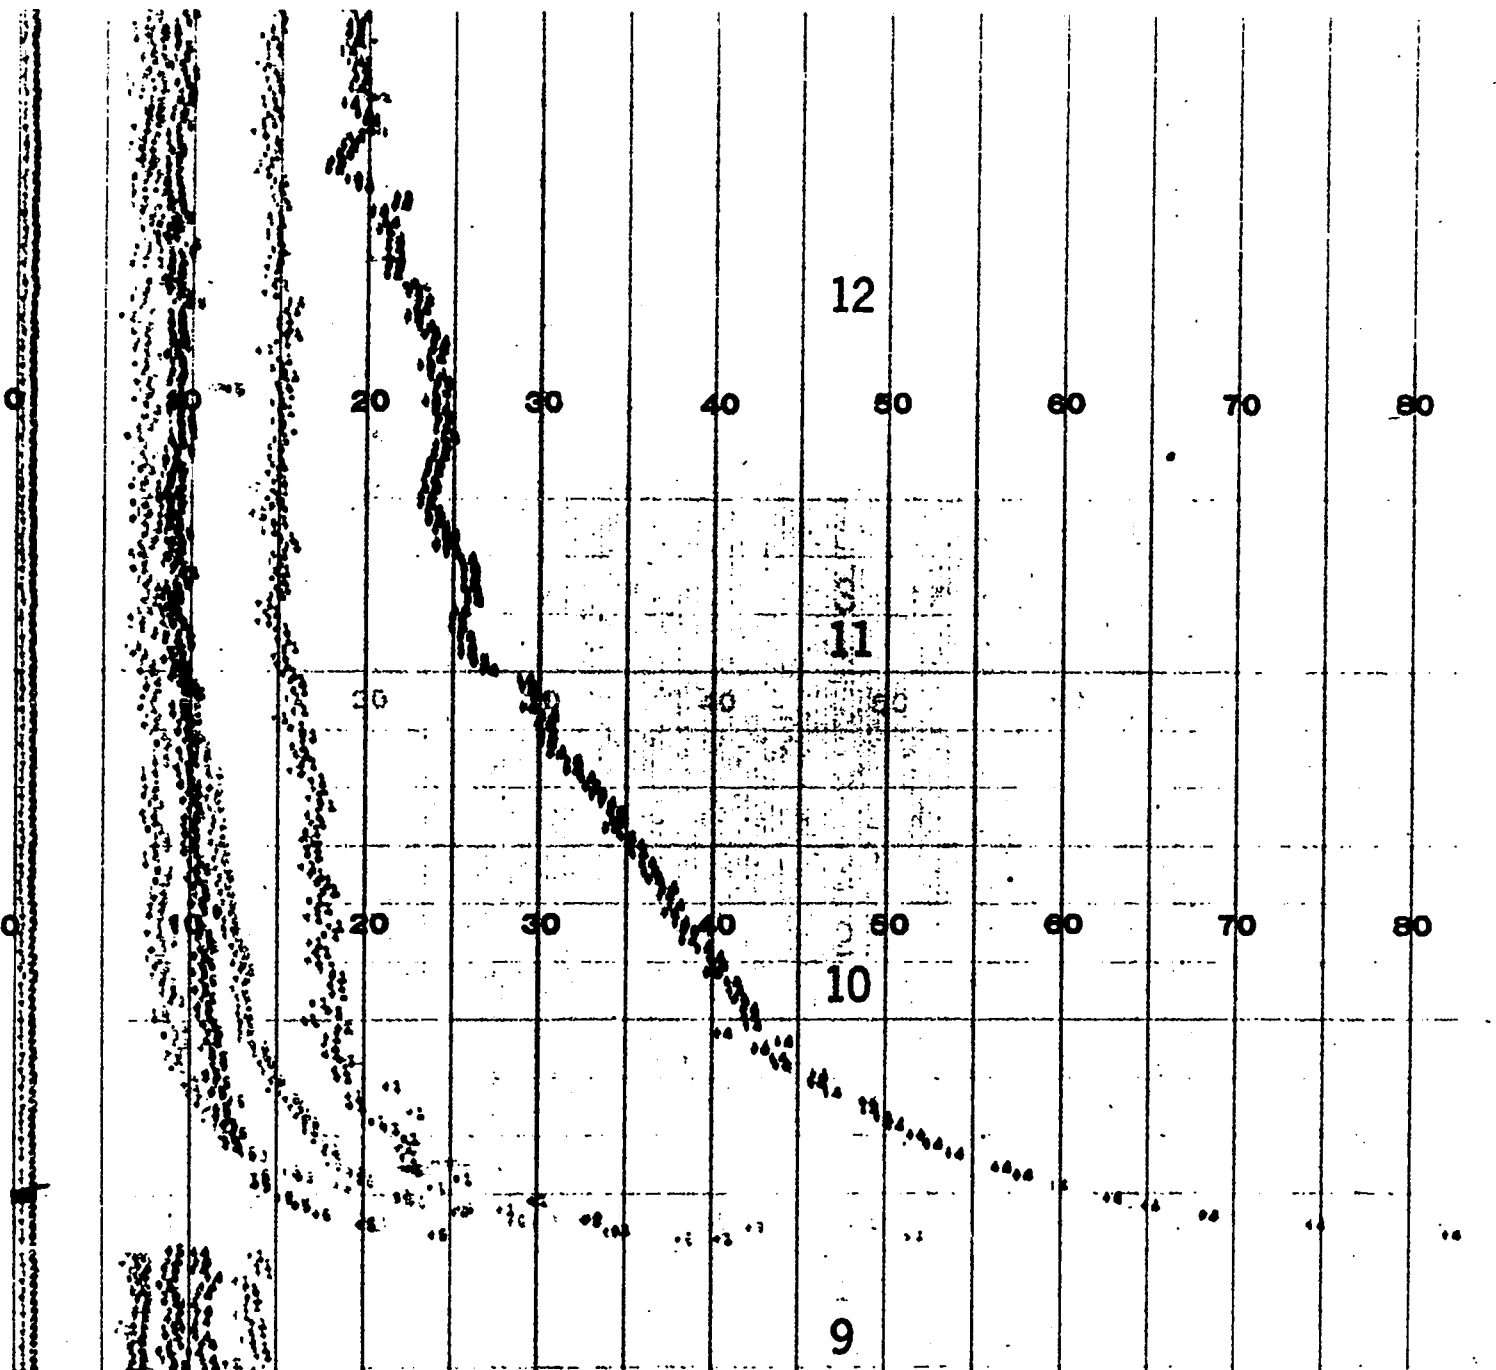
None of the gamma-sensitive recording detectors within range of the accident showed an ideal trace. They suggest, however, that there was but a single burst -- see, for example, the record reproduced in Fig. 14.

Fig. 14 Trace of slow-acting recorder (Point No. 4) located 160 ft from tank.

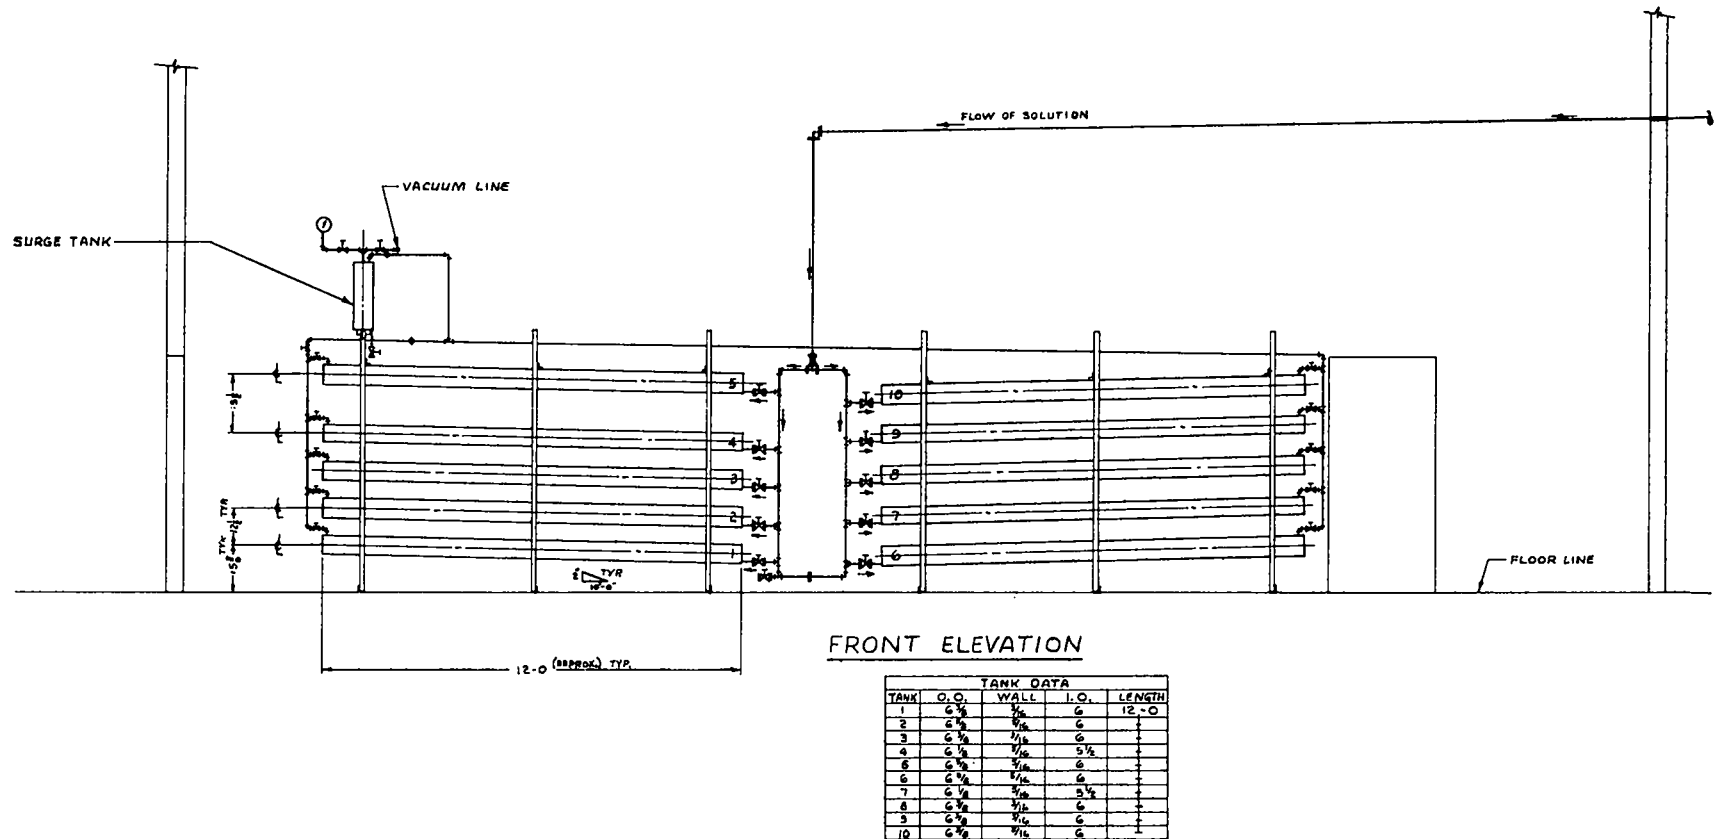
Immediately after the incident, a bank of ten 6- and 5-in.-diameter cylinders was fabricated and set up about 100 feet from the point of the accident (see Figs. 3, 15, and 16). This storage array was connected to a transfer line that leads from the bottom outlet of the solvent-treating tank. As the disposition of plutonium in the tank was then unknown, opening of the bottom outlet valve was a suspect operation and was therefore accomplished from behind a temporary shield by means of a 10-foot extension handle. The solution was vacuum-transferred into the bank of cylinders without complication on January 1, 1959. The solution level within the cylinders was followed by gamma-sensing instruments. Maximum reading at contact was about 1 r/hr, and indications along the wall of the solvent-treating tank immediately after emptying were less than 50 mr/hr.

Successive 9-liter lots of solution were removed from the storage cylinders, and each batch was sampled for chemical analysis. Results of analysis are summarized in Table 3. Not only was the bulk of the plutonium found to be in the organic solvent phase, but a concentration of Zr^{95} in a suspension at the aqueous-organic interface suggested that the situation was the same at the time of the accident. Furthermore, the chemical form in which the plutonium occurred in the solvent was consistent with the hypothesis that it had been complexed with TBP hydrolysis products.

Fig. 15 Geometrically-favorable tanks used to receive the solution.

Fig. 16 Schematic diagram of geometrically-favorable storage cylinders.
