LA-5755

Reporting Date: September 1974

**Demolition of Building 12,
An Old Plutonium Filter Facility**

**los alamos
scientific laboratory**

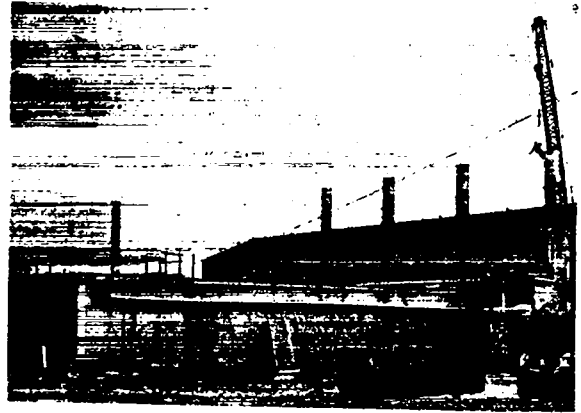
After the blower room roof (except for a section over blower No. 4 and another section over the electrical panels) was removed, work was started on removing the stacks. Figure 7 shows a rigger being raised to the top of the first 15.2-m (50-ft) stack to attach a lifting collar. The stacks had a square base that was slipped over a slightly smaller male fitting on the blower to provide the air seal. This joint had been taped and painted to make it air tight. The stack was removed by cutting the tape, cutting some external supports (which were not contaminated), and lifting the stack off the blower with a crane. The bottom of the stack and the opening of the blower were immediately covered with preassembled sheets of plywood. The stack was then placed on a lowboy, the ends were sealed with metal plates, and the stack was wrapped in plastic for hauling to the burial site. Figure 8 shows the blower room after the first three stacks were removed.

Fig. 7. Preparing to remove stack No. 1.

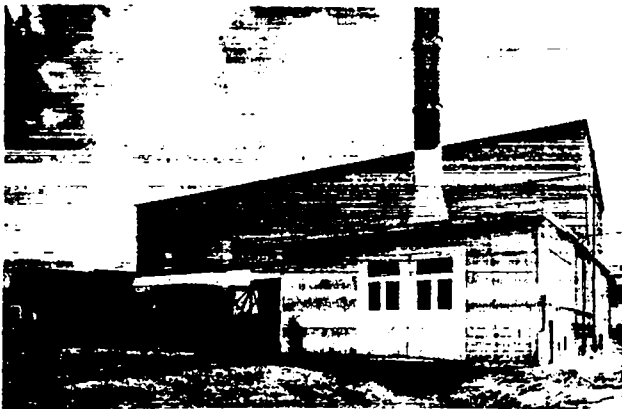
Fig. 8. Blower room after removal of stacks Nos. 1, 2, and 3.

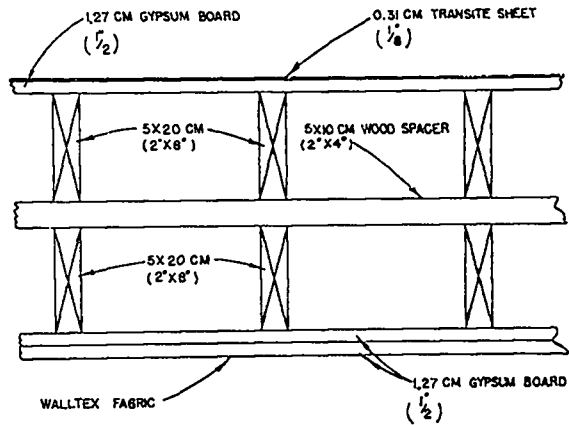
The construction details indicated that the contamination of walls and ceiling might be restricted to the first layer of material. As shown in Fig. 13, the roof was made of two layers of wood beams, 5 cm by 20 cm (2 in. by 8 in.), supported by metal I beams. The beams were covered with two layers of gypsum board and a 0.3-cm layer of transite. The final layer was a hot tar and roofing paper application. The ceiling was two layers of gypsum board covered by a fabric called "Walltex." A 1.6-mm-thick metal nailing strip was used to prevent the nails from pulling through the gypsum board when the plenum was operating at its lower air pressure. After the metal strips were pulled from the ceiling, the surface fabric layer, covered with several coats of paint, was easily pulled off leaving a nearly contamination-free surface.

Fig. 13. Details of roof construction.

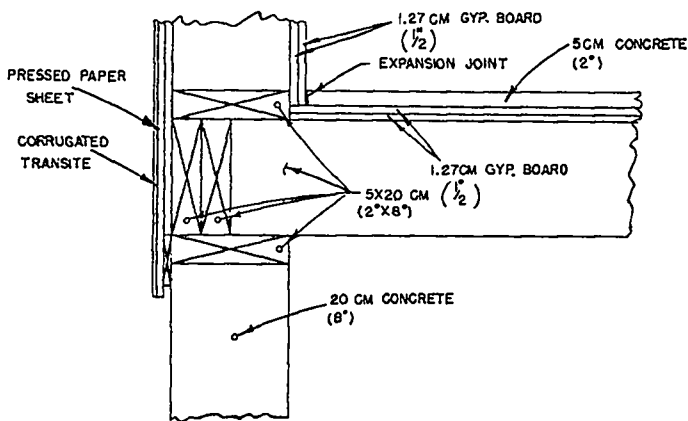
Figure 14 shows construction of the walls and floor. The walls were made of two layers of gypsum board nailed to the inside of the 5-cm by 20-cm studs. Here, too, the gypsum board could be pulled off without contaminating the studs. All exposed surfaces were immediately covered with a coat of paint to seal porous surfaces.

Fig. 14. Details of floor and wall construction.

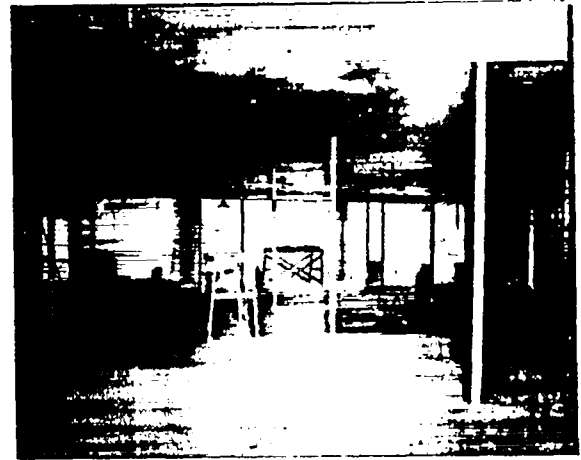
Demolition of the plenum could now be completed using power equipment to tear down the roof and walls in a normal manner. The appearance of the intake plenum's interior is shown in Fig. 15, and the appearance of the area that housed the precipitrons and filters is shown in Fig. 16.

Fig. 15. Intake plenum after stripping and painting.

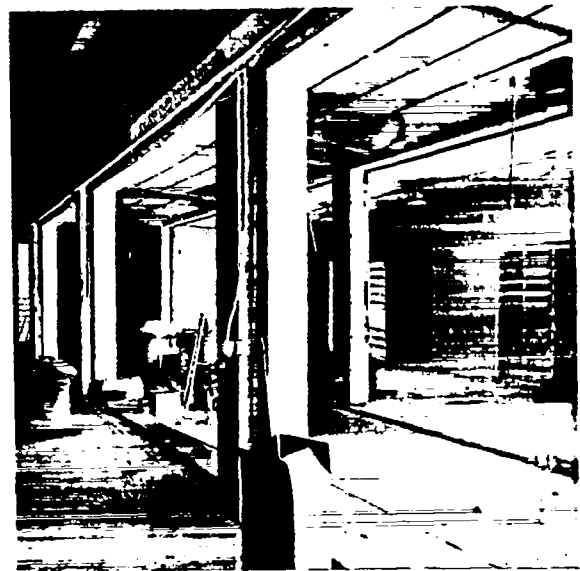
Fig. 16. Precipitron and filter area after stripping and painting.

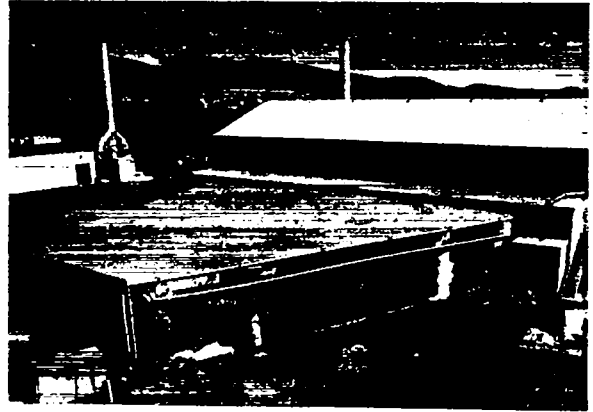
The external siding was made of paperboard nailed to the 5-cm by 20-cm studs covered with corrugated asbestos siding. The asbestos siding was removed, monitored for alpha contamination, and hauled to the LASL waste disposal site. Figure 18 shows the building after the siding was removed. Because no alpha contamination was found on the siding, it was hauled to the disposal site in an open truck.

Fig. 18. Building 12 after corrugated siding had been removed from intake plenum wall.

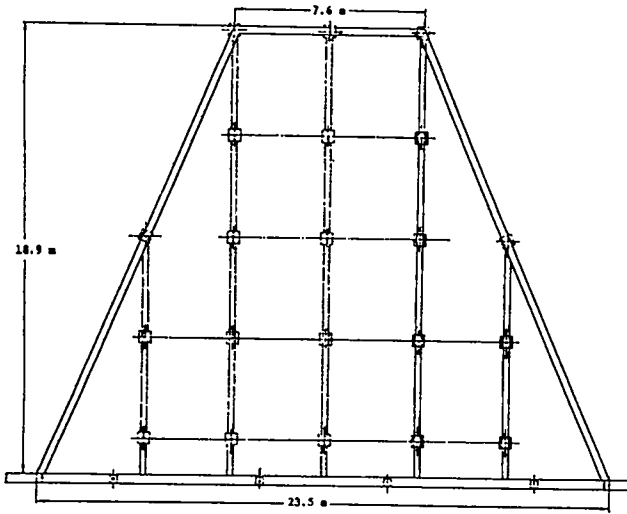
The next stage was to tear out the intake plenum floor with a payloader. The foundation was extensive, as shown in Fig. 22. The concrete at the point where the external foundation intersects with the internal foundations was often 46 cm thick. The foundation was 1.52 m deep, and because some of the soil inside was contaminated, the decision was made to have the equipment dig deep enough to go beneath the foundation and to load foundation, soil, and floor at the same time. Figure 23 shows the equipment in the process of removing the plenum floor area. When that was completed the building was reduced to the steel, brick and concrete shown in Fig. 24.

Fig. 22. Foundation for intake plenum.

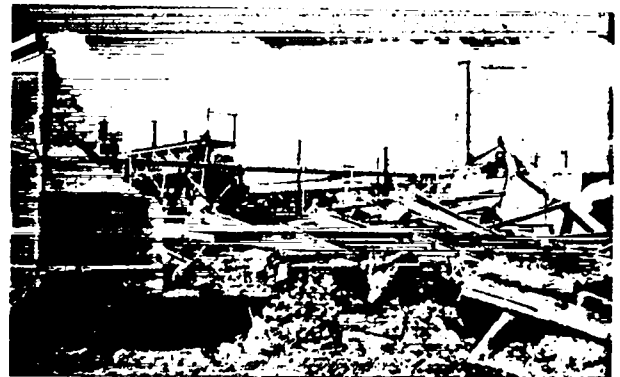
An attempt was made to pull some of the steel down with a cable and in the process to break some bolts and rivets so that the individual beams could be loaded onto the truck. Unfortunately, the construction was such that when the bulldozer pulled on a piece of steel at the end of the building, the whole steel assembly toppled over and became the tangled mess shown in Fig. 25. The steel then had to be cut apart with cutting torches and loaded onto an open dump truck with a crane. Figures 26, 27, and 28 show various stages of this operation.

Fig. 25. Appearance of structural steel after attempt to pull down individual pieces.

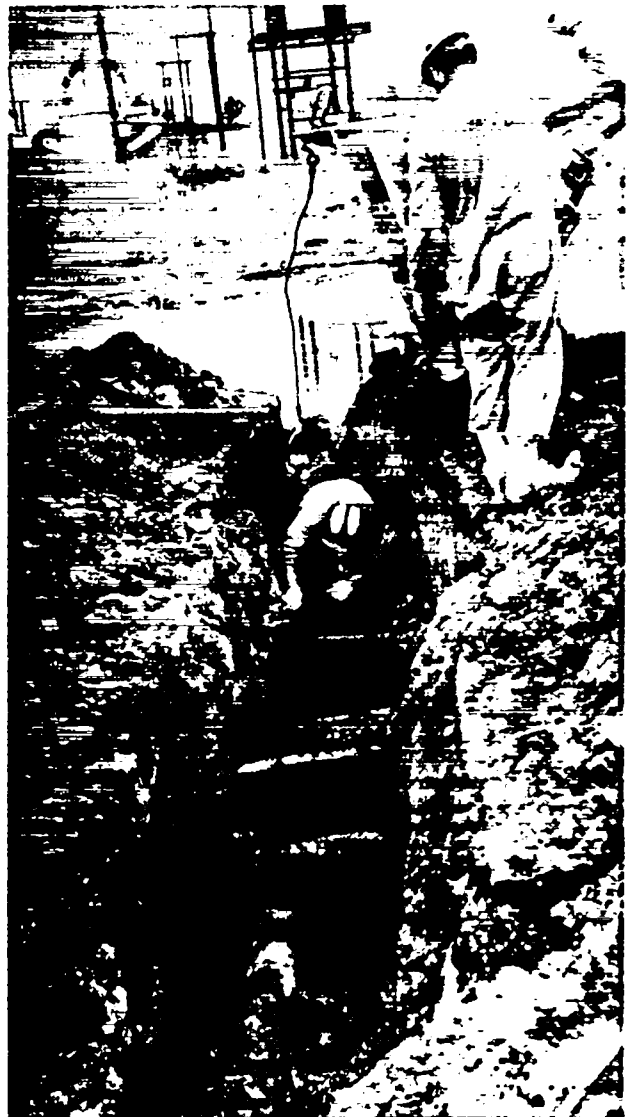
The final task was to remove the drain pipe that led from the precipitron and filter area to a tile field. The tile field had been removed several years earlier, but the plugged drain line remained in place. Workers engaged in removing the drain line are shown in Fig. 32. Although this cast iron drain line had been embedded in the soil for nearly 30 yr, corrosion had penetrated less than 0.16 cm ($< 1/16$ in.).

Fig. 32. Removing drain line.

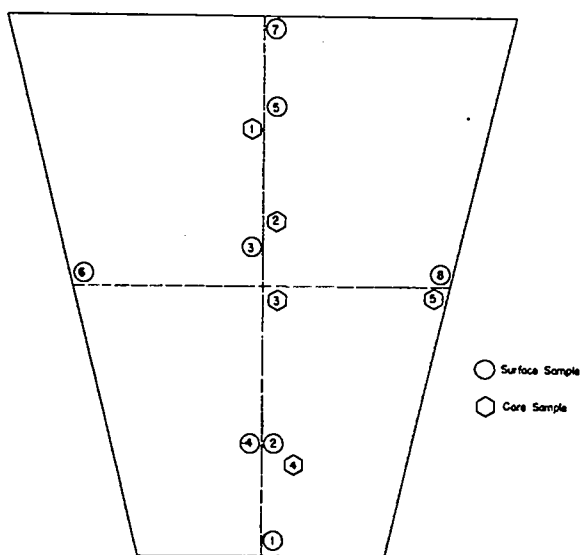
As was mentioned in Sec. IV., water from clean-up operations escaped the building through expansion joints in the concrete floor. For this reason, the concrete was broken and surface and core samples of dirt were collected at suspect locations to determine the magnitude and depth of contamination. The surface samples were collected with a spoon from the top centimeter of soil, and

Fig. 37. Locations of soil samples taken underneath intake plenum.
