*Chloride-Catalyzed Corrosion of
Plutonium in Glovebox Atmospheres*

Los Alamos
NATIONAL LABORATORY

John M. Haschke, Thomas H. Allen, Luis A. Morales
David M. Jarboe and Charles V. Puglisi

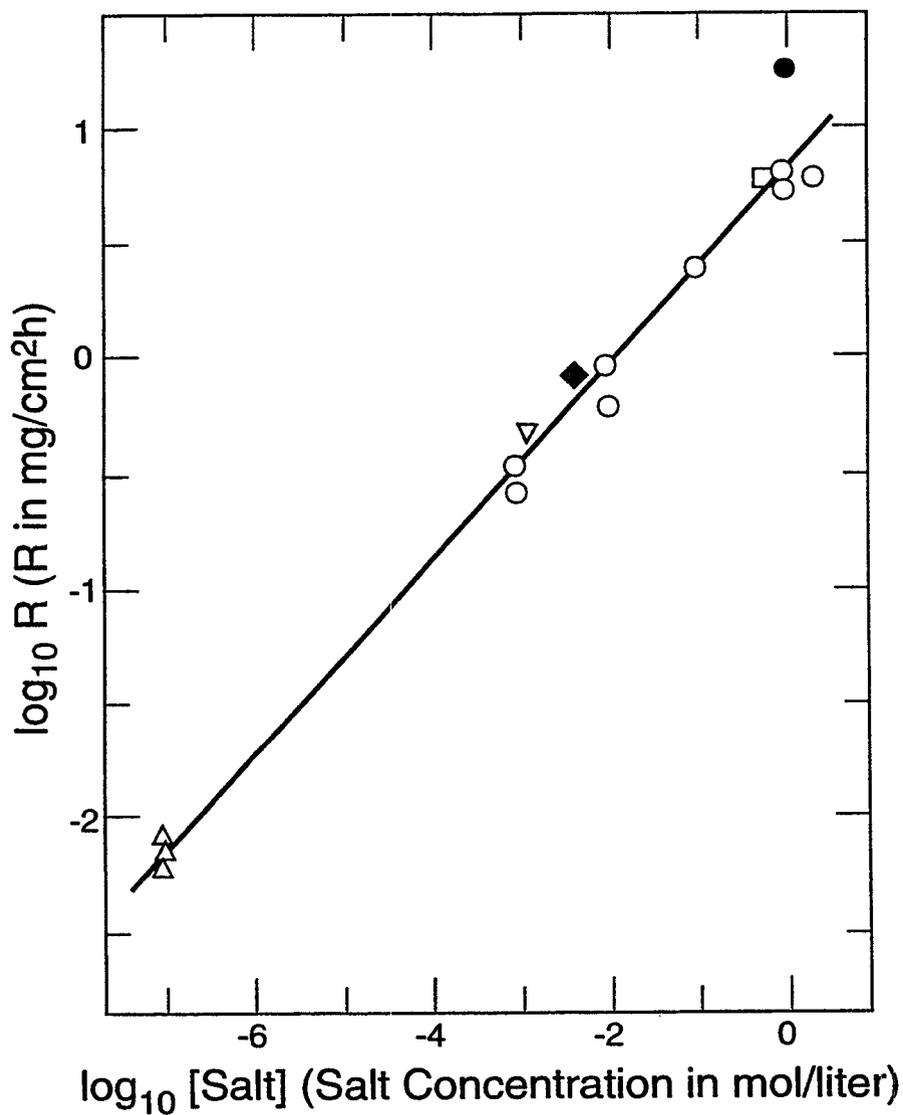
Although independent of alloying, the rate of plutonium corrosion according to Equation (6) is markedly enhanced by the presence of soluble salts (e. g., chlorides, bromides, nitrates) in the aqueous phase [6]. In near-neutral ($5 < \text{pH} < 8$) solutions, the corrosion rate (R) is insensitive to alloying, rapidly enters a linear (constant rate) stage of corrosion, and is an exponential function of the molar salt concentration ([salt]). The dependence of R on [salt] during the linear stage of reaction is shown in Figure 1 and is described by

$$R \text{ (in mg Pu/cm}^2 \text{ hr)} = 7.25 [\text{salt}]^{0.43} . \quad (7)$$

R in tap water containing 23 ppm (0.0013 M) soluble salts is almost a hundred fold faster than the corrosion rate in distilled water. Increasing the salt concentration to 1.0 M (17 850 ppm) causes an additional ten-fold increase in the corrosion rate of water. The corrosion rate is not significantly altered by the identities of dissolved cations or anions. Analytical data show that salt species are not incorporated in the solid product; they only catalyze corrosion of Pu according to Equation (6).

Figure 1. Dependence of the plutonium corrosion rate (R) on the molar salt concentration ([salt]) in aqueous solution at 25°C [6]. Rates for alpha- and delta-phase metals are indicated by filled and open symbols, respectively. Upright triangles, circles, the inverted triangle, the diamond, and the square are for distilled water, calcium chloride solutions, sodium chloride solution, and synthetic sea water, respectively.
