investigation report

Plutonium Contamination

Incident

*Wednesday, October 14, 1981*

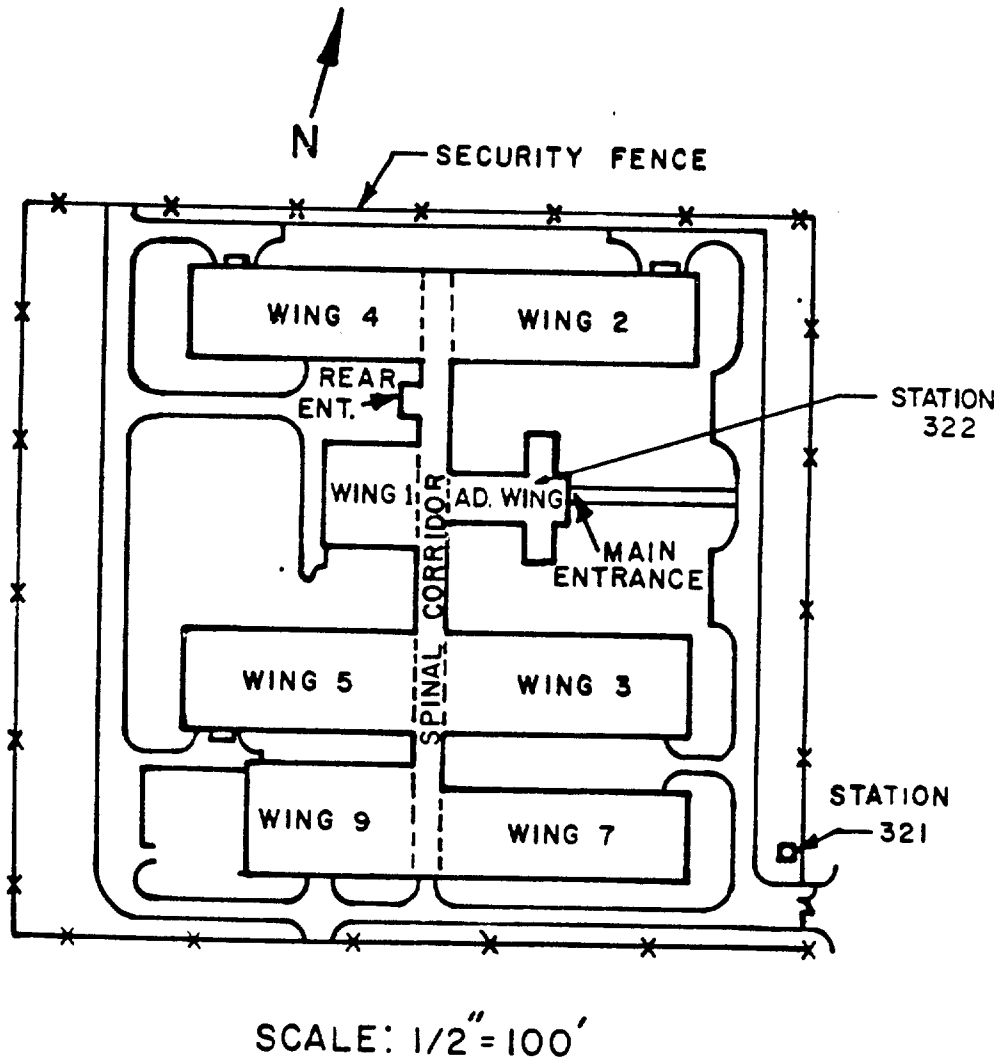
FIGURE 4. Site plan for the CMR building. The contaminated samples originated in Wing 2 and were opened in Wing 3.

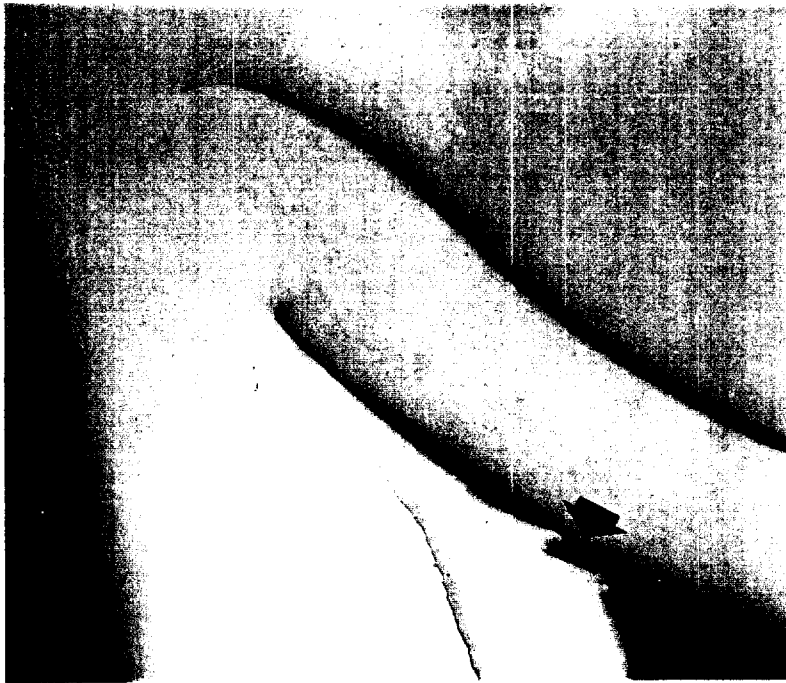
Fig 9 Photomicrograph of a corner of an impacted heat source capsule, showing some entrapped PuO_2 .

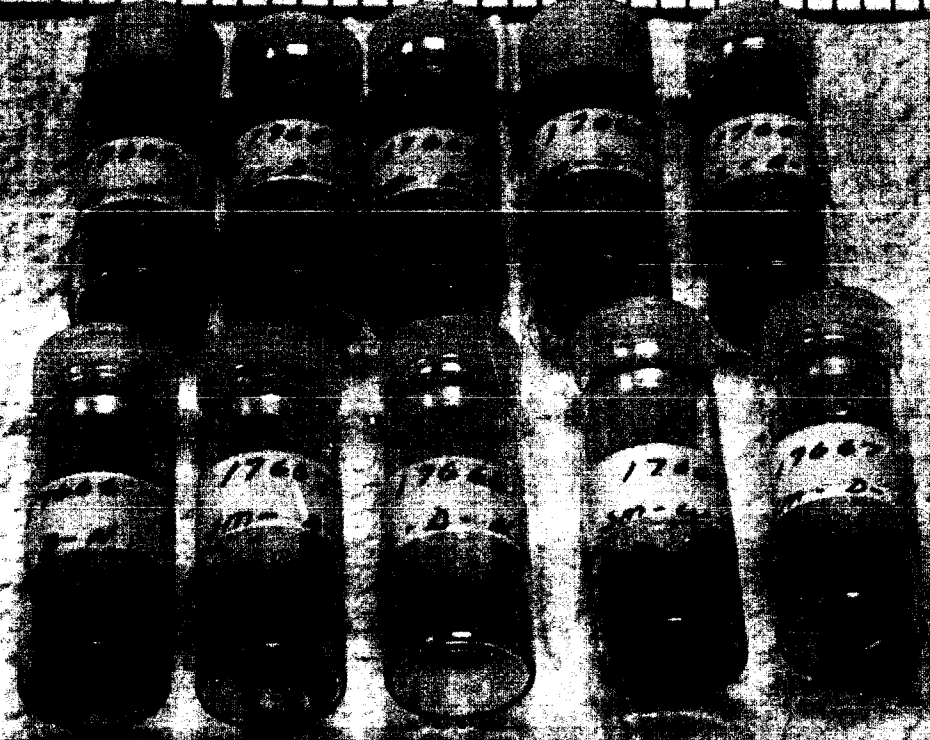
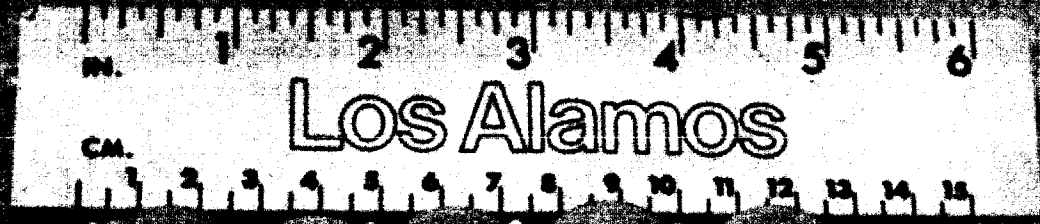
10 vials containing metallic fragments. The vials were individually labeled with only the sample numbers and the plastic lids were taped on. The analyst later recalled that the vials were not in a plastic bag. However, when Room 3110 was inspected after the incident an unmarked plastic bag, very similar to one that should have been used in packaging the samples, was found. Photographs of the can, the sample vials , and one of the Travelers are shown in Figures 11, 12 and 13. Contaminated alloy may be seen in some of the vials.

FIGURE 12. The ten contaminated sample vials.

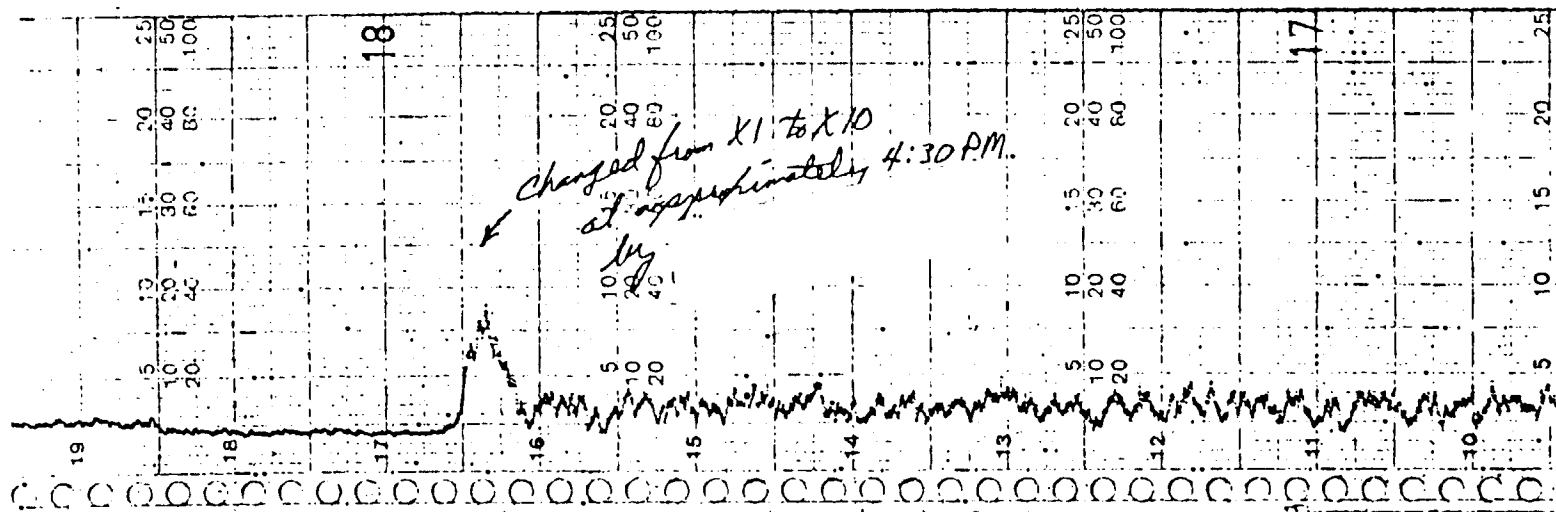
4. The Wing 3 HPT failed to detect the rise above background on the CAM in Room 3111 at about 4:30 to 4:40 p.m. when he switched the scale setting (Figure 14). However, the room lights were turned off, with only the emergency service light on, and the HPT stated that he had a migraine headache. Because of the design of the CAM, it is difficult to see the most recent portion (about the last 15 minutes) of the strip chart. Had the HPT noticed the most recent portion of the strip chart, or the CAM meter reading, he should have been suspicious and taken steps to investigate what was occurring.

8. The rise on the CAM strip chart was not observed in time to minimize the incident.
9. Many people were in a hurry to leave between 4:30 and 5:00 p.m.

FIGURE 14. Strip chart from the CAM in Room 3111, showing a rise at about 4:20pm.

The sensitivity was switched to the x10 scale at about 4:40pm.
