LA-10446-MS

Issued: September 1985

Radiation Monitor for Surveillance of Moving Vehicles

Robert F. Dvorak

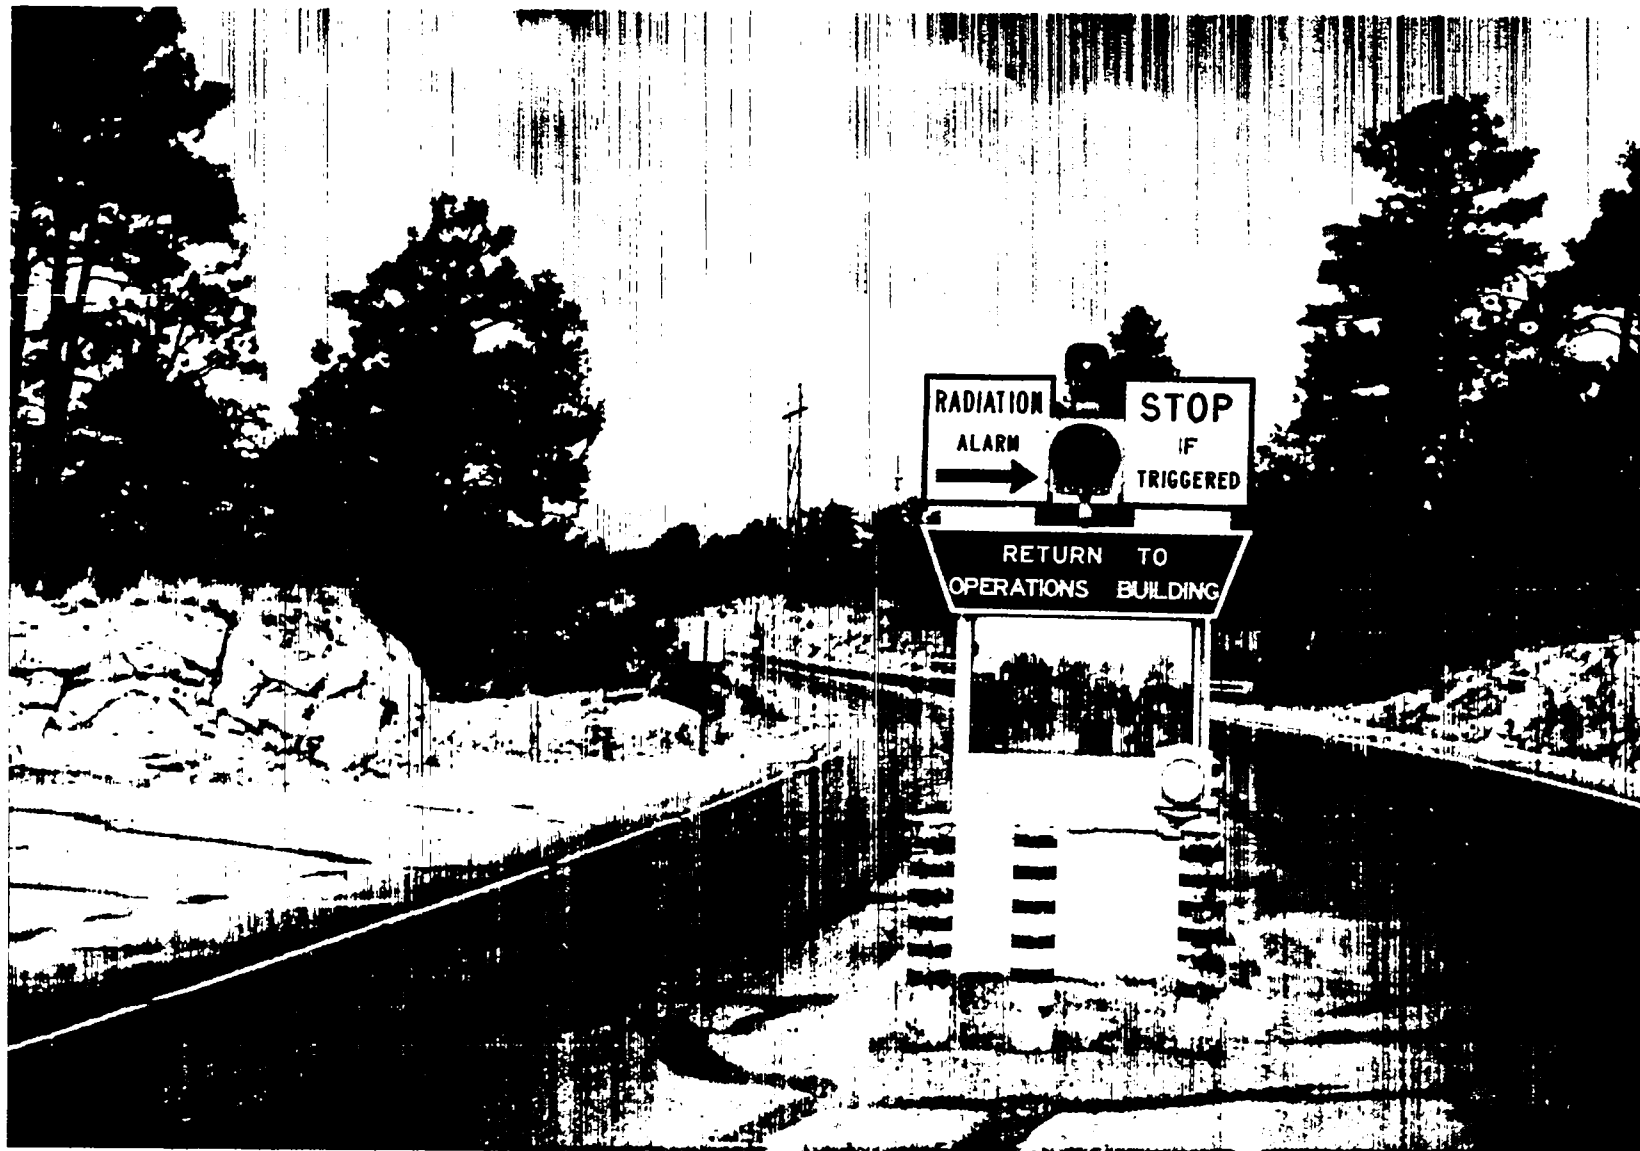
Figure 1. The guard station with alarm light and Klaxon. The system electronics are mounted inside the station.

station in the exit lane. The electronics package was mounted in the guard station with connection to the detector by buried conduit. An alarm light and a Klaxon horn were mounted on the roof along with instructions to stop at the guard station on alarm. Fig. 1 shows the guard station with attendant signs, light, and Klaxon horn.
