## Catalyzed Corrosion of Plutonium: Hazards and Applications

### Failed Storage Container for Plutonium Metal

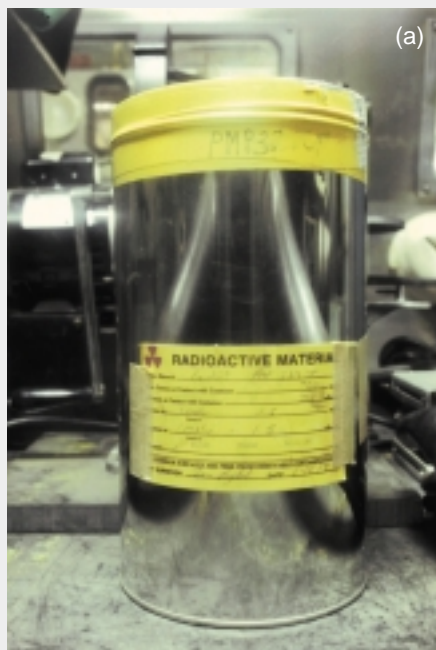
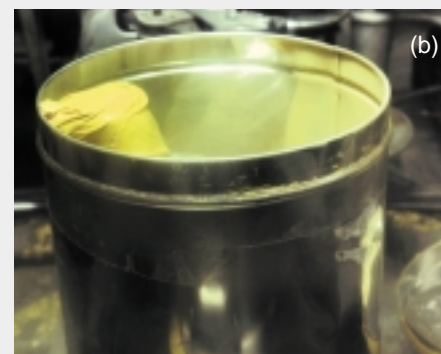
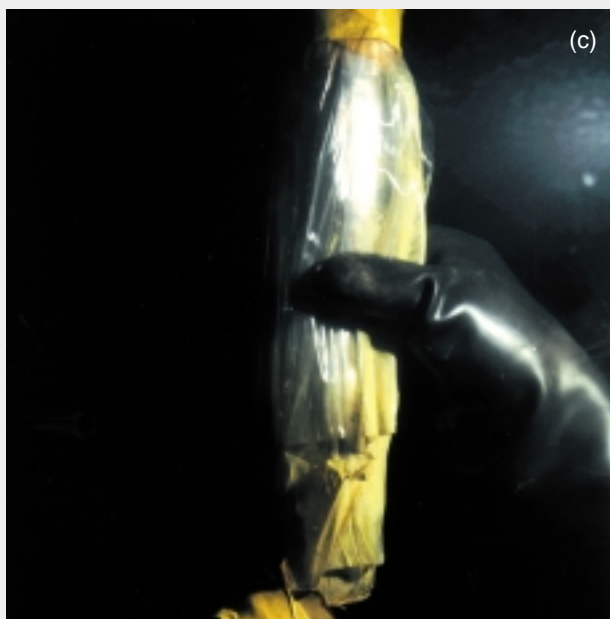
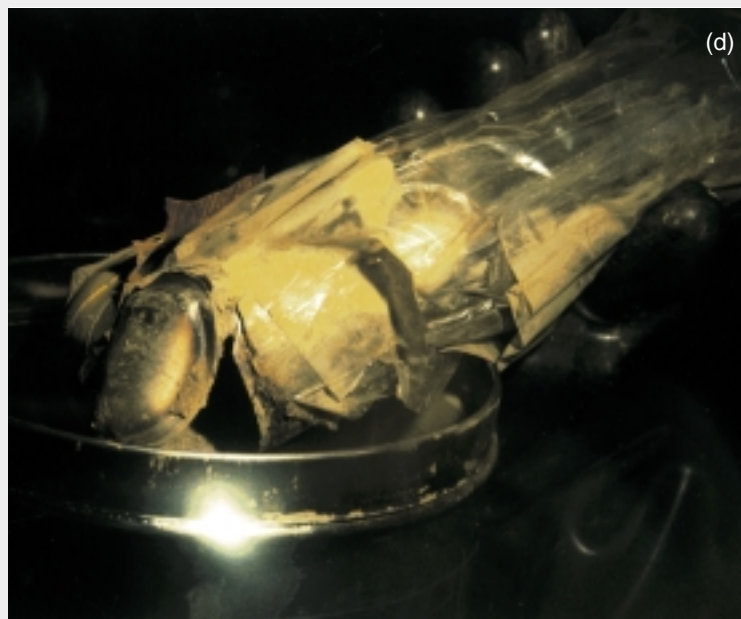
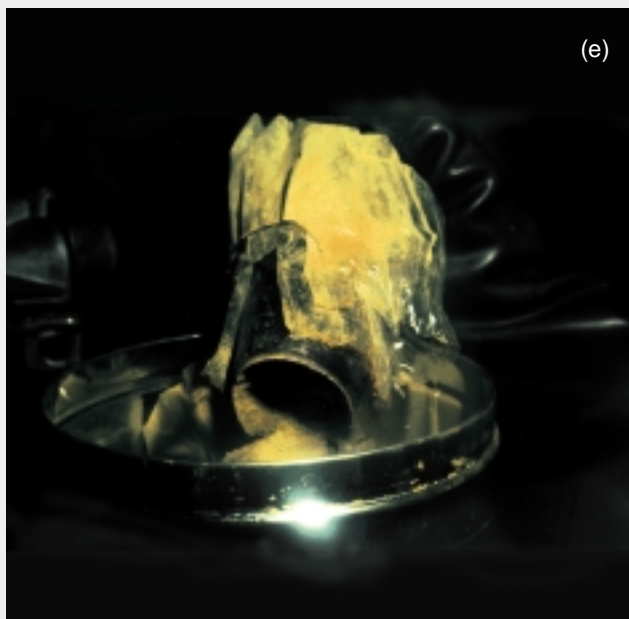
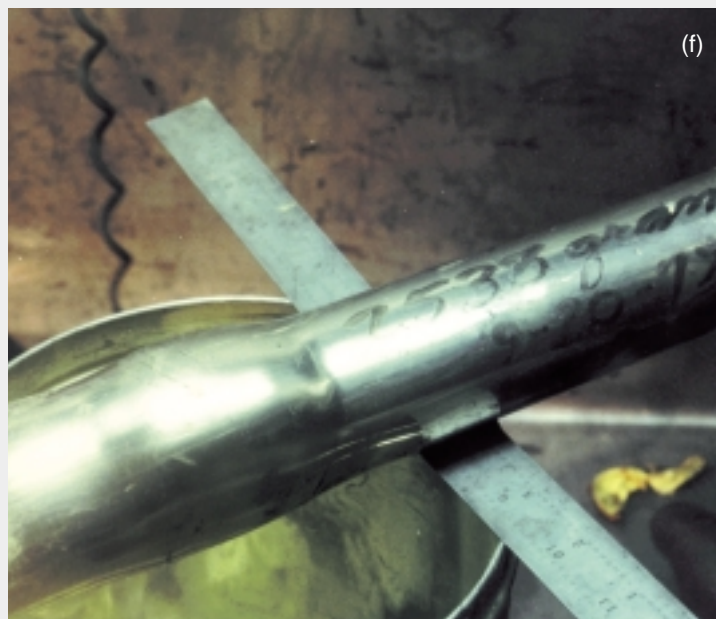
container was lifted out, its end ruptured because of pressure from the continuing rapid formation of plutonium oxides and other low-density corrosion products. A typical plutonium casting would form about 10 grams of PuO<sub>2</sub> per year from normal oxidation in air. Instead, the observed extent of the reaction was many orders of magnitude greater. Also, the inner vessel, which still contained unreacted metal, had become hot, and its diameter had increased by about 50 percent. The vessel was transferred to an argon-filled glove box, where the reaction ceased at once.

the metal casting during storage and to very rapid corrosion during the 3-hour waiting period in the reduced-oxygen glove box. The weld at the ruptured end of the inner vessel had evidently been defective from the start, allowing gases to be continually pumped in and out of that vessel, as atmospheric pressure changes compressed and expanded the sealed plastic bagging. Plutonium oxide particles were entrained by thermal currents in the vessel, transported through openings in the weld, and deposited on the plastic over several years. During that period, the bagging isolated the metal casting from any external oxygen source, and the normal surface  $\text{PuO}_2$  was apparently autoreduced to  $\text{Pu}_2\text{O}_3$ . Over time, the plastic bagging became discolored near the weld, as well as embrittled from the radiolytic decomposition induced by  $\alpha$ -particles emitted from the deposited plutonium oxide particles. The molecular hydrogen produced during the radiolysis of the plastic entered the inner vessel and formed hydride on the  $\text{Pu}_2\text{O}_3$ -activated surface of the casting. During these processes, the storage package did not change its mass, and therefore the problem was not detected. When the embrittled plastic failed during storage, air reached the inner vessel, and a hydride-catalyzed reaction of the oxygen and nitrogen with the hydride-coated plutonium ensued at a throttled rate determined by access of air to the reaction zone. The resulting expansion of the solid led to the complete failure of the defective weld.

Each photo shows a step in the disassembly of the container for a 2.5-kg casting of plutonium metal. (a) The outer container is placed in a glove box; (b) when the lid is removed, the plastic bagging shows; (c) when the plastic bagging and inner cylinder are lifted out of the container, discolored, embrittled plastic decomposed by radiolysis is revealed; (d) a rupture in the inner container is visible; (e) the corrosion product pours out of the ruptured end; and (f) an increase in the inner vessel's diameter near the ruptured end shows the extent of hydride-catalyzed corrosion during a 3-hour period.

The experience and knowledge we gained from evaluating this incident and from studying catalyzed corrosion reactions find broad application in reducing the nuclear danger. The safe storage of plutonium requires using two metal containers with certified seals and ensuring that organic materials are excluded from the package. These two safety criteria are incorporated in the plutonium storage standards adopted by the U.S. Department of Energy and the International Atomic Energy Agency.
