**LA-8715-PR**

**Space Nuclear Safety and Fuels Program**

**October 1980**

### I. GENERAL-PURPOSE HEAT SOURCE (GPHS)

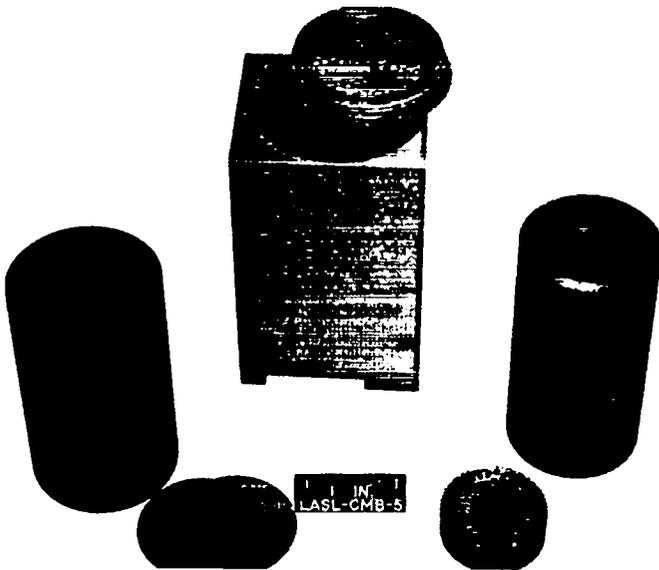
The 0° impact of IRG-89 (DVT-3) was accomplished by a special half-module.

This capsule assembly was impacted at 58 mps, 850°C, and 0° (end-on) as part of the special half-module sample shown in Fig. 1. The aeroshell was machined slightly over half size, with a relief volume on one side of the graphite impact shell (GIS) location to simulate the internal crushup volume present in the GPHS module. The wall thicknesses were reduced 1.27 mm to simulate ablation losses. The insulation and impact-shell assemblies were normal, except for the following fueled clad, which was UO<sub>2</sub> in Pt-30 Rh.

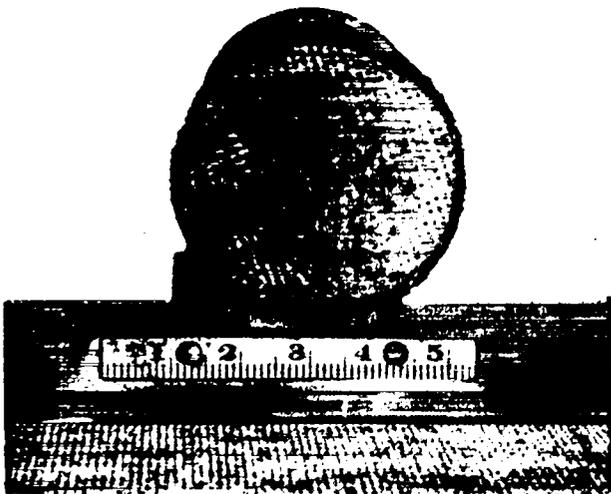
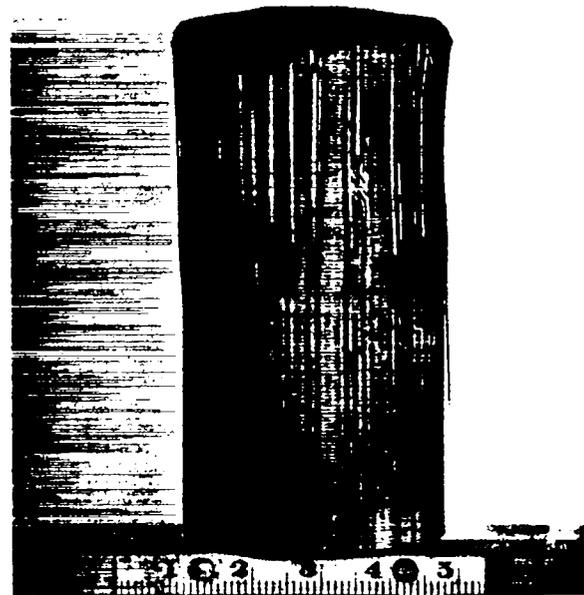
The impact assembly from test DVT-2 (IRG-89) was intact when recovered. a) The CBCF end-disk was completely crushed and pushed into the holes in the end of the impact shell. b) The impact shell's body was cracked and belled by the impact.

The recovered test sample is shown in Fig. 2. The impacted end of the aeroshell was separated by the impact and the CBCF insulating disk was completely crushed. The impact assembly is shown in Fig. 3. It remained intact after the impact, but the impact end was delaminated and belled.

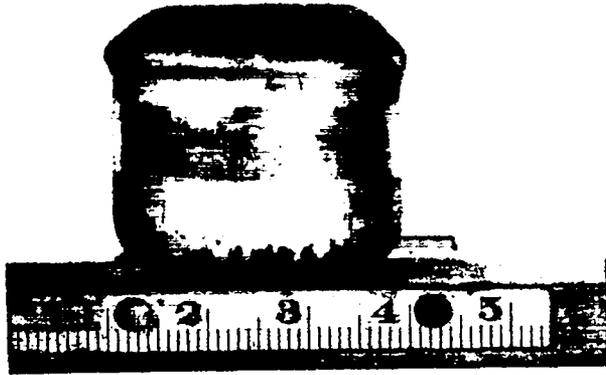
Fig. 4.  
The fueled clad from DVT-3 (IRG-89) was deformed by the impact, but did not fail.

The recovered capsule, shown in Fig. 4, was deformed in the manner characteristic of the 0° orientation in the current design of the GPHS module. No failures were visible.

3. IRG-89. Although the local strains in the belled region of this capsule were relatively large (Fig. 4), the capsule did not fail. The reason for this is shown in Fig. 18, which is a section through this deformed region. The wall thickness in the bulged region is unthinned, perhaps even thickened, indicating that the net effective stress was compressive. No external surface cracks were observed in IRG-89, but the vent cover weld had failed, Fig. 19. This failure is of little consequence, but it illustrates the extreme sensitivity of coarse-grained iridium. The photomicrograph also illustrates the adjacency of the vent-cover and decontamination-cover welds. A design improvement would result if the latter were increased in diameter.

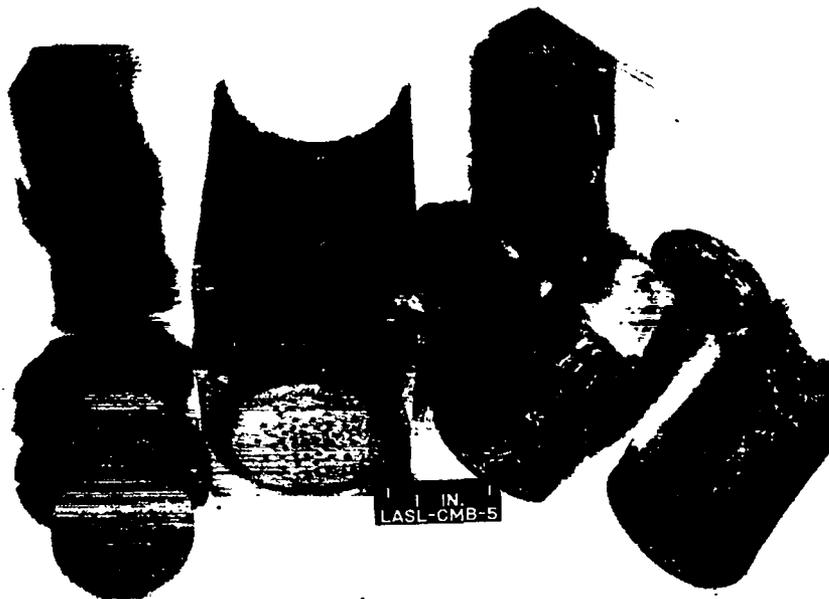
Fig. 5.  
The graphite components of sample DVT-4 (IRG-90) were damaged significantly by the impact. The fueled clad, which had been removed before this photograph was made, was deformed, but had not released any fuel.

The pieces recovered from the impact catch tube are shown in Fig. 5 without the fueled clad, which was removed to the glove box. Both the aeroshell and the leading impact shell split longitudinally during the impact. Their respective end caps were also removed by that event.

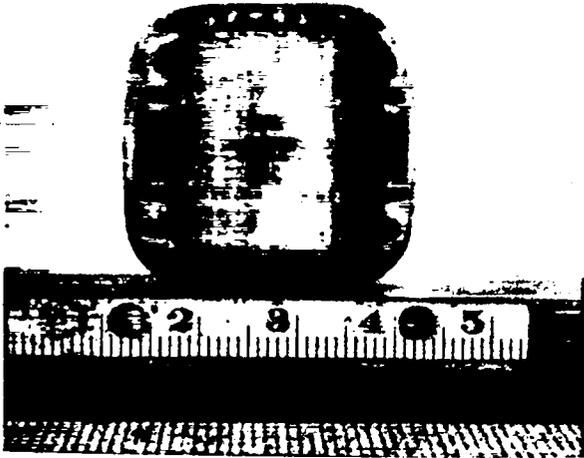
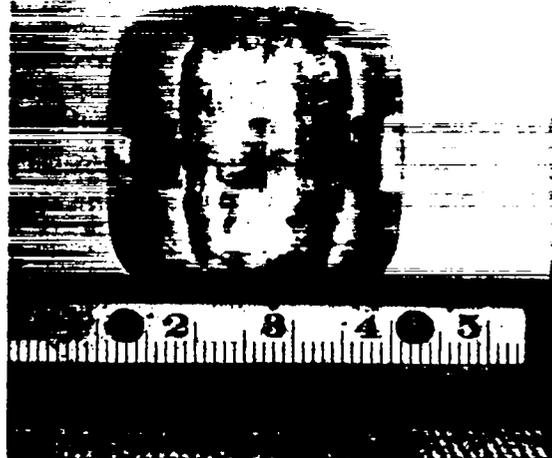
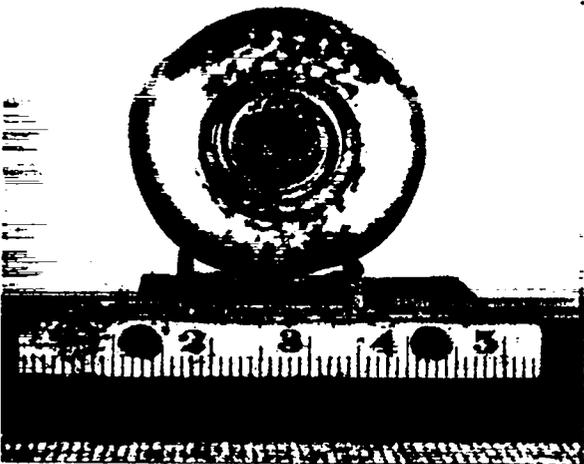
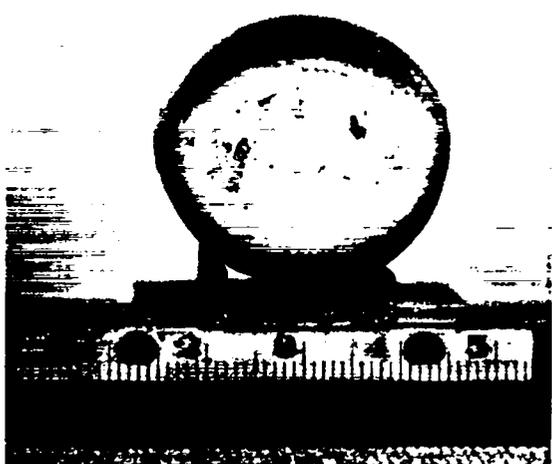
The fueled clad from DVT-4 (IRG-90) was not deformed severely by its impact. a) Impact face; b) trailing side; c) vent end; and d) plain end.

The recovered fueled clad, IRG-90, is shown in Fig. 6. The general character of the deformation is quite similar to that of IRG-88, which was also impacted at 90° (September Monthly Report), but the deformations of the present capsule are less. All test conditions and sample components in the two 90° tests, DVT-2 and DVT-4, were as identical as possible. The results differed in the gross strains of the fueled clads and in the degree of graphite fragmentation. Qualitatively, the graphite in DVT-4 was the more damaged, which supports the idea that the deformation of the fueled clad is controlled by the balance of the impact resistances of the fuel and the crushing graphite.

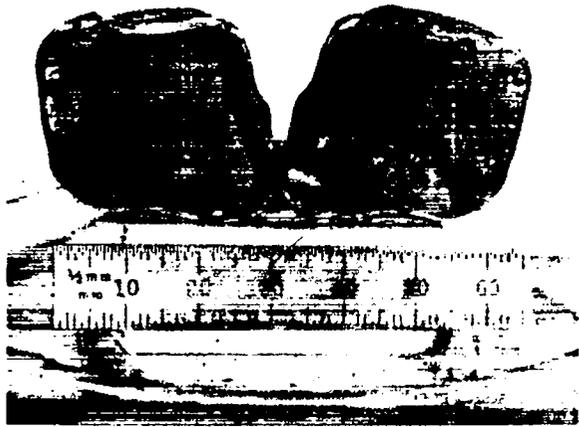
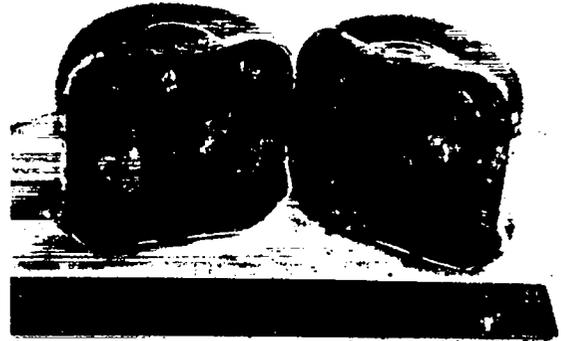
Fig. 7.  
After the iridium capsules were cut open, the degree of fuel fracture was evident. a) IRG-87; b) IRG-89, and c) IRG-90.

After recovery, the capsules from DVT-1, DVT-3, and DVT-4 (IRG-87, -89, and -90) were opened so that the fuel could be recovered for particle-size analyses. The fuel from IRG-88 (DVT-2) was not removed in the same manner, because of the failure of the clad. The split capsules with the fuel inside are shown in Fig. 7. The major fuel shear planes that controlled the local deformation offset in IRG-87 are readily apparent in Fig. 7a. Similar shear planes are visible in IRG-89 (Fig. 7b), but the full support provided by the aeroshell and impact shell in the end-on orientation prevented the differential movement necessary to cause the capsule offset. The fuel fragmentation in IRG-90, shown in Fig. 7c, was greater than that observed in either of the other orientations.

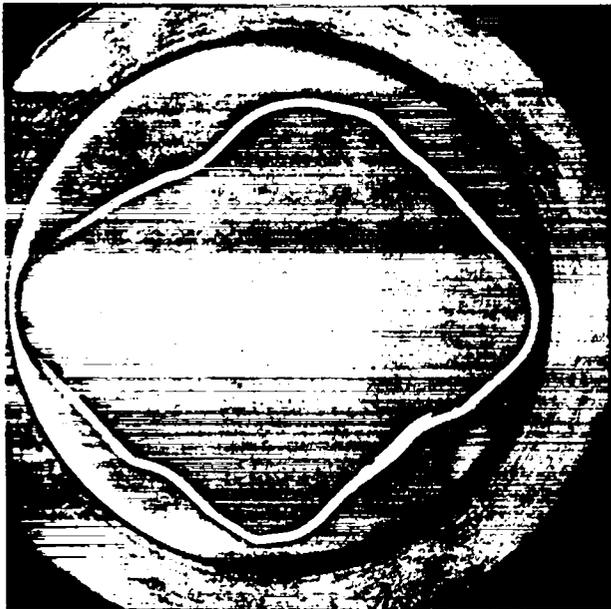
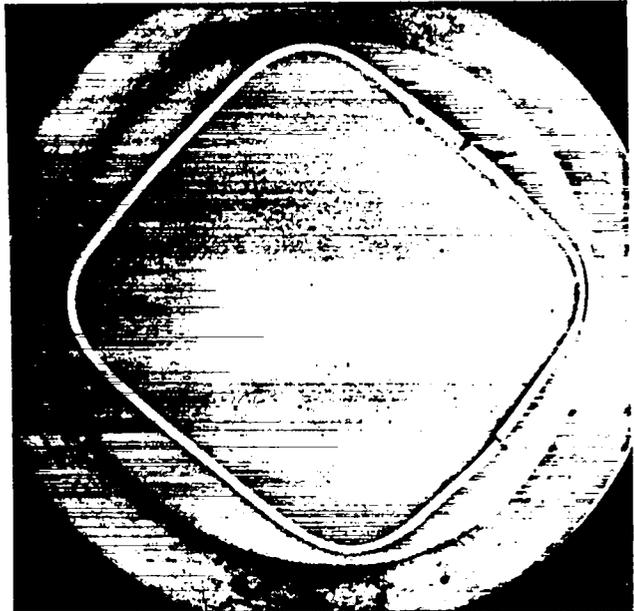
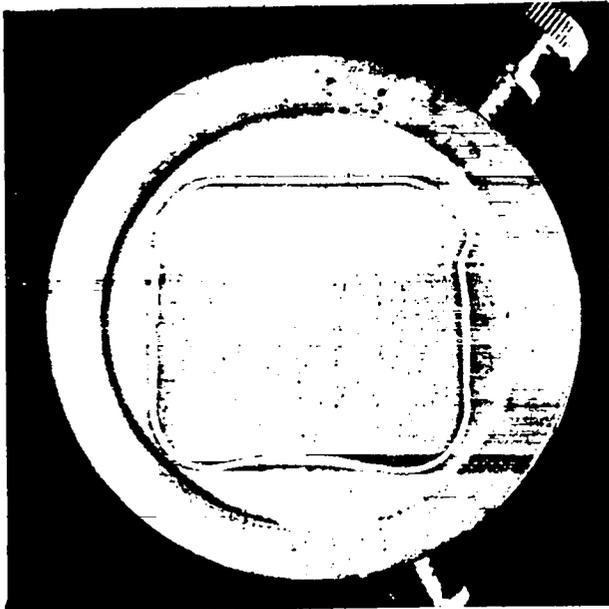
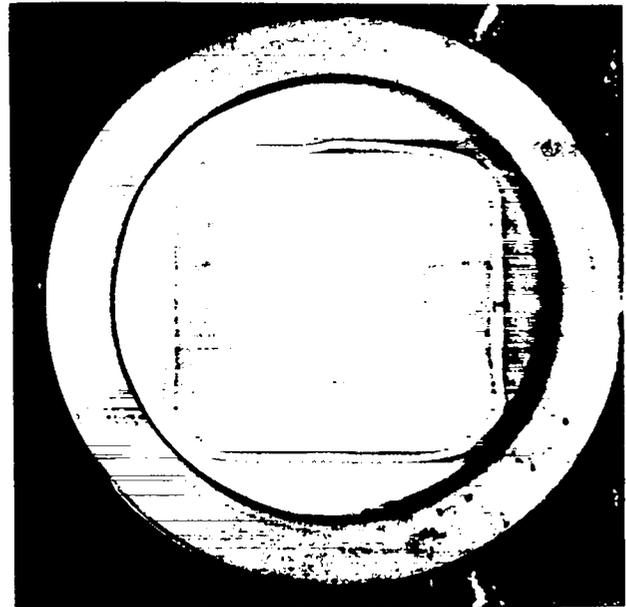
Fig. 8.  
Cross sections of the iridium capsules used in the DVT impacts. a) IRG-87, 27°; b) IRG-88, 90°; c) IRG-89, 0°; and d) IRG-90, 90°.

Full diametral-longitudinal sections of each of the fueled clads were cut, polished, and examined. These are shown in the photomicrographs of Fig. 8. The sections shown were not taken through the regions of maximum local strain, but were taken to illustrate the deformation in a plane of symmetry intersecting the impact target.

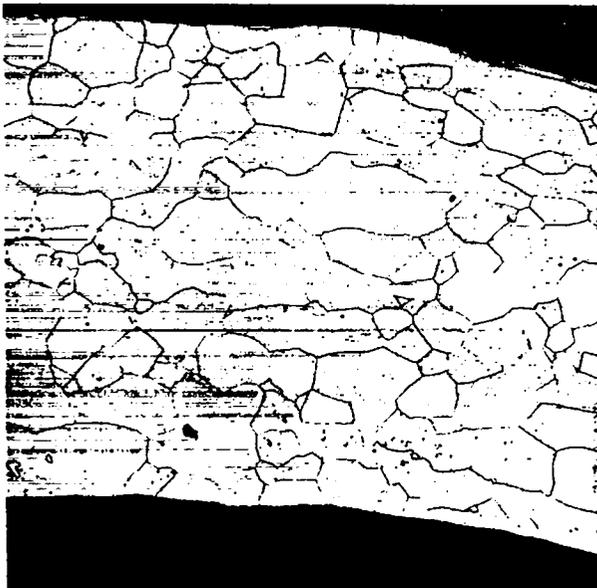
Fig. 11.  
The etched section of IRG-87 revealed a grain size of  $\sim 5$  grains/thickness. 100X.

The grain size typical of IRG-87 is exemplified by the photomicrographs of Fig. 11, which shows a grain size of ~15 grains/thickness. The closure weld, shown in Fig. 12, was sound and had the proper microstructure and penetration.

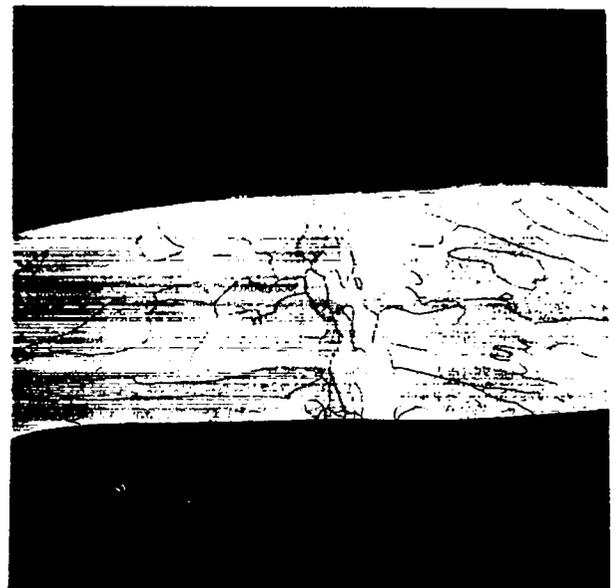
Fig. 12.  
The closure weld of IRG-87 was completely satisfactory. 50X.

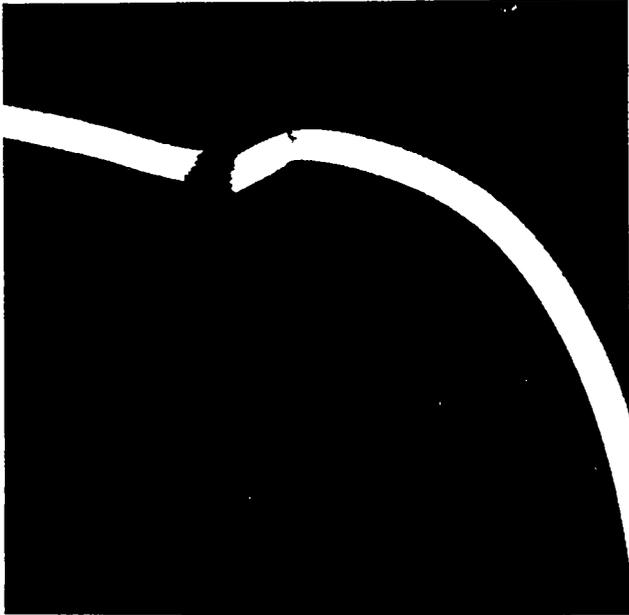
Fig. 13.  
The major longitudinal fracture on the  
impact face of IRG-88. 7X.

2. IRG-88. The section through the major longitudinal crack is shown in Fig. 13 at low magnification and in Fig. 14, etched, at higher magnification. There is little or no evidence of plastic deformation in the iridium wall, except where a fuel fragment was pressed into the capsule, as seen in the right side of Fig. 14. This indicates that the present design of the GPHS module, with CBCF insulation, does not provide the needed support to the capsule during a 90° impact. Continued use of this design will require a significant temperature increase, if failures are to be eliminated.

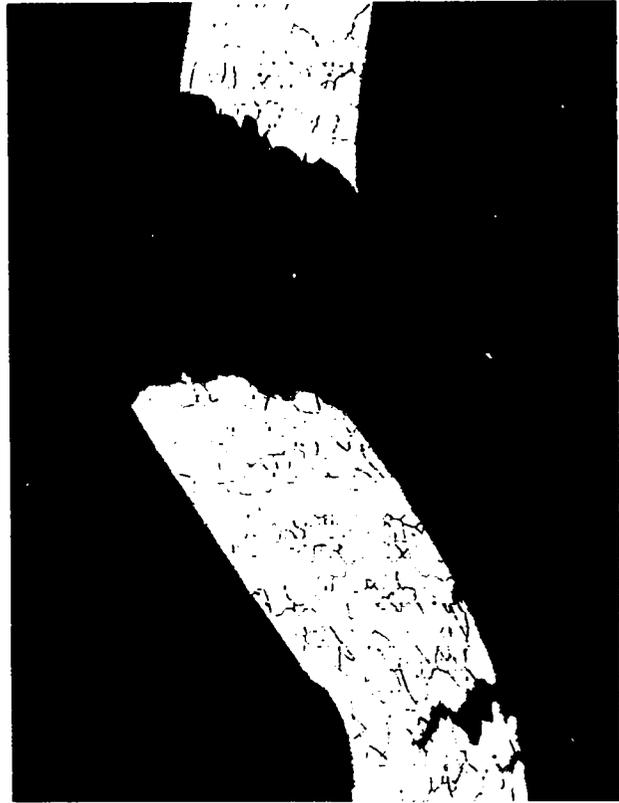
Fig. 14.  
The failures in IRG-88 were all in the  
form of grain boundary cracks. 40X.

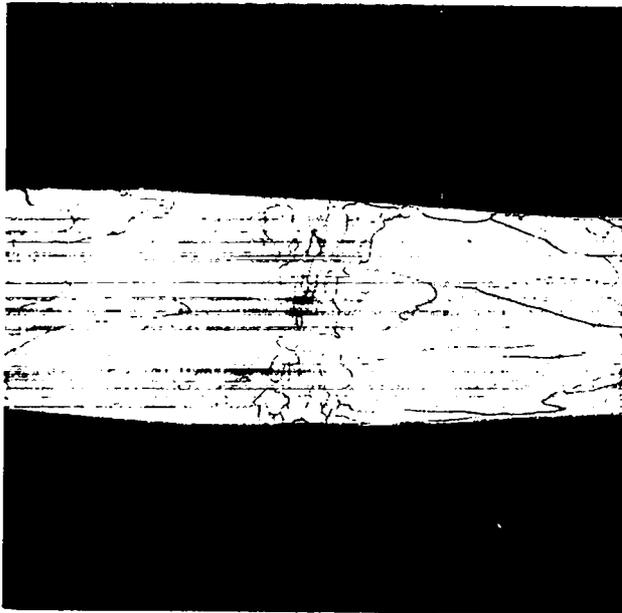
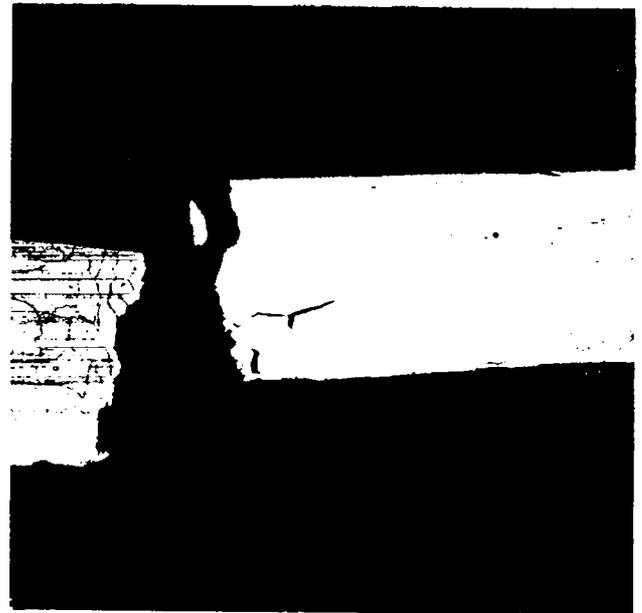
The weld microstructure of IRG-88 was normal. The failure shown in (b) is thought to be a secondary crack propagated after the longitudinal primary crack was formed. 40X.

The microstructure of the closure weld is shown in Fig. 16. The weld was sound and of good quality before the impact, as demonstrated by the structure revealed in Fig. 16a. Figure 16b shows the weld in its failure region. The apparent large grains on the right of the photomicrograph result from incomplete etching of the general orientation and are not as large as they appear. The general grain size was again ~15 grains/thickness, which is normal for this heat treatment series, but, as Fig. 7 shows, the grain size is not uniform through the wall.

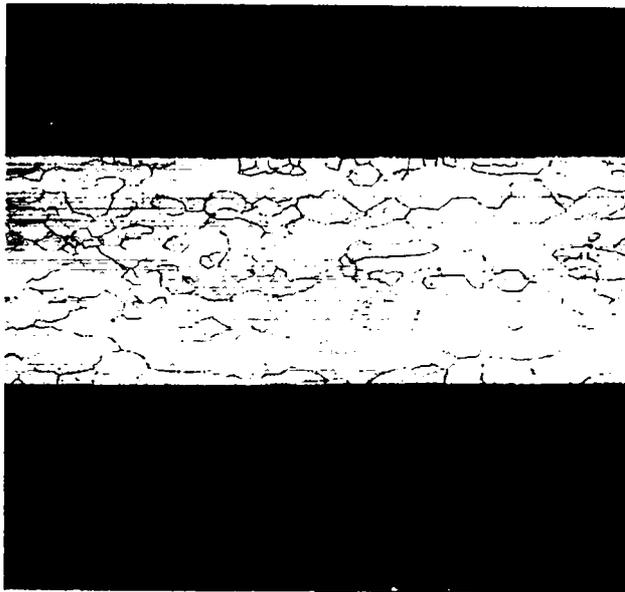
Fig. 17.

The grain size of IRG-88 was ~15 grains/ thickness, but there is some evidence of a size gradient in the capsule wall. 50X.

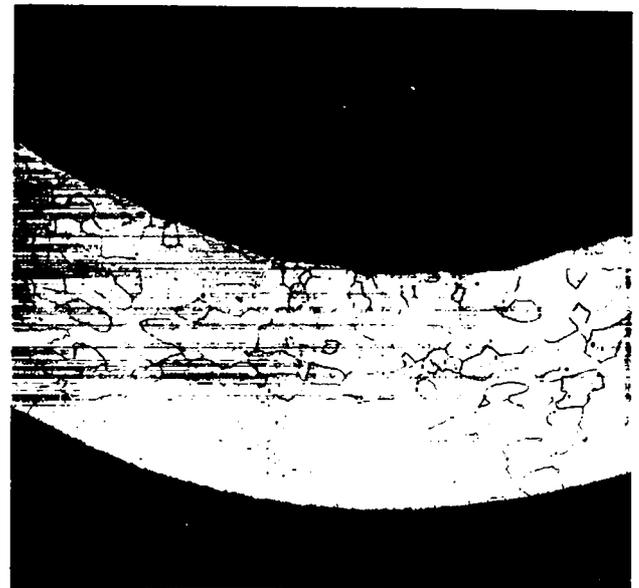
Fig. 18.

The belled region in IRG-89 was not thinned during its deformation and did not fail. 50X.

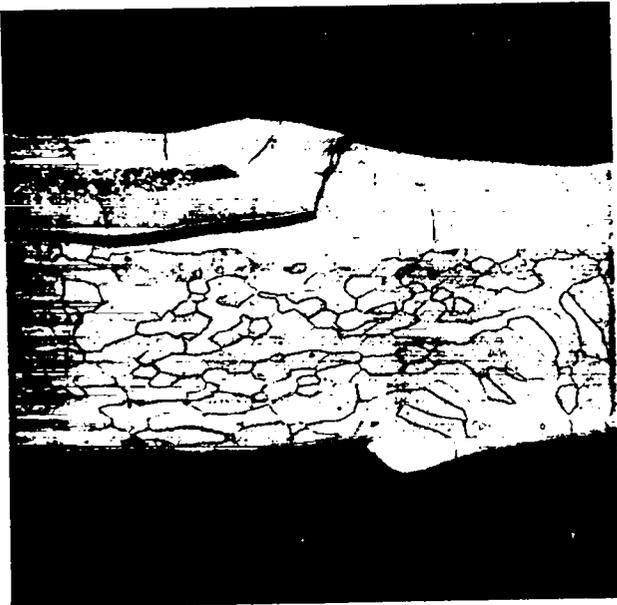
Fig. 19.  
The vent assembly weld of IRG-89 was cracked after the impact. 50X.

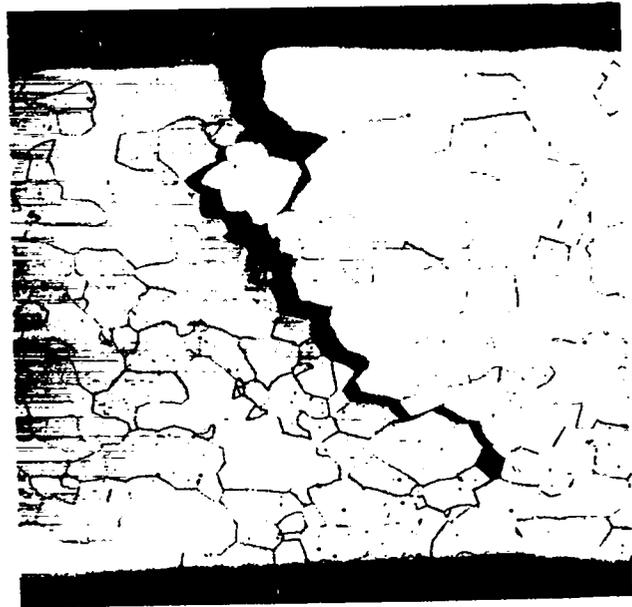
Fig. 20.  
The wall of IRG-90 was nearly penetrated by a longitudinal crack on the impact face. 100X.

4. IRG-90. Even though capsule IRG-90 sustained only modest strains during the impact and did not fail and release fuel, it contained several cracks on the impact face in the same general region as the longitudinal failures in IRG-88, which was also impacted in the 90° orientation. The worst of the cracks in IRG-90 is shown in Fig. 20. The crack had the usual intergranular character and penetrated 90% of the wall thickness. Other, shallower, cracks were present on the impact face, too. The presence of these cracks in a sample with so little overall strain reinforces the argument that the CBCF design does not provide enough support to prevent failures. If the fuel or the impact shell and aeroshell had been less resistant, the iridium in IRG-90 would have failed.

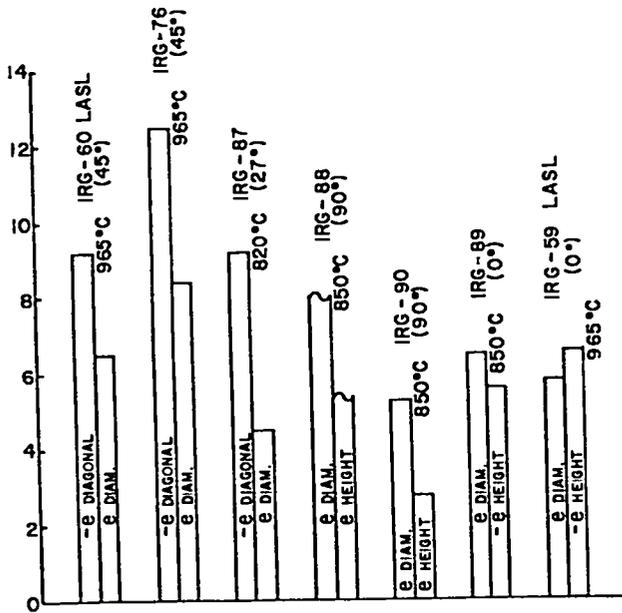
Fig. 21.  
Major clad strains observed after module impact tests.

The strains observed in the leading iridium capsules used in the DVT impact series are compared to those seen in three other comparable module impacts in Table I (local strains) and Fig. 21 (gross strains). It is unfortunate that there is no 90° test at the higher temperature to complete the comparison.
