# The Decommissioning of the TA-42 Plutonium Contaminated Incinerator Facility

# THE DECOMMISSIONING OF THE TA-42 PLUTONIUM CONTAMINATED INCINERATOR FACILITY

## ABSTRACT

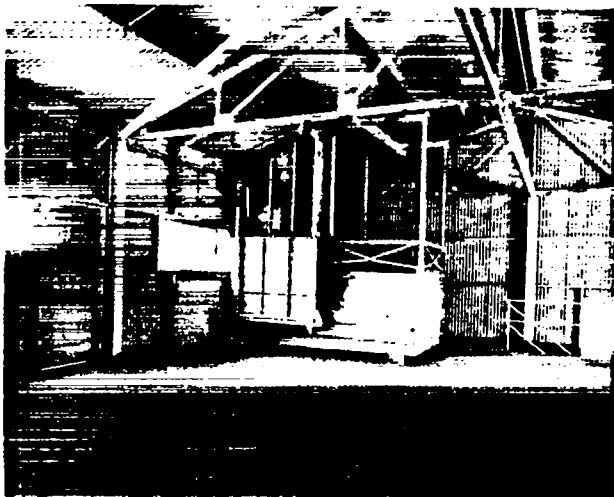
Fig. 3.  
Incinerator feed port and interior of control office building after preliminary decontamination in 1975.

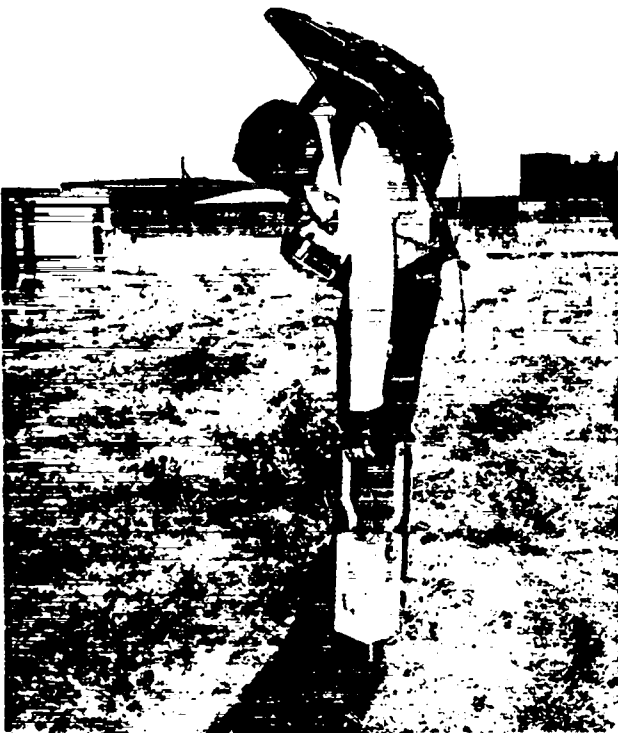
Fig. 7.  
Phoswich detector in field.

Preliminary contamination surveys with a Laboratory-developed portable phoswich system<sup>1</sup> (Fig. 7) indicated detectable surface soil contamination within the fenced area, in the equipment, in the ash storage tanks, and in the septic tank and tile field effluent line. Most of the contamination present, excluding the contents of the ash storage tanks, was attributed to the decontamination operations.

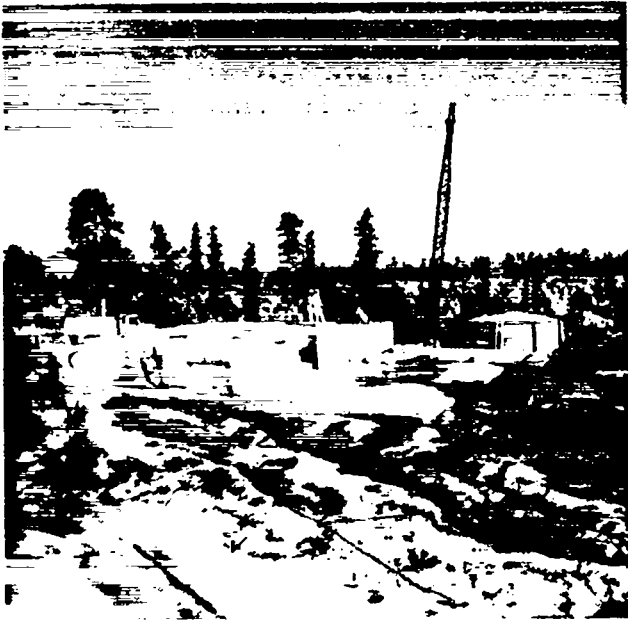
Fig. 11.  
Bare concrete floor after removal of  
structures.

After removal of the structural steel (Fig. 11), the drain pipes in and under the building foundation were filled with hot asphalt to contain the contamination. The gross alpha activity on accessible portions of the pipes measured  $22 \text{ dis/s/cm}^2$ . The uncontaminated foundation was crushed with a crane and a steel ball (Fig. 12) and piled (Fig. 13) for loading into dump trucks.

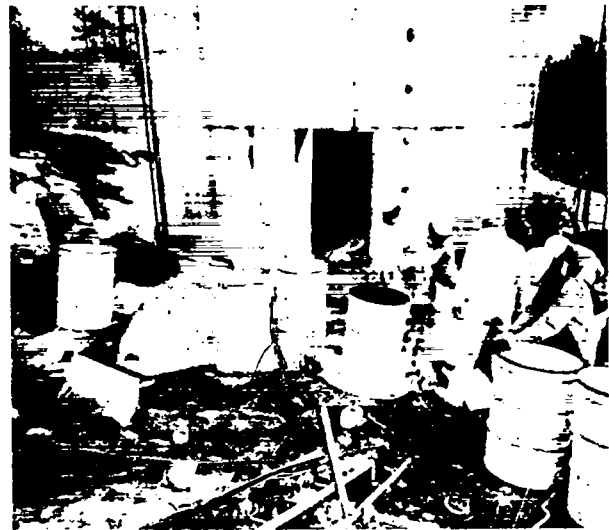
Fig. 14.  
Removal of dry sludge from ash  
storage tank.

Doors were cut on the sides of the two 140 000-liter ash storage tanks to permit personnel entry. One tank (Fig. 14) contained 2000 liters of dry sludge contaminated with  $130 \text{ nCi } ^{239}\text{Pu}$  per gram of sludge. The other (Fig. 15) contained 2600 liters of wet sludge with  $1000 \text{ nCi } ^{239}\text{Pu}$  per gram of sludge. A portable air blower, equipped with a high-efficiency particulate air (HEPA) filter and rated for  $0.3 \text{ m}^3/\text{s}$ , was used to provide ventilation during work inside the tanks.

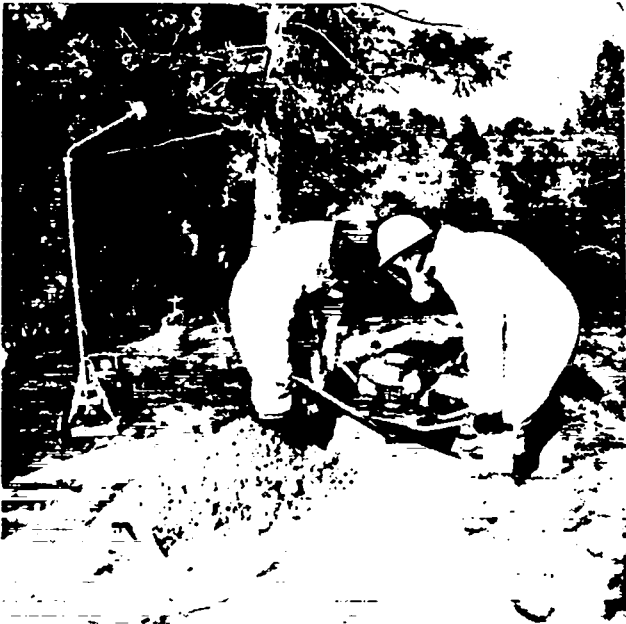
Fig. 17.  
Exploratory holes augered into the  
septic tile field.

Three exploratory holes were augered (Fig. 17) into the septic tank tile field to establish contamination levels. Levels encountered indicated that the soil was not highly contaminated and could be removed by a backhoe, using water for dust control (Fig. 18). The gross alpha contamination was less than 1 nCi per gram of soil.

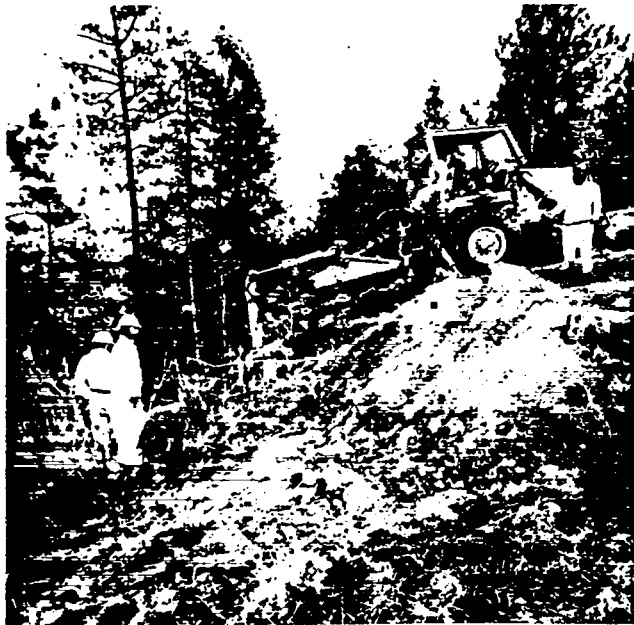
Fig. 19.  
Soil excavation at edge of canyon  
wall.

The tile field drain pipe daylighted at the edge of a canyon. Phoswich surveys indicated general contamination in the immediate area. Migration of the contamination below the surface necessitated excavation of a pit area measuring 3.2 m wide, 3.8 m long, and 3.2 m deep at the canyon wall (Fig. 19). After soil removal operations were completed, the site was monitored for plutonium contamination. The levels encountered were determined to be as low as practicable. The site was then contoured to conform with the surrounding terrain and native grasses were planted (Fig. 20).

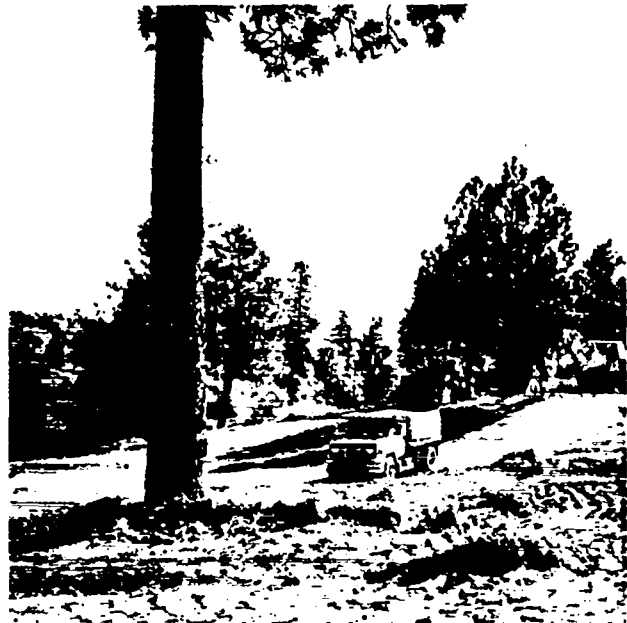
Fig. 22.

Transportation of waste was in tarpaulin-covered dump trucks.

All wastes were transported in tarpaulin-covered dump or flat-bed trucks (Fig. 22). Trucks, loaders, and bulldozers used to load or transport contaminated materials were monitored during the job and decontaminated as necessary.
