LA-6064-MS

**Ductile to Brittle Transition of U-0.75 wt% Ti
Penetrator Cores**

DUCTILE TO BRITTLE TRANSITION OF U-0.75 WT% Ti PENETRATOR CORES

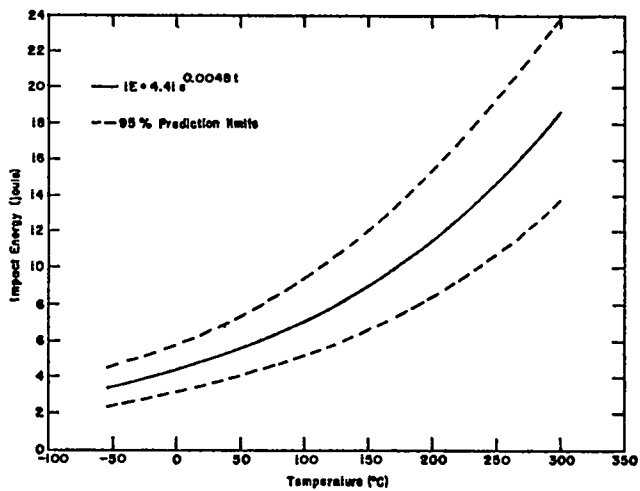
Fig. 1.

Impact energy vs temperature for U-0.75 wt% Ti penetrators.

The impact energy data obtained from this investigation are listed in the Appendix. LASL statisticians evaluated the data and found that the best fit was obtained by the following equation: impact energy (IE) in joules = $4.41e^{0.0048t}$, where e is the natural logarithm and t is the temperature. Figure 1 shows the plot of the above equation. Of the 28 data points observed, only 1 fell outside the 95%

prediction limits.* This point was at -54°C and outside the upper limit. If the alloy composition and processing history were similar, the curve generated by the equation could be used to predict impact values at temperatures up to 300°C .

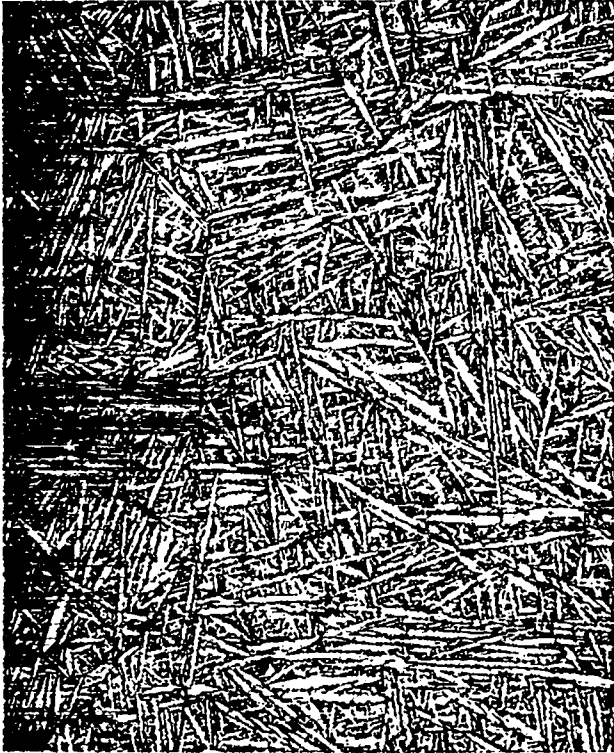
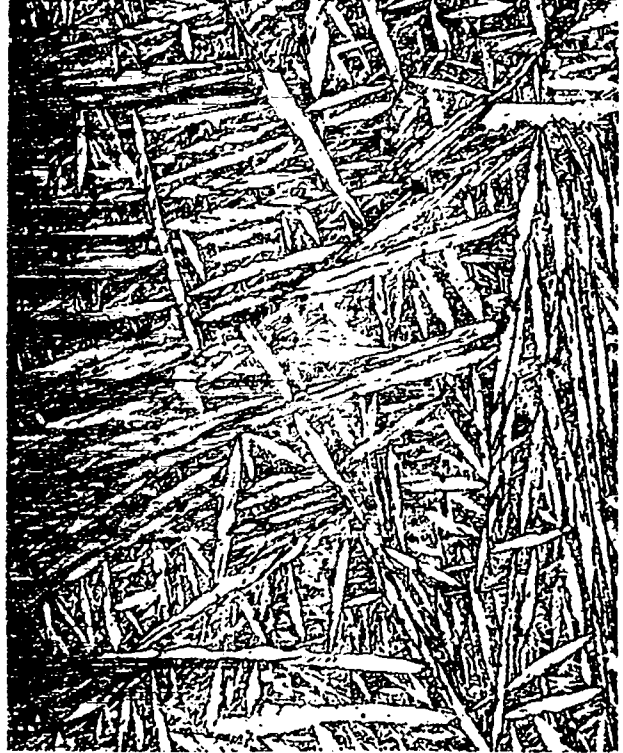
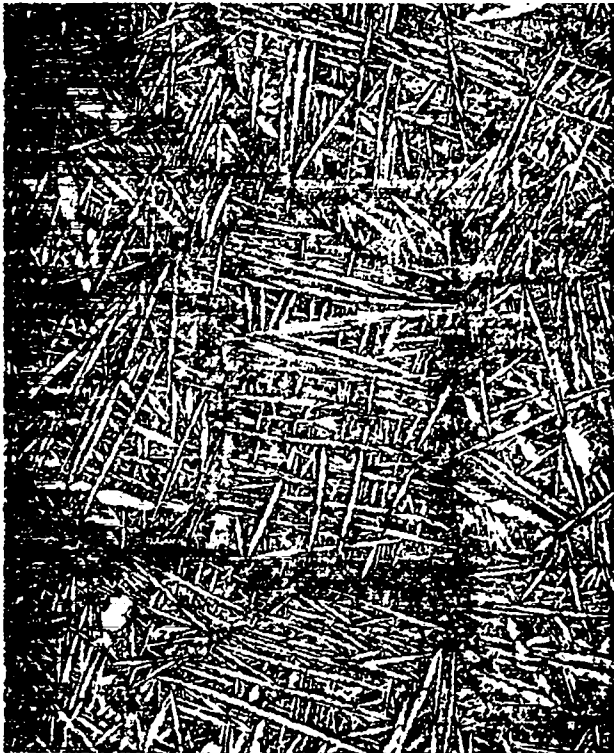
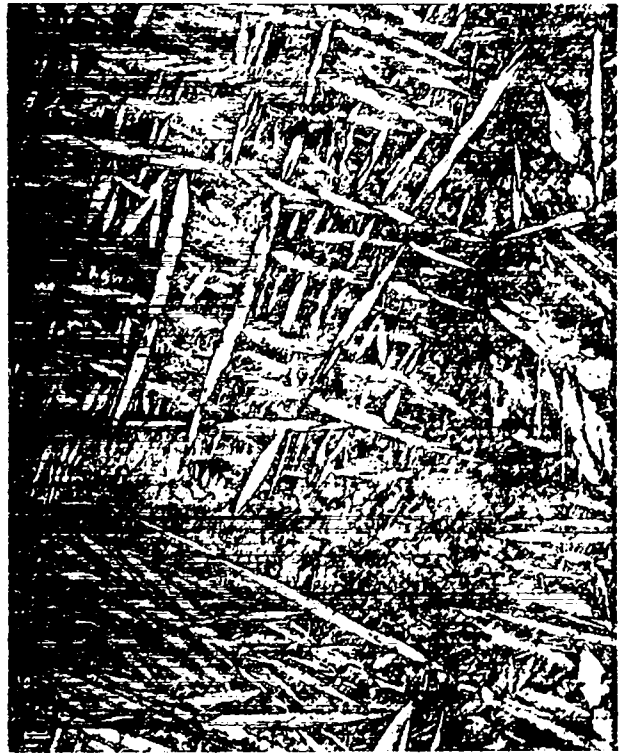
*Fig. 4.
Charpy bar tested at 23°C.*

a. Optical, 100X, side 1, 450 DPH

b. Optical, 250X, side 1

c. Optical, 100X, side 2, 430 DPH

d. Optical, 250X, side 2

e. SEM, 700X
Fig. 4.
Continued.

Figures 4a and b show a structure just past the optimum aging peak on one side of the specimen, whereas Figs. 4c and d show a structure on the opposite surface that represented a more overaged condition. The diamond pyramid hardnesses (DPH) generally confirmed this observation. The appearance of these two structures in the proximity of a penetrator core suggests a difference in quenching rate from the solution treatment temperature across this sample. Figure 4e again represents a brittle, cleavage fracture.

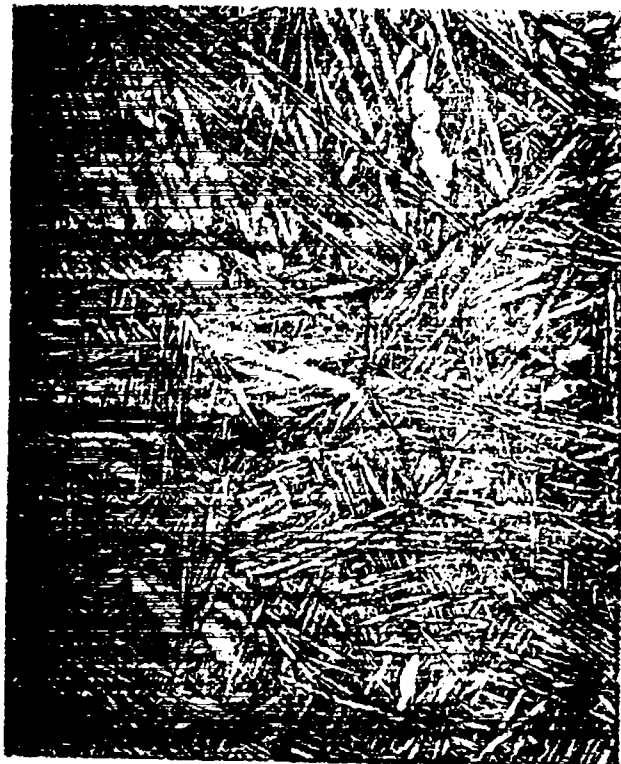
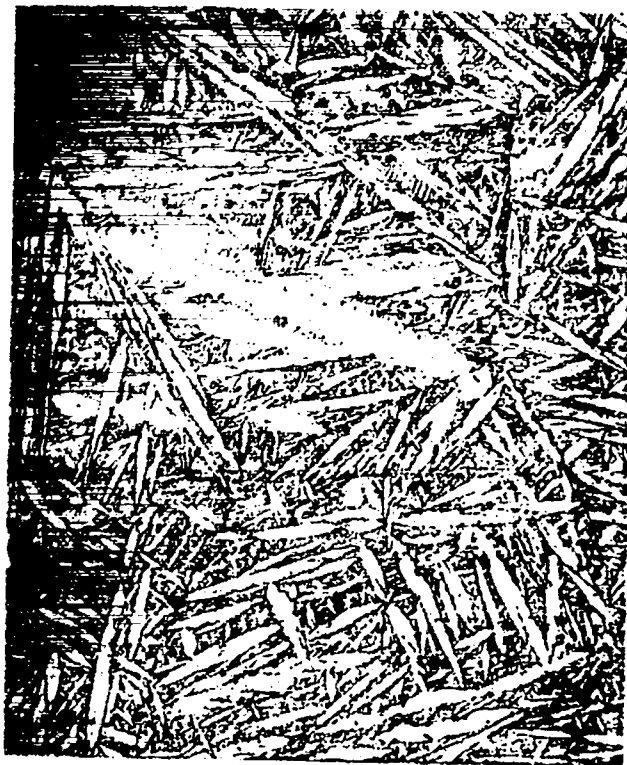
*Fig. 7.
Charpy bar tested at 200°C.*

a. Optical, 100X, 460 DPH

b. Optical, 250X

c. SEM, 700X

d. SEM, 1000X

e. SEM, 1000X

Figures 7a and b represent a structure with very little overaging. Figure 7c shows the entire width of the ductile zone at the notch, and Fig. 7d shows a higher magnification view. Figure 7e shows the transition from ductile to brittle fracture.
