NUCLEAR-CRITICAL ACCIDENT AT THE LOS ALAMOS
SCIENTIFIC LABORATORY ON DECEMBER 30, 1958

LAMS-2293
HEALTH AND SAFETY
(TID-4500, 14th ed.)

H. C. Paxton
R. D. Baker
W. J. Maraman
Roy Reider

This report is an informal account of the findings of a Los Alamos Scientific Laboratory committee appointed to investigate the circumstances surrounding the nuclear-critical accident that occurred at the Laboratory in December of 1958. It has been prepared to distribute the information as promptly as possible and presents the facts known at the time of writing.

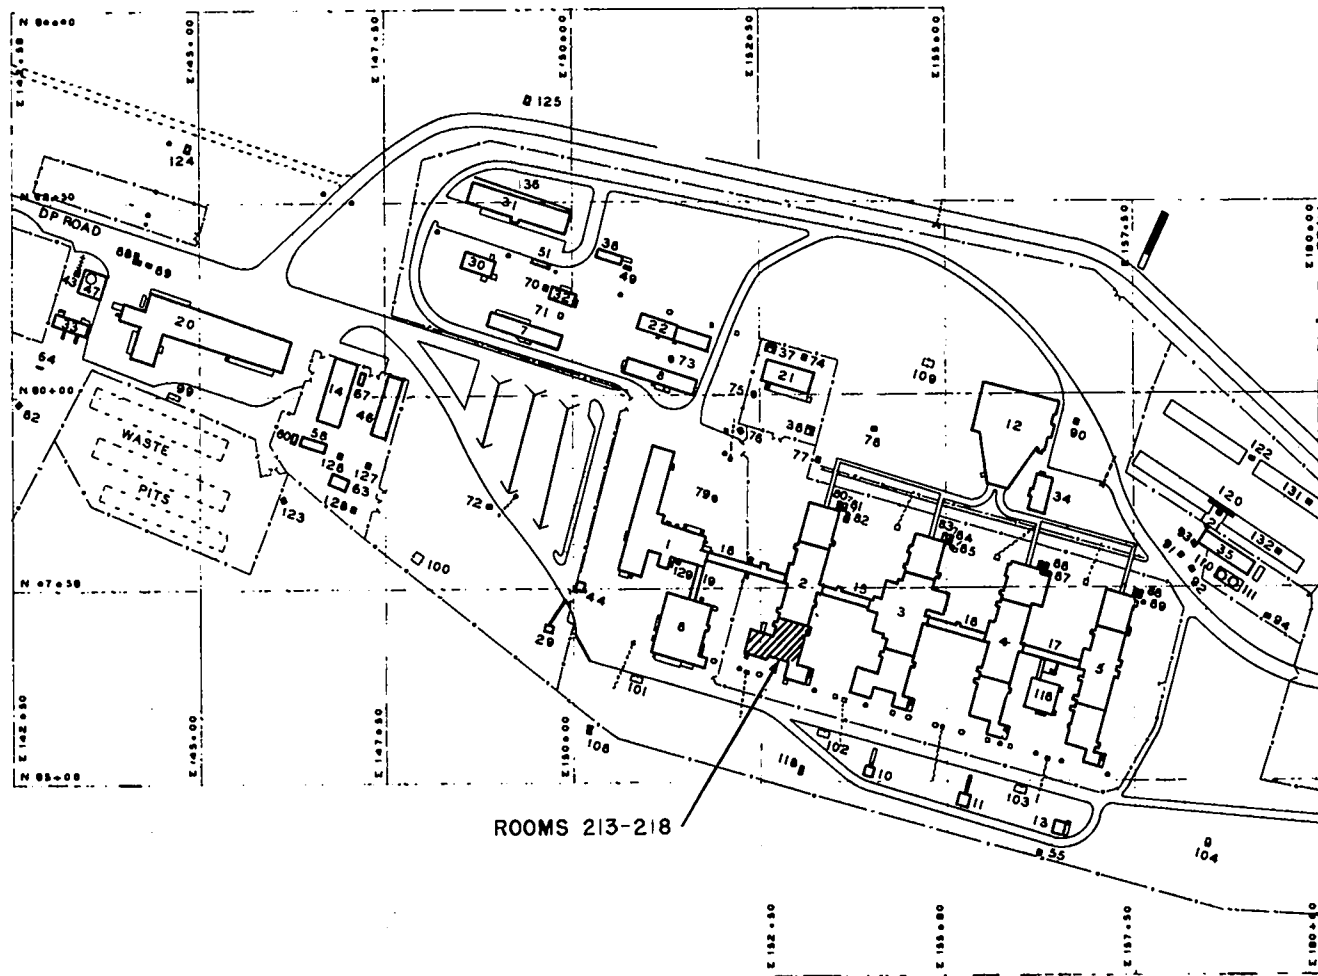
The layout of the site at which the accident occurred and the specific area involved (Rooms 213-218) are shown in Fig. 1. The part of the plutonium recovery operation involved in the accident was the tri-n-butyl phosphate (TBP) solvent-extraction process used to concentrate and purify plutonium from so-called "lean" residues, typically, solutions containing less than 0.1 g/liter of plutonium and traces of americium. A simplified flowsheet for the process is given in Fig. 2, and Fig. 3 shows the corresponding layout of equipment in the plant. Figures 4 to 9 delineate the steps involved in the procedures shown in Fig. 2.

Fig. 1 Map of DP Site. Shaded area indicates location of accident.
