LA-5755

Reporting Date: September 1974

**Demolition of Building 12,
An Old Plutonium Filter Facility**

**los alamos
scientific laboratory**

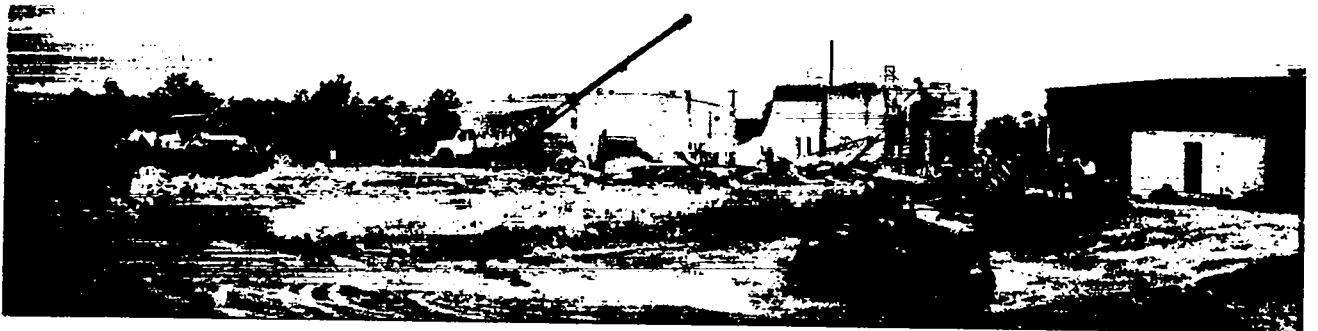
Fig. 28. Precipitron area after most of the steel had been removed.

After the steel was cleared away, only the concrete floor and foundations in the precipitron and filter remained (Fig. 28). The only contaminated areas on the floor

slabs were the edges that had been in contact with the expansion joints, and these areas were immediately painted. A bulldozer (Fig. 29) was used to lift the floor slabs and push them to an area where the payloader could load them onto a dump truck. Then the bulldozer was used to loosen and break the foundation into pieces small enough to load. Most of the foundation was 15 to 20 cm thick and 1.5 m deep. However, one piece of the foundation was nearly 75 cm wide, 1.5 m deep, and 30 m long. Efforts to break this foundation into small chunks with the bulldozer proved fruitless. Therefore, this 30-m piece of foundation had to be weakened by drilling a series of holes as a perforation line. Part of this perforation line is shown in Fig. 30. The bulldozer was then able to break this foundation into pieces small enough to be lifted onto the truck. Figure 31 shows the removal of the last concrete and dirt from the site.

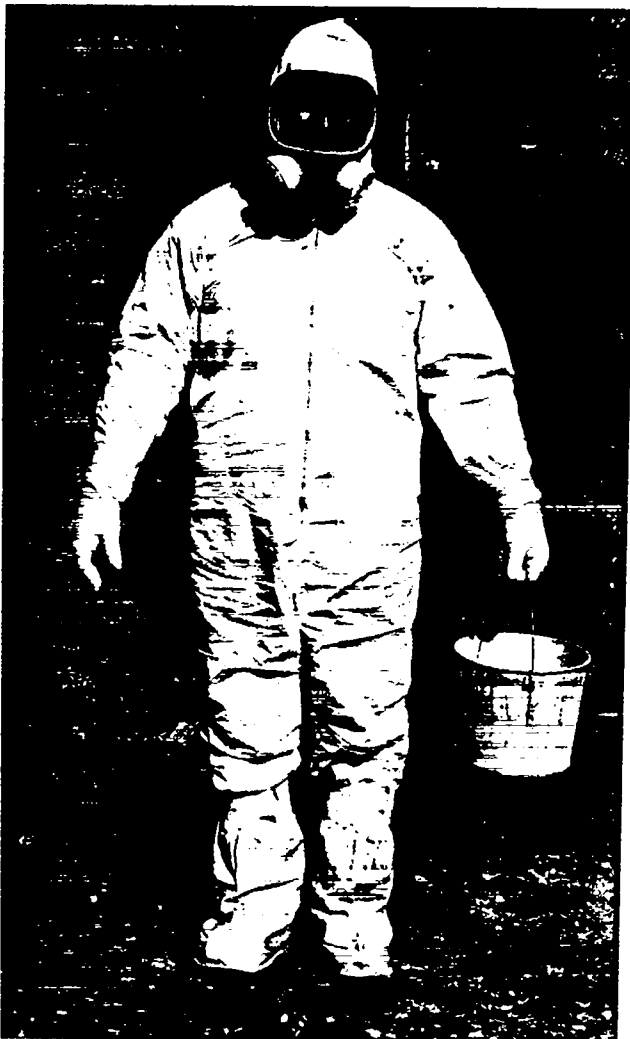
Fig. 34. Worker suited for demolition work.

Demolition workers were provided protective (anti-contamination) clothing for work in the area. For work inside the building, workers were double-suited with coveralls, booties, a cap and hood, gloves, and underwear (Fig. 34). Disposable paper coveralls, hoods, and plastic booties were used for outerwear. The outer garments were overlapped and taped together, and openings in the coveralls were taped shut. This clothing provided adequate protection against worker contamination during the demolition, and no personnel decontamination beyond normal showering and washing procedures was required.

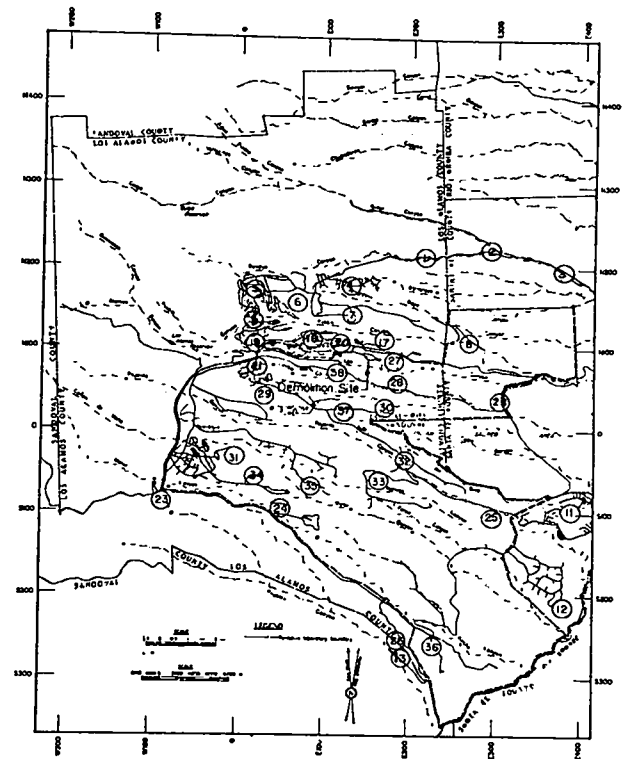
Fig. 35. Location of demolition site and air sampling stations.

The Los Alamos Scientific Laboratory Environmental Studies Group monitored the environmental impact of the demolition operation with its routine air sampling network and a special on-site sampling program. The routine air sampling network, consisting of 36 sampling stations was supplemented with two additional stations to more adequately encircle the demolition site. The positioning of the supplemental samplers was limited somewhat by availability of electrical power and access to the equipment. The location of these sampling stations (with the exception of the Santa Fe, Espanola, and Pojoaque stations) and of the demolition site are shown in Fig. 35.

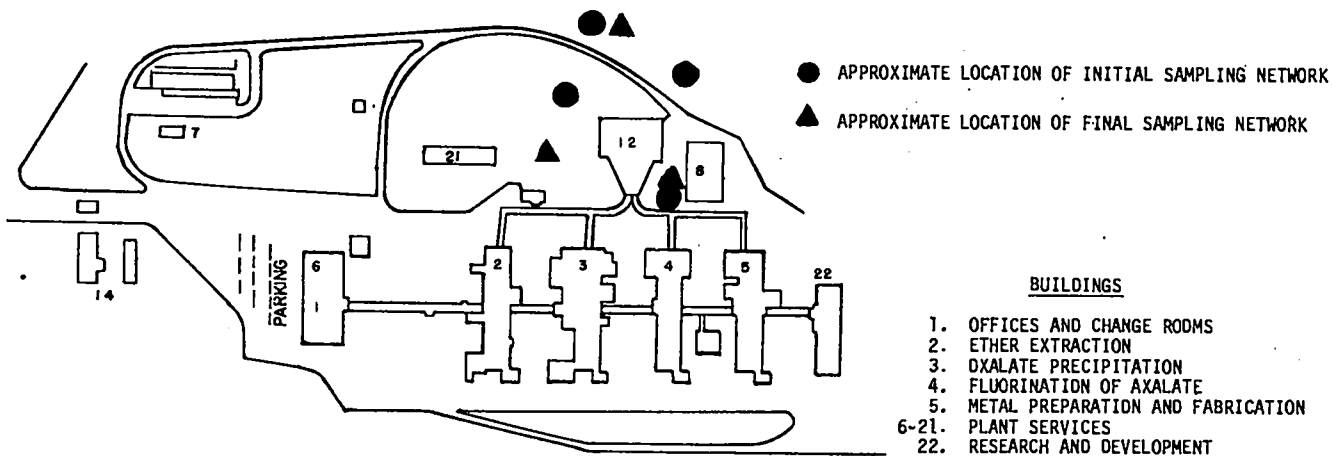
Fig. 36. On-site (TA-21) air sampler locations.

Air monitoring in the immediate vicinity of the structure was added to provide an early detection of a release of radioactivity. If such a release had been detected the operation would have been curtailed until more protective demolition measures could be used. These samples (location of samplers shown in Fig. 36) were collected daily. Because of mechanical failures, a variety of sampling devices and rates were used. On April 4, 1973, at the start of the sampling operation, the network consisted of four Staplex "Hi-Volume" samplers. They sampled through 76-mm-diam Microsorban paper (similar to the filter media for the weekly samples) at a rate of approximately $0.37 \text{ m}^3/\text{min}$. Two of the samplers were located near buildings and used line power; the other two were driven by gasoline-powered generators.

By the end of April three of the samplers had been changed to use 100-mm Microsorban filters to increase the flow rate and reduce pump heating. The flow increased to approximately $0.52 \text{ m}^3/\text{min}$. These samplers were located, as shown in Fig. 36, so that they could be operated on line power and were used throughout the remain-
