investigation report

Plutonium Contamination

Incident

*Wednesday, October 14, 1981*

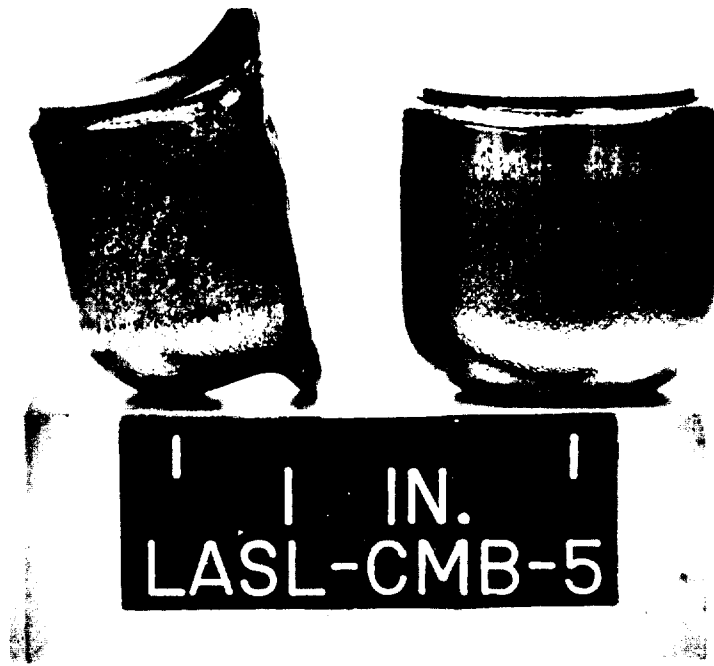
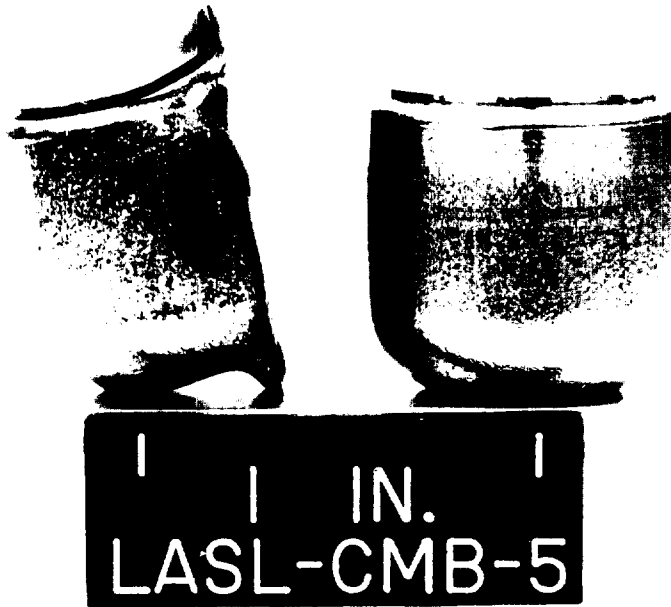
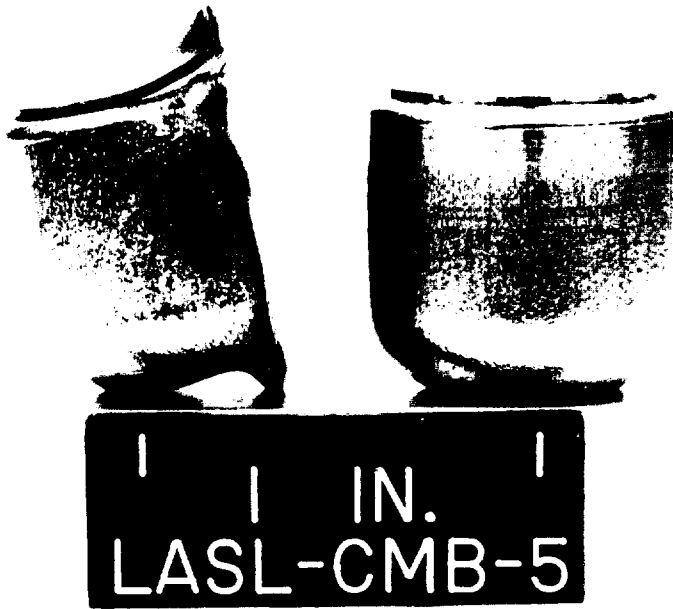
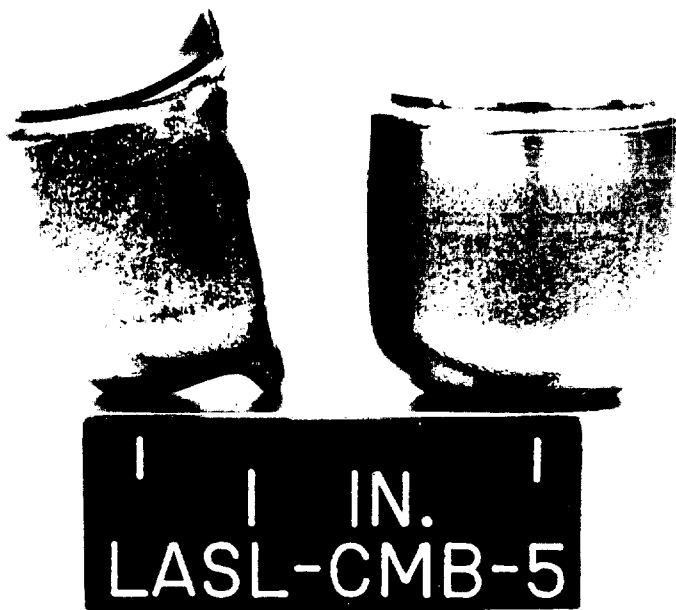
The right-hand side of Figure 7 shows an assembled heat source before impact, while the left-hand side of the figure shows the source after an impact test.

Fig 7 Appearance of heat source capsule before and after impact testing.

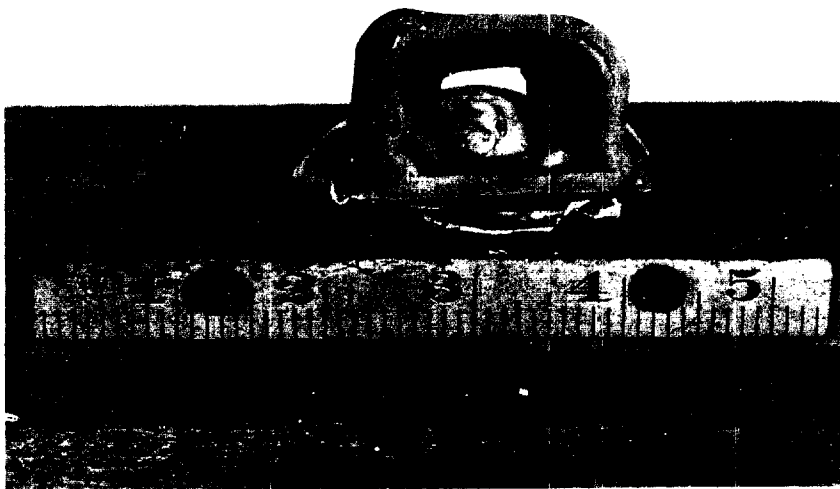
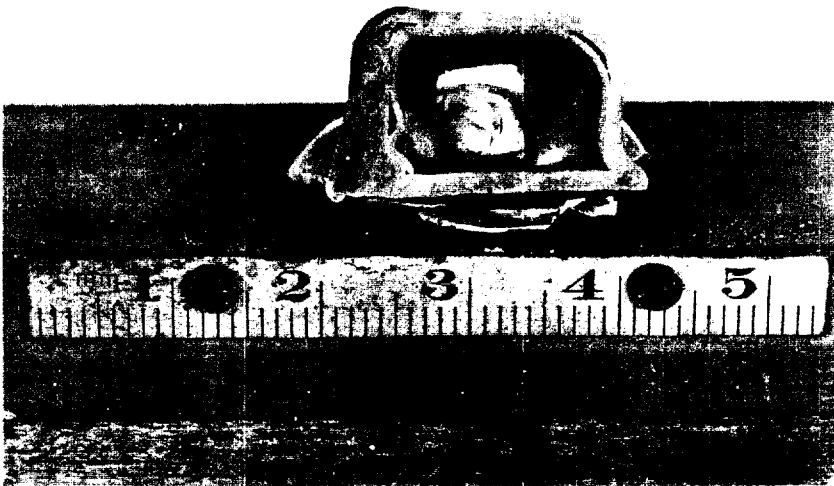
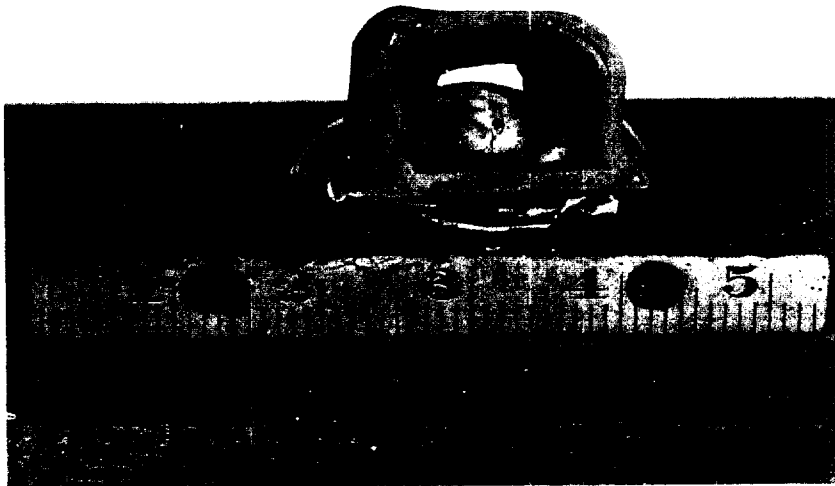
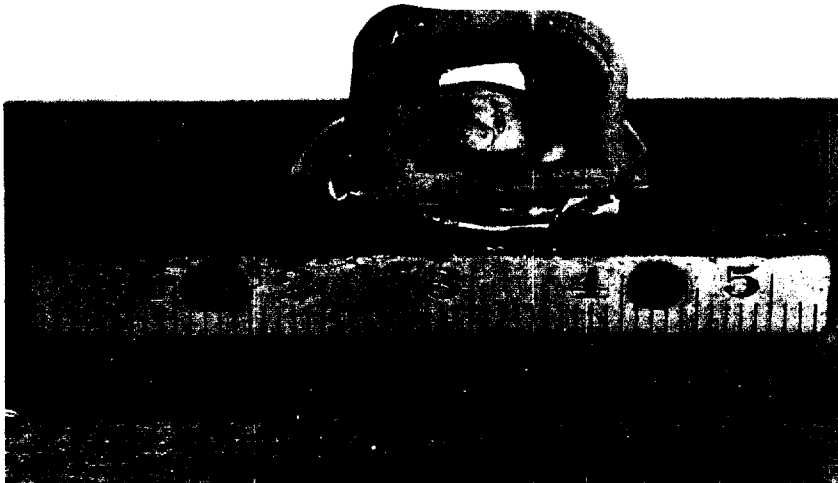
After impact, the source is placed in a glovebox and the outer cup is peeled off. The $^{238}\text{PuO}_2$ fuel is removed by way of a rectangular hole cut in the side of the capsule. The capsule is cleaned ultrasonically to remove most of the remaining fuel; it has been estimated that no more than about 2 mg typically remain. After impact, about 2% of the PuO_2 particles are found to pass through a 5 micron screen showing that impaction produces some pulverization of the oxide particles. After the fuel is removed, the capsule is sectioned as shown in Figure 8. Impact also causes folds and wrinkles in the liner cup and some of the fuel may remain embedded as shown in Figure 9. The capsule is further sectioned to provide samples of the welds and other regions for chemical analysis. The testing program began in December 1979, and by September 30, 1981, a total of 17 heat source capsules had been tested, giving rise to 160 separate analytical samples. An additional 10 weld-test samples, also contaminated with $^{238}\text{PuO}_2$, were submitted to CMB-1. In the capsule development stage of this program, 43 noncontaminated samples of the T111 alloy were prepared. The last set of these was submitted to CMB-1 on July 14, 1980.

Fig 8. Sectioned heat source capsule after ultrasonic cleaning
