TITLE: THE DETERMINATION OF BINDER DEGRADATION IN PLASTIC-BONDED EXPLOSIVES

AUTHOR(S): E. M. Wewerka, E. D. Loughran, and J. M. Williams

SUBMITTED TO: Conference on Propellant, Explosives, and Pyrotechnics Compatibility with Plastics and Additives, Picatinny Arsenal, Dover, New Jersey, December 3-4, 1974.

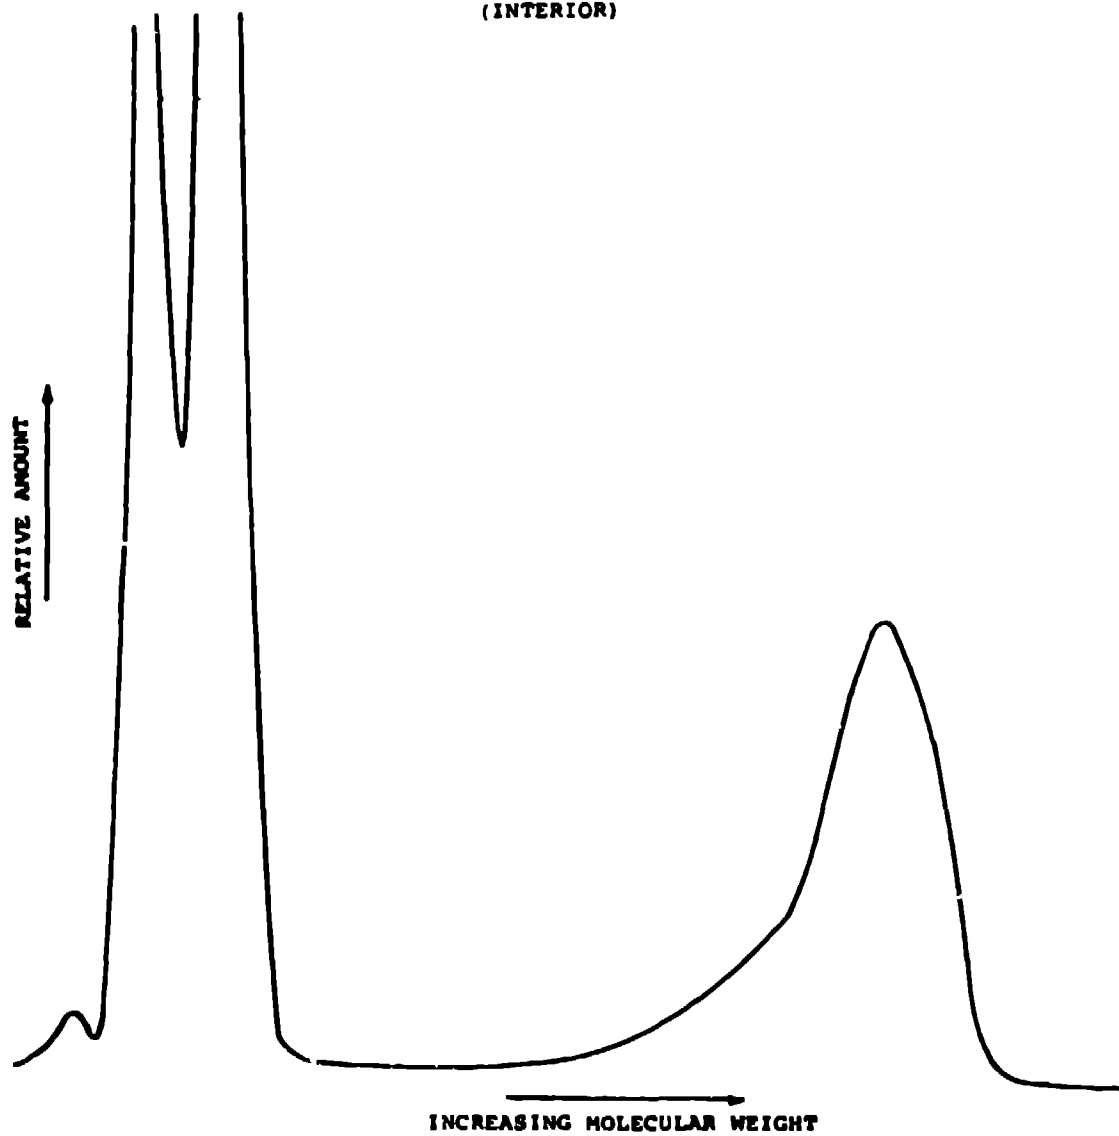
removed from the surface (Fig 4). These observations indicate that the nitrocellulose was depleted at the surface either by migration or reaction during storage; however, it is possible that it crosslinked and was no longer soluble in the extraction solvent.

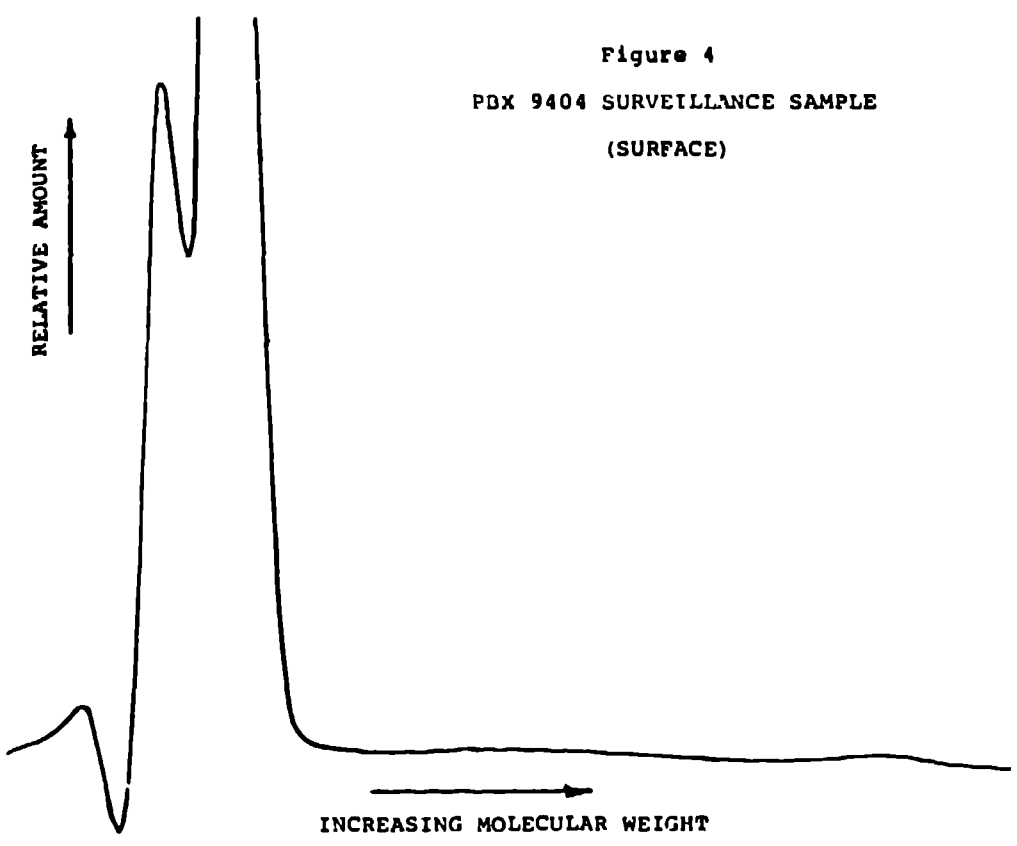
A final example of the use of GPC for analyzing binder degradation in explosive system is provided by our experience with a surveillance sample of PBX X-0234.** A GPC curve of a X-0234 reference sample is shown as the continuous trace in Fig 5. The acrylate polymer in this explosive has been poorly polymerized, shown by the low-molecular-weight tail extending all the way to the CEF peak. The dashed curve was obtained from the binder in an X-0234 sample that had been stored for just 4 weeks at 75°C. Here, as in the 9404 case just discussed, the polymeric component was found to be largely absent from the GPC curve; however, prior experience with another explosive similar to X-0234 suggests that the acrylate polymer in the surveillance sample was crosslinked during storage, rendering it insoluble.⁽¹⁾
