Title: **Mechanical Response of Shock
Conditioned HPNS-5 (R-1) Grout**

Author(s): Harry N. Plannerer

Author: Harry N. Plannerer
Los Alamos National Laboratory
Earth and Environmental Sciences Division
Los Alamos, NM 87545

09 December 1997

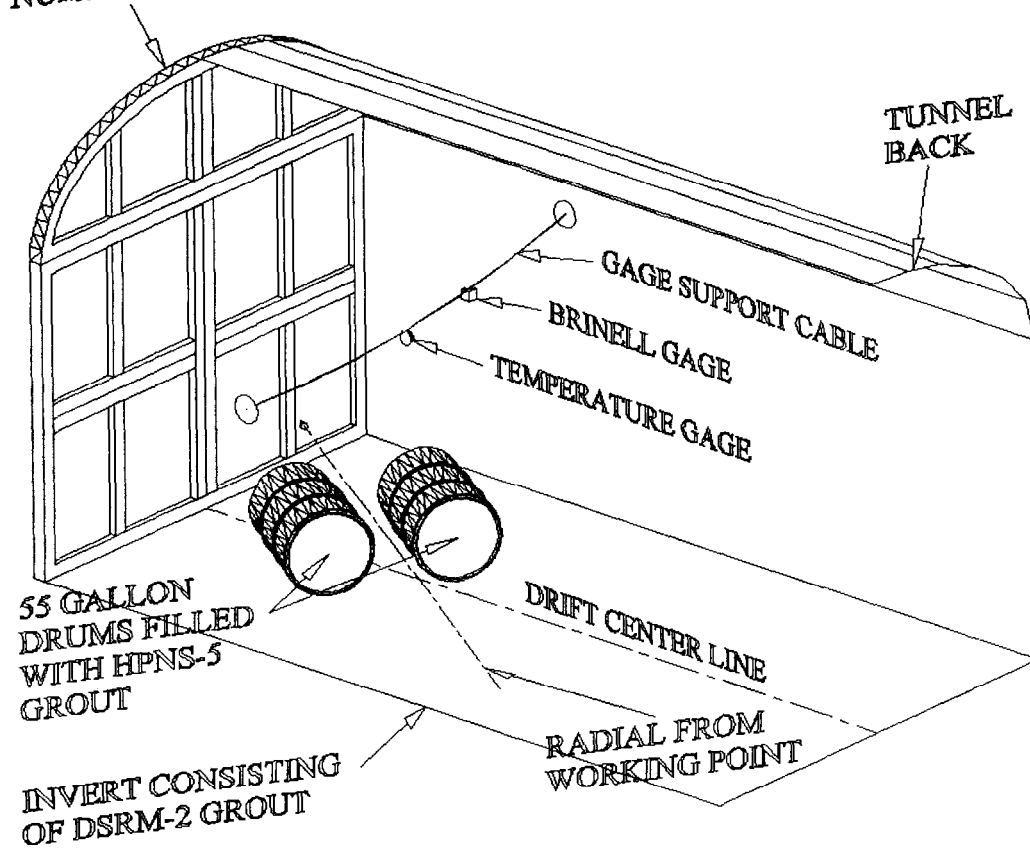
Fig. 1. Sketch portraying the configuration of grout-filled drums as emplaced in pour 30 of the U12p.04 by pass drift. The base of the drums (not visible in this perspective) were oriented toward the working point. The drift at pour 30 was 11 feet wide and 11 feet from invert to back.

Defense Nuclear Agency's DISTANT ZENITH line-of-sight event, executed in the NTS U12p.04 drift on 19 September 1991 (U. S. G. S., 1991), presented the opportunity to subject containerized stemming materials to a nuclear-driven stress wave and to retrieve them for characterization. The grout for this experiment was batched 30 August 1991 for the U3-jz handling exercise, placed in two 55-gallon drums and allowed to establish initial set prior to transport to the Area 12 portal. The grout-filled drums were then positioned in pour 30 of the U12p.04 by pass drift with their sides resting on the invert and flat circular bases oriented toward the working point (Fig. 1). It was planned that one drum each would be placed at two locations within the pour selected for their significantly different stress levels. However, as built they

were both placed side by side at the greater stress level location. The drums were enveloped in HSSL-50/50 (R-4) superlean grout (Table 1) during the button-up stemming operation of pour 30 on 03-04 September 1991. The HPNS-5 grout had cured 20 days at the time of the DISTANT ZENITH device detonation.

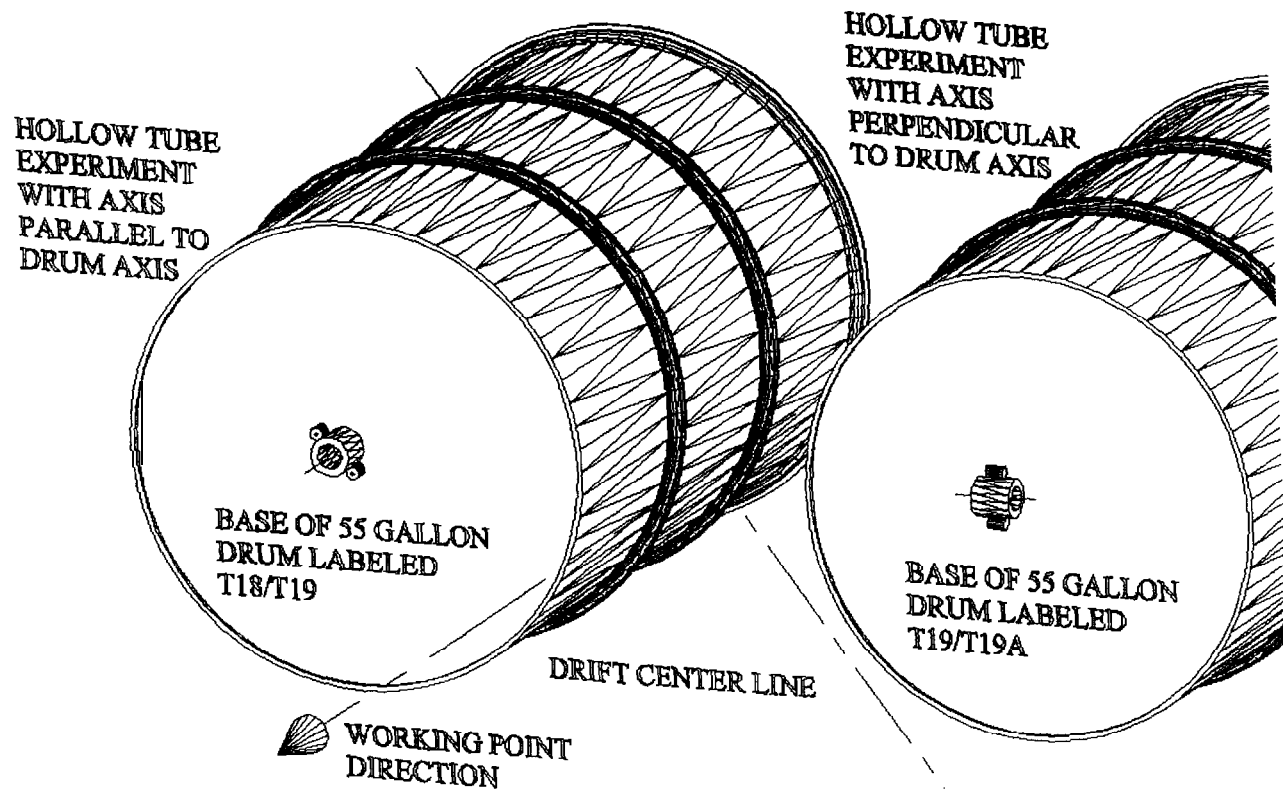
Fig. 2. Sketch portraying the orientation of the hollow tube experiments relative to the base of each grout-filled drum and to a radial from the working point.

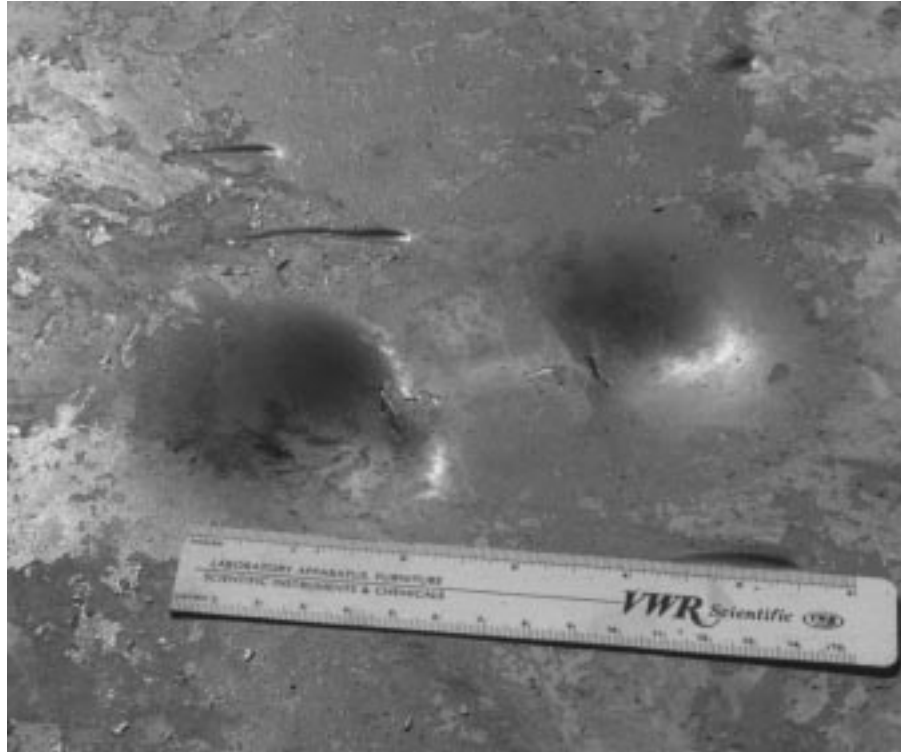
Fig. 3. View of sealed tube experiment exposed along the base of a grout-filled drum after shock conditioning. The axis of the tool steel cylinder is parallel with the flat circular base of the 55 gallon drum, and is aligned such that the extension of the axis passes through the two depressions visible in the figure. This view is shown with metal drum base removed. The two depressions, each measuring 2.5 inch to 2.75 inch diameter and 0.4 inch deep, were created when the differential stress between bulk grout and the interior of the steel cylinder was sufficient to favor ductile flow in the grout surrounding the cylinder end caps. The ductile behavior of the grout allowed its extrusion into the unoccupied volume (except for air) of the cylinder interior. Ductile flow ceased when the advancing extrusion front was confined by a similar front advancing from the opposite end of the cylinder (Fig. 4). Discoloration of the grout surface was caused by a coating on the interior of the 55 gallon steel drum. Top of scale is in inches, the bottom in centimeters.

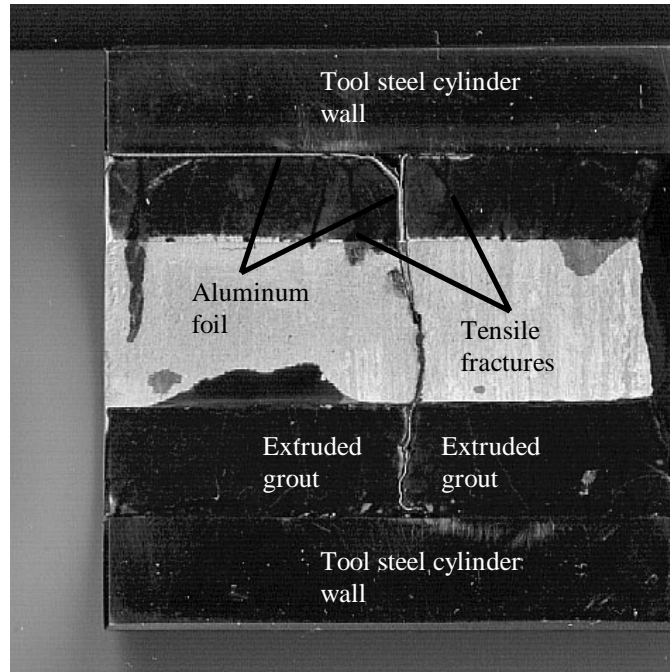
Fig. 4. Section along axis of tool steel cylinder extracted from one of two grout-filled drums which were subjected to a stress wave with average peak magnitude between 55.2 MPa and 74.8 MPa. The cylinder was originally void of material, sealed at both ends and placed in freshly poured HPNS-5 (R-1) grout at the base of a 55 gallon drum. The axis of the tool steel cylinder was oriented parallel with the flat circular base of the drum. Dark coloration of grout and adjacent tool steel in this figure is due to a stain. The light grey coloration is that of the grout exposed by extraction of a small diameter core along the axis of the experiment. In section, grout is observed to have extruded into the cylinder from both ends, pushing the aluminum foil end covers ahead of the advancing grout. A continuous, nearly planar aluminum foil - aluminum foil contact marks the meeting of advancing fronts. Aluminum foil is also observed between grout and the steel cylinder wall. The cylinder wall length is 2 inches.

With the package removed from the grout filled drum and sectioned along its cylindrical axis, HPNS-5 was found completely filling the center of the cylinder (Fig. 4). The aluminum foil and RTV sealant originally capping the ends of the cylinder were not ruptured, but rather were pushed from both ends to meet and form a nearly flat contact half way down the inside of the cylinder. No grout was found between the transported foil layers of aluminum. The foil and sealant were also found along the inside cylinder wall separating grout from the A2 tool steel. The grout, with its fine microscopic grain size, has nearly homogeneous texture and color. Several round-edged light colored inclusions similar to those found in unshocked material lie along the sectioned plane. These revealed no evidence of being fractured or distorted. Macroscopically, there was no appearance of shear banding or slip lines. There was also no evidence of turbulence along interfaces. These characteristics suggest that the grout was extruded into the air-filled space as a ductile material. Jagged hair-line tensile failure cracks perpendicular to the cylinder axis suggest a linear volume reduction parallel to the axis following full or partial extrusion into the original air-filled space.

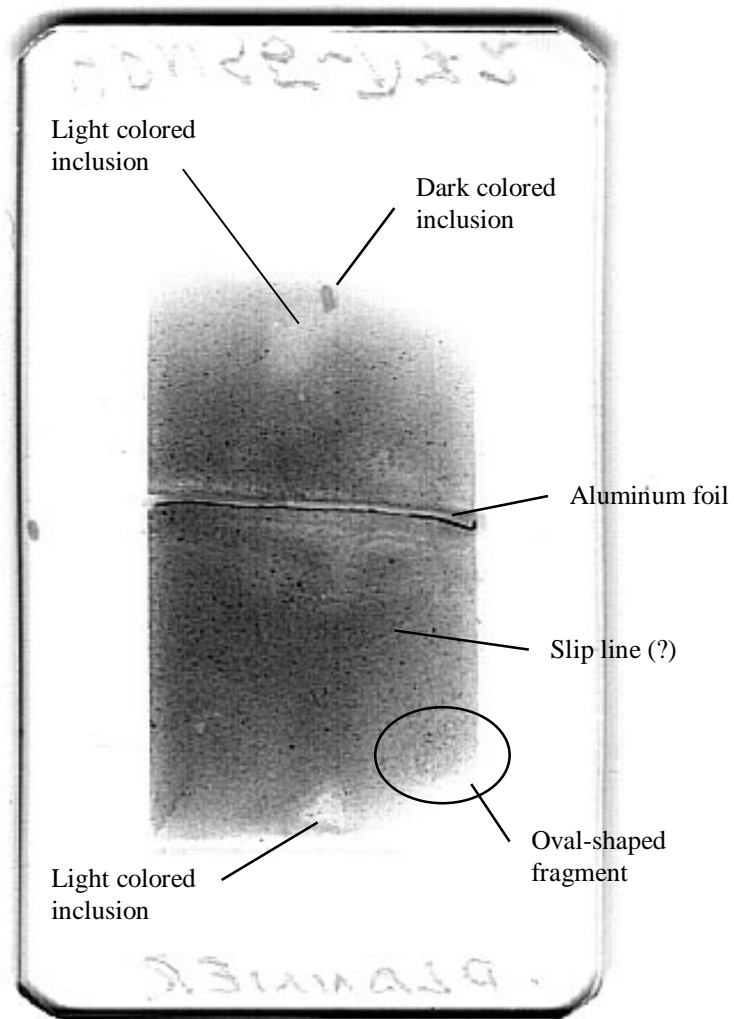
Fig. 5. Thin section view of grout - grout interface from sealed tube experiment shown in Fig. 4. The interface is marked by the thin dark line representing aluminum foil. Except for light and dark colored inclusions, the HPNS-5 grout appears largely homogeneous and featureless. Oval shaped fragments appear along the thinnest portions of the thin section. Slip lines appear as curved lines concave toward the interface. Width of glass plate outline (horizontal) is 1 inch.

Subtle features in a thin-section of the extruded grout provide evidence that the ductile flow is a microscopically brittle mechanism known as cataclastic flow (Paterson, 1978). Two features, noted in Fig. 5, are consistent with this mechanism. Their interrelationship, however, could not be deciphered from optical examination. The first feature consists of oval shaped structures with boundaries defined by slight grain size variations. These oval shaped structures appear to be fragments of grout that were available for rearrangement and relative transport past similar material. The second feature consists of curved lines suggestive of shear or sliding surfaces. These possible slip lines are not regularly spaced. Their curvature appears to be concave toward the extruding surface front which would be expected with

ductile flow. Both features are distinguishable from the ghostly angular inclusions present in the pristine grout, which have no obvious distortions following shock conditioning.

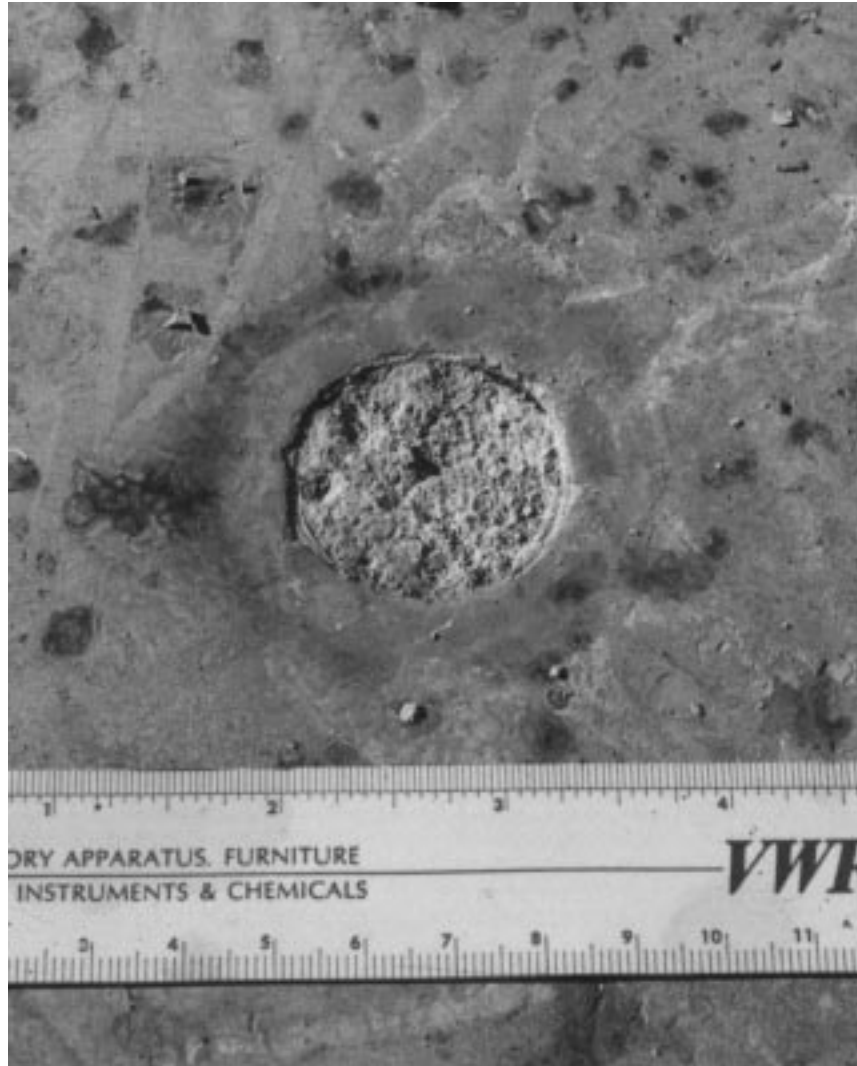
Fig. 6. View of sealed tube experiment exposed along the base of the second grout-filled drum after shock conditioning. The tool steel cylinder is oriented perpendicular to circular base of 55 gallon drum to yield a circular outline. This view is shown with metal drum base removed. Interior of the cylinder is filled with HSSL-50/50 (R-4) superlean grout, which originally surrounded the grout-filled drums after they were emplaced in the by pass drift of the DISTANT ZENITH event. HPNS-5 (R-1) grout surrounds the cylinder. Discoloration of the grout surface was caused by a coating on the interior of the 55 gallon steel drum. Top of scale is in inches, the bottom is in centimeters.

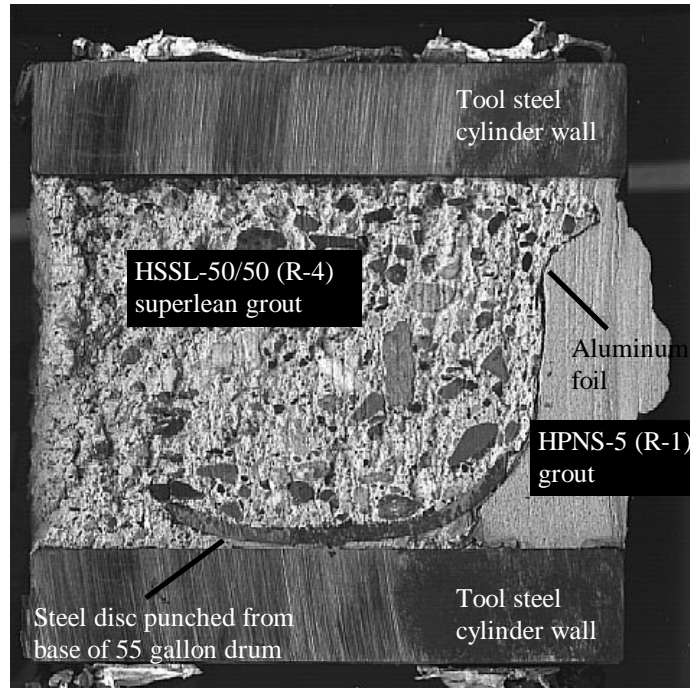
Fig. 7. Section along axis of the tool steel cylinder extracted from the second of two grout-filled drums which were subjected to a stress wave with average peak magnitude between 55.2 MPa and 74.8 MPa. The cylinder was originally void of material, sealed at both ends and placed in freshly poured HPNS-5 (R-1) grout at the base of a 55 gallon drum. The axis of the cylinder was oriented perpendicular to the flat circular base of the drum such that the left end of the cylinder, as viewed above, was against the base of the drum. The drum was then placed in the by pass drift of the DISTANT ZENITH event. In section, the cylinder was invaded from the left with HSSL-50/50 (R-4) superlean grout which punched a hole through the base of the 55 gallon steel drum. Superlean grout was the back fill used to button up pour #30 of the by pass drift. From the right HPNS-5 extruded a short distance into the cylinder pushing the aluminum foil end cap ahead of the advancing front. The cylinder wall length is 2 inches.

Sectioned along its axis, the A2 tool steel cylinder was also found filled with grout (Fig. 7). From one end of the cylinder came HSSL-50/50 superlean grout and from the other came HPNS-5 grout. At the conclusion of the flow processes, HSSL-50/50 occupied most of the tube volume. The HPNS-5 grout extruded 0.5 inch (1.25 cm) at most, and the extruding process pushed the original aluminum foil end cap ahead of it. The boundary between the two grouts is undulatory, evidently owing to the fluid-like mechanics of HSSL-50/50. The superlean grout was found to have encapsulated the circular piece of steel punched from the base of the drum, and transported it along the side of the tube's inner wall.

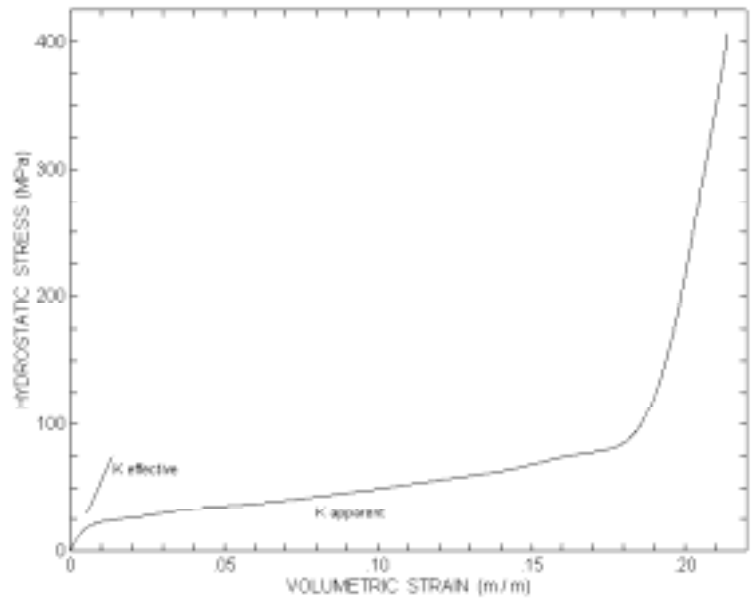
Fig. 8. Volume strain response of shock conditioned HPNS-5 (R-1) grout to hydrostatic stress. Linear elastic behavior occurs from ambient to 10.5 MPa stress. The effective elastic bulk modulus, $K_{\text{effective}}$, is represented with the slope of the indicated line segment. Between 10.5 MPa and about 80 MPa the grout is subjected to crushing and the elimination of pore volume. For this stress range the linear segment is represented with slope K_{apparent} , the apparent bulk modulus. Above 80 MPa the grout responds with stiffening or loading of the grout matrix.

The volumetric strain response of the shock conditioned grout to 400 MPa (58.0 ksi) hydrostatic stress is represented in Fig. 8. The curve in this figure displays an initial steep rise in response to linear elastic deformation that is interrupted with a long shallow slope corresponding to elimination of pore volume before the slope returns again to a steep rise. The proportionality between hydrostatic stress and volume strain occurs from ambient stress to 8.5 - 10.5 MPa (1.23 - 1.52 ksi). The average slope of the line representing this relationship is 5.51 ± 0.28 GPa (799.4 \pm 40.6 ksi), which is the effective elastic bulk modulus ($K_{\text{effective}}$) for the shock conditioned HPNS-5 grout. This constant is known as an "effective" constant because the grout is not responding solely as a solid material but as a solid structurally modified with microcracks (microfractures) and pores. Individual elastic ranges determined for seven test specimens and their corresponding $K_{\text{effective}}$ values are listed in Table 2.

Above 10.5 MPa hydrostatic stress, the elastic behavior is lost. The stress is sufficient to cause microstructural damage to the grout matrix surrounding pores and incipient microcracks. The effect is one of crushing and elimination of pore volume. Depending on stress magnitude, the amount of volumetric compaction may be significant, i.e. volume strain will exceed 2% - 5% and can reach 17% or greater. The slope of this curve in Fig. 8 is shallow

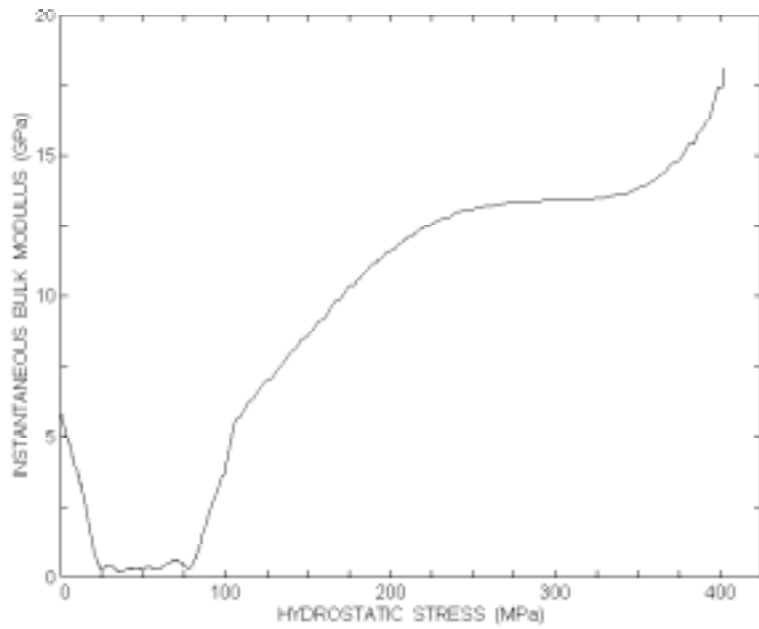
Fig. 9. Instantaneous bulk modulus of shock conditioned HPNS-5 (R-1) grout as a function of hydrostatic stress.

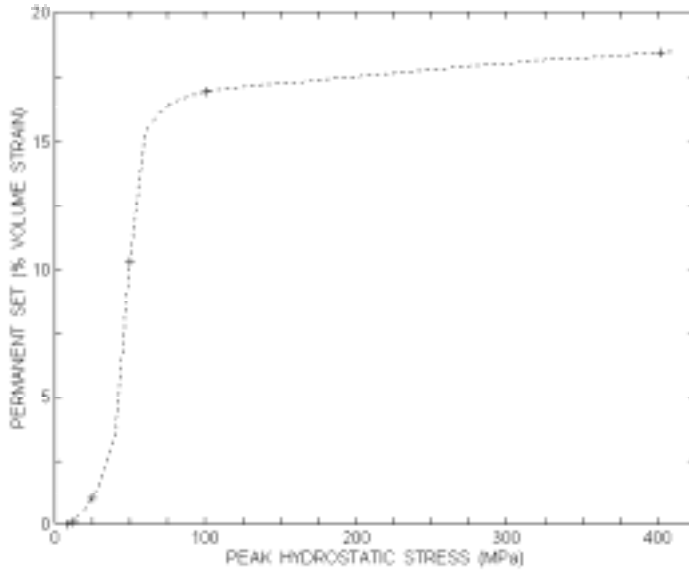
Fig. 10. Permanent set for shock conditioned HPNS-5 (R-1) grout as a function of peak hydrostatic stress. Data obtained from mechanical tests are indicated with '+' marker.

A load and unload cycle of hydrostatic stress with peak stress beyond the elastic range does not allow the grout full strain recovery. The unrecovered strain is known as permanent set. Permanent set as a function of peak hydrostatic load for stress conditioned grout is shown in Fig. 10. From about 25 MPa (3.6 ksi) to 60 MPa (8.7 ksi) peak stress the permanent set dramatically increases from about 1% volume strain to more than 15% strain.

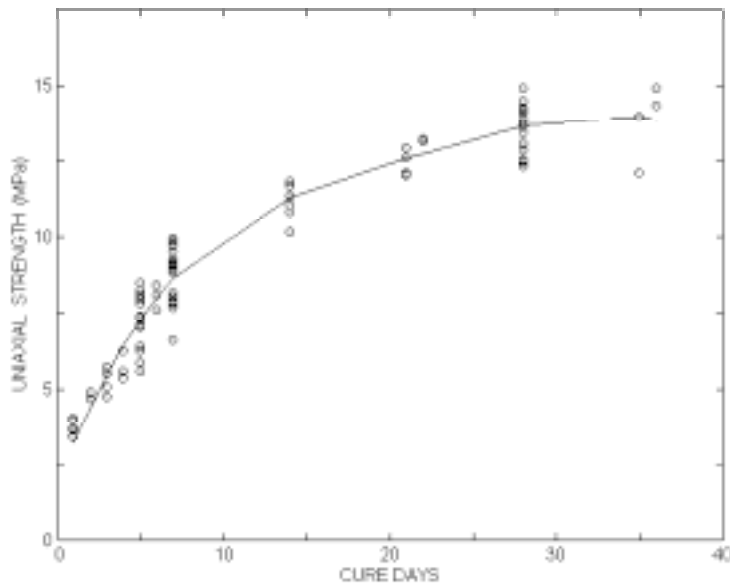
Fig. 11. Uniaxial compressive strength of pristine HPNS-5 (R-1) grout as a function of days cured. This data set was obtained from grout prepared for the U3-ml emplacement and satellite boreholes. A polynomial fit to the data set is shown with the curved line.

Ultimate strength of the unconfined grout as a function of cure time may be estimated from uniaxial compressive strength data obtained from break tests. These strength data represent the grout's fracture failure strength. Figure 11 shows the uniaxial compressive strength of HPNS-5 (R-1) grout as a function of days cured. These data were obtained for grout collected during several batching activities, including the deep rigid plug emplacement for the DIVIDER event in borehole U3-ml. The solid curve through the data represents a polynomial fit to the U3-ml data set. At a cure time of one day the grout exhibits an ultimate strength of about 3.5 MPa (510 psi) increasing to 12.7 MPa (1.84 ksi) at 20 cure days. The containerized grout placed in the

DISTANT ZENITH event would have exhibited an unconfined compressive strength of about 12.7 MPa at the time of event detonation.

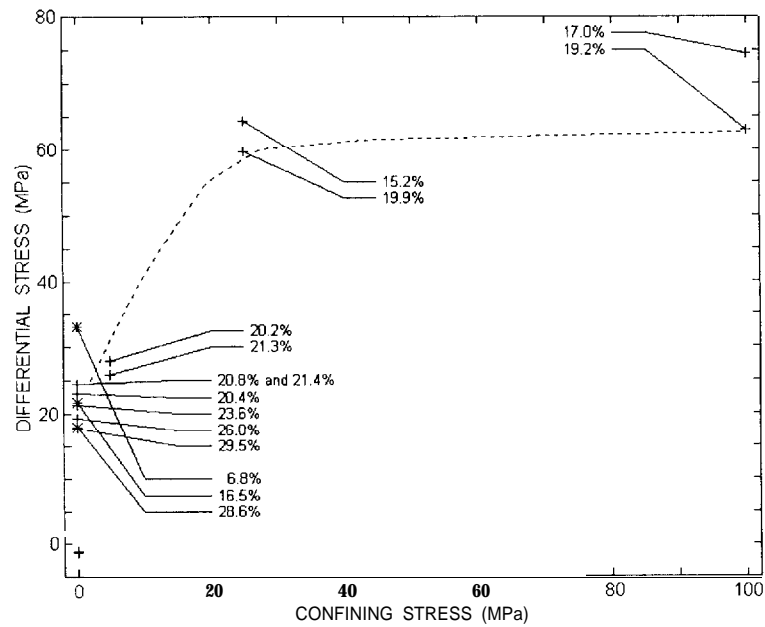
Fig. 12. Ultimate strength of pristine (*) and shock conditioned grout (+) cured for more than 374 days. Moisture content of test specimens are indicated with percentage values. Moisture contents for the two tensile tests were not determined. Dashed line approximately represents the ultimate strength of shock conditioned grout at 20% moisture content as a function of confining stress.

The ultimate strength for unconfined grout cured for more than 374 days was determined from standard uniaxial compressive strength tests to be 18.0 - 33.2 MPa (2.61 - 4.82 ksi) for pristine grout and 17.8 - 24.6 MPa (2.58 - 3.57 ksi) for shock conditioned grout. As with the break tests, these strength data represent the grout's fracture failure strength. The strength values are a function of moisture content (Table 3; Fig. 12) with the ultimate strength increasing as moisture content and bulk density values decrease. At about 29% moisture content both pristine and shock conditioned grouts display similar strengths. The rate at which the grout strength increases with decrease in moisture content is otherwise dissimilar for pristine and shock conditioned materials.

At a confining stress of 25 MPa (3.63 ksi) the ultimate strength of shock conditioned grout with 19 - 20% moisture content increases to 59.6 MPa (8.65 ksi). Above 25 MPa confining stress the rate of increase substantially diminishes such that at 100 MPa (14.50 ksi) the strength is 62.9 MPa (9.13 ksi). Again, the strength values are a function of moisture content. Similar data for pristine grout is not available. Between ambient and 5 MPa confining stress the failure mechanism for the grout at ultimate strength changes from brittle fracture to ductile behavior. This characteristic of the grout is discussed further in a separate section.

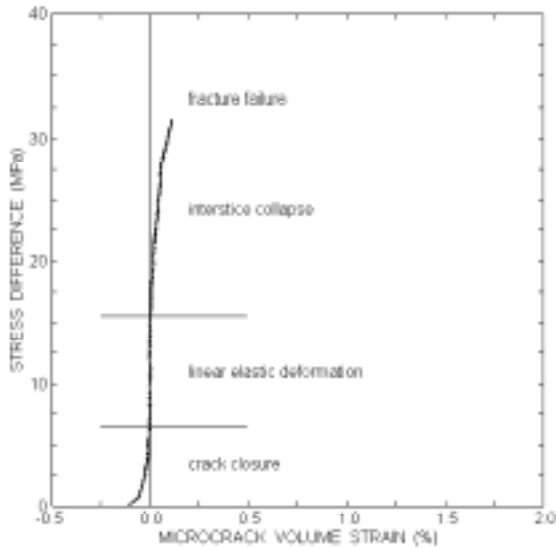
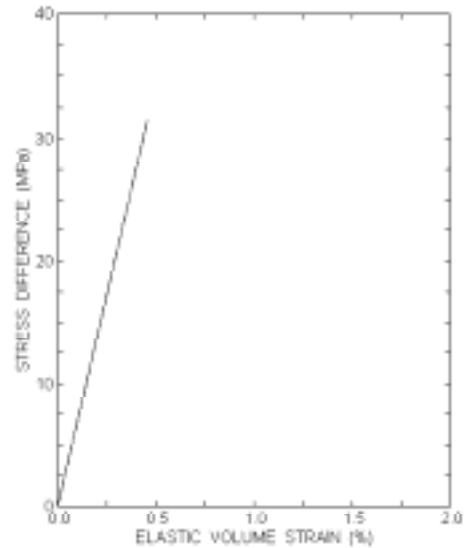
Fig. 13a. Deviation from linear elastic deformation for pristine specimen HPNS5-U3 subjected to uniaxial compression. Vertical line at zero strain represents elastic behavior. Deviations trending to more positive values with increasing stress imply compaction strain. Horizontal lines are stress levels separating types of mechanical behavior.

Fig. 13b. Elastic volume strain contribution to specimen HPNS5-U3 in uniaxial compression.

Three stages of mechanical response are recognized from Fig. 13a for pristine grout specimen HPNS5-U3 in uniaxial compression. The trace which starts left of zero and approaches zero strain with increasing stress identifies the initial stage as crack closure (compaction). Crack closure gives to linear elastic deformation as the crack volume approaches, and then maintains, a value of about zero strain. At this point the total contribution to specimen deformation shifts to linear elasticity. As the trace for crack volume deviates from zero strain it progresses to positive strain values (compaction) indicating interstice collapse. Dilatancy is not detected in this trace. As the differential stress approaches ultimate strength, the elastic strain contribution (Fig. 13b), which is also a compactional strain, dominates specimen deformation.

The effect of shock conditioning on strain response is evaluated by comparing specimen HPNS5-DZ-DRM2#2 (Fig. 14a) with HPNS5-U3 (Fig. 13a). Both specimens were tested in uniaxial compression. Overlooking the omission of a crack closure response, the significant difference in the traces comes with the magnitude of the microcrack strain response during interstice collapse. This compaction strain contribution overtakes that resulting from elastic deformation, and dominates up to ultimate strength. This behavior among shock conditioned specimens continues and is more pronounced at a confining

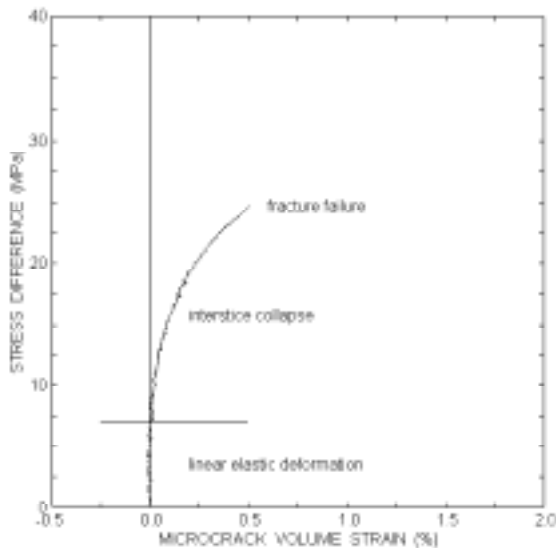
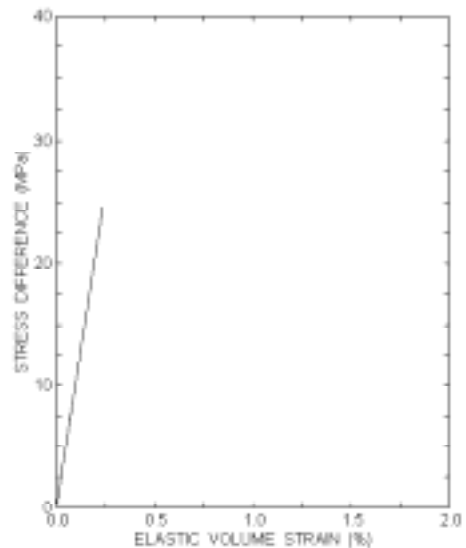
Fig. 14a. Deviation from linear elastic deformation for shock conditioned specimen HPNS5-DZ-DRM2#2 subjected to uniaxial compression.

Fig. 14b. Elastic volume strain contribution to specimen HPNS5-DZ-DRM2#2 in uniaxial compression.

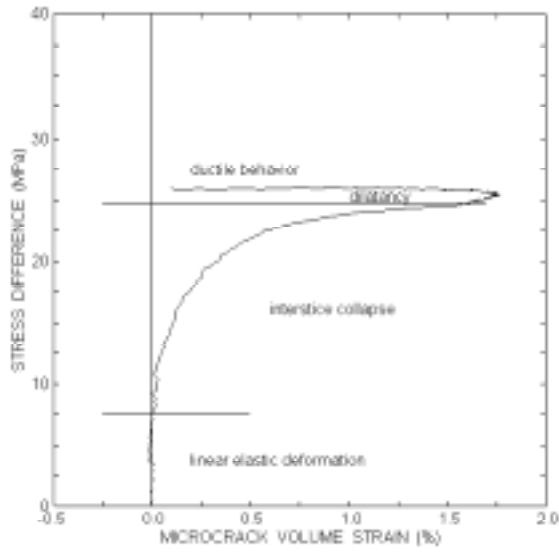
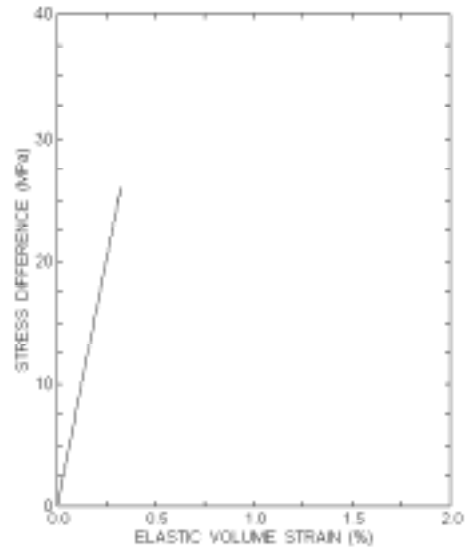
Fig. 15a. Deviation from linear elastic deformation for shock conditioned specimen 301 subjected to a differential stress while maintained at 5 MPa confining stress.

Fig. 15b. Elastic volume strain contribution to specimen 301 in triaxial compression.

stress of 5 MPa (Figs. 15a and b). The characteristic is lost in specimens maintained at 100 MPa confining stress (Fig. 16a and b).

In Figs. 15a and 16a a stress level is indicated for the transition between interstice collapse and dilatancy marking the initiation of microcrack growth. Microcrack growth creates volume strain and counters the contributions to compaction strain due to both elastic response and interstice collapse. The net result is a decrease in compaction strain. Ultimately the specimen exhibits a net volume change that is expansive. That is, it is possible to have the final grout volume, intact with no macroscopic fractures, equal or exceed its original volume.

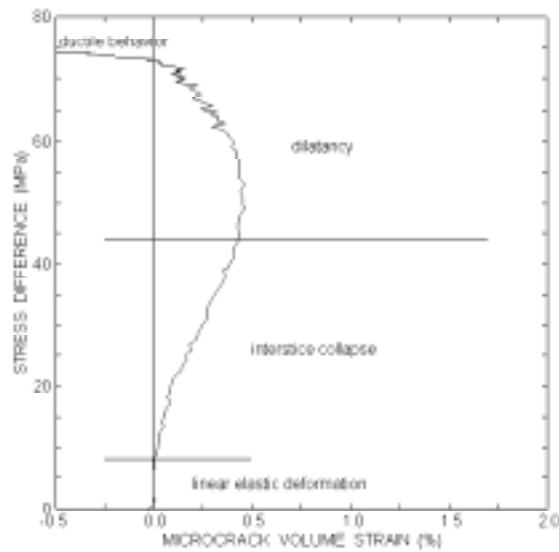
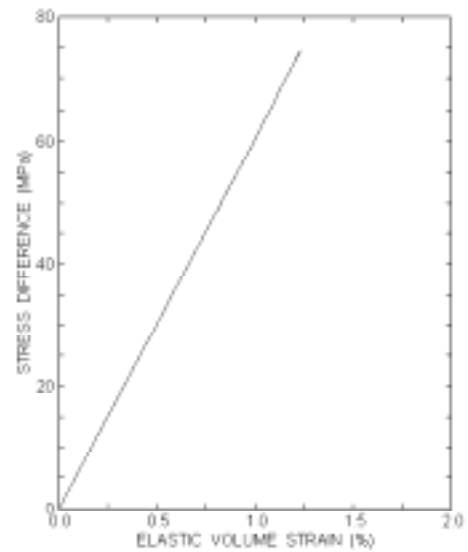
Fig. 16a. Deviation from linear elastic deformation for shock conditioned specimen 306 subjected to a differential stress while maintained at 100 MPa confining stress.

Fig. 16b. Elastic volume strain contribution to specimen 306 in triaxial compression.

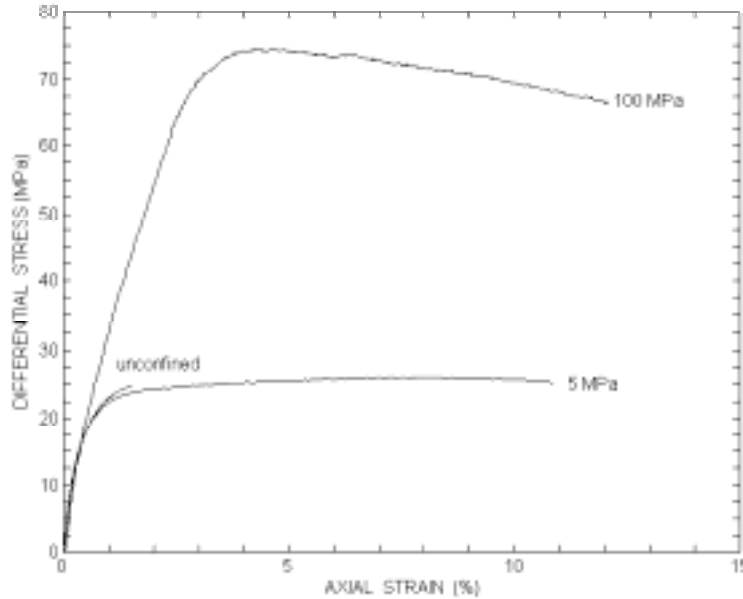
Fig. 17. Comparison of axial strain response of shock conditioned HPNS-5 (R-1) grout to triaxial loading at three different confining stresses. Confining stress is indicated at terminus of each trace. Trace for unconfined specimen HPNS5-DZ-DRM2#2 culminates with brittle fracture failure at 24.6 MPa differential stress and 1.53% compaction strain. At 5 MPa confining stress, specimen 301 followed nearly an identical strain response as HPNS5-DZ-DRM2#2, but instead of failing in brittle fracture made the transition to ductile behavior. As a ductile material the grout sustained a differential stress of about 25.9 MPa. With this sustained stress the specimen was capable of flowing until restricted by some physical boundary. The mechanical test was terminated prior to ductile fracture failure. Specimen 306, having a significant reduction in pore volume resulting from hydrostatic loading to 100 MPa confining stress, attained an ultimate strength of 74.5 MPa differential stress at 4.6% compaction strain. Like specimen 301, this grout made the transition to ductile behavior, however, could not sustain the ultimate strength of 74.5 MPa. As the specimen continued to deform, its instantaneous strength diminished. Again, the mechanical test was terminated before the grout failed in ductile fracture.

Figure 17 shows axial strain as a function of differential stress for three shock conditioned specimens, one specimen that was tested unconfined, and one specimen each at 5 MPa and 100 MPa confining stress. The form of this figure conveys the characteristics of ductile behavior. For the unconfined specimen the trace of its axial strain rises steeply with stress to about 17.5 MPa (2.54 ksi) before the slope of the trace yields, significantly decreases, and finally terminates with fracture failure at 24.6 MPa (3.57 ksi). The specimen maintained at 5 MPa confining stress follows nearly the identical trace as the unconfined specimen. However, specimen distortion with greater than 10% axial strain is observed as the specimen attains and sustains ultimate strength. This specimen was incapable of sustaining a differential stress greater than 25.9 MPa (3.76 ksi) but as long as that stress was sustained the specimen was capable of flowing until restricted by some physical boundary. This characteristic reasonably describes 'fully ductile' behavior (Jaeger and Cook, 1979) as the terminology is applied to ductile metals.

At 100 MPa confining stress the trace of the axial strain shows that the specimen achieved an ultimate strength of 74.5 MPa. Unlike the specimen at 5 MPa confining stress, this specimen was incapable of maintaining ultimate strength. As the grout lost strength it continued to show large strain distortions. By maintaining instantaneous ultimate strength the specimen was capable of flowing indefinitely unless physically restricted. This characteristic of the stress-strain envelope reasonably describes work softening.
